## NARRATIVE RISK ASSESSMENT – PASSIVE TEMPLATE FINAL v2.0

### PASSIVE LEVEL CROSSING RISK ASSESSMENT

This is a risk assessment for Thurston Station level crossing.

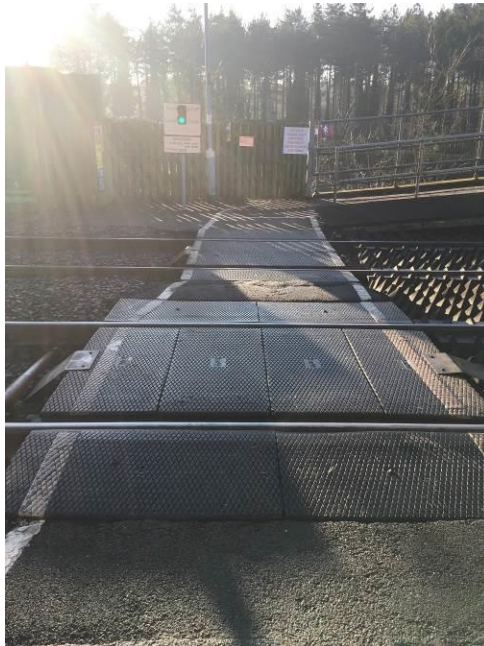
DSAC

Sighting is slightly obscured by the MSL equipment on the down side.

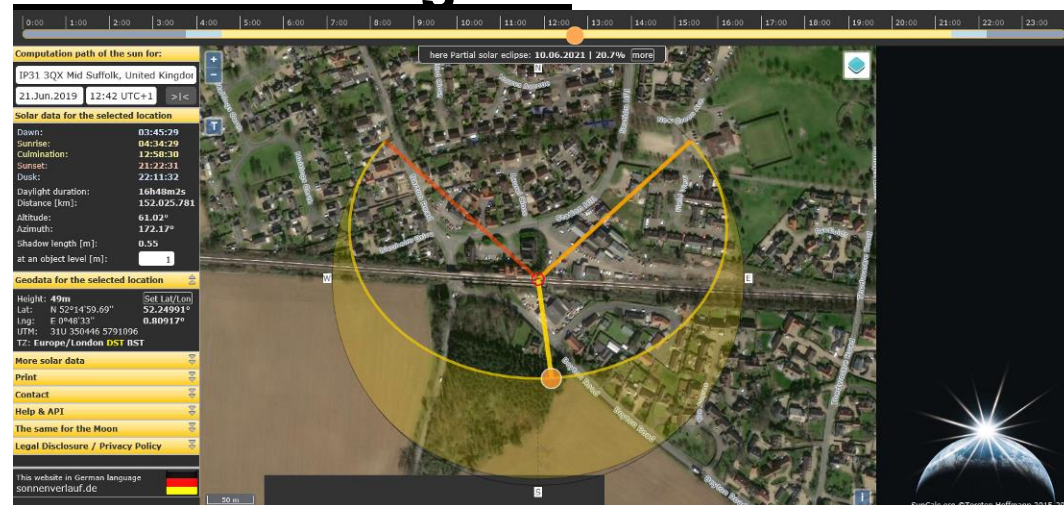
## Summer sun glare

At Thurston Station level crossing the orientation of the road/path from the north is 180°; the orientation of the railway from the north to the up line in the up direction is 270°. Low horizon can result in sun glare; sun glare is a known issue.

- Frequent trains
- Large number users
- Low sighting
- Near station
- Sun glare
