## Annual Inspection

Mid Suffolk District Council

Thurston Playing Field

Inspection Ref: 1915608

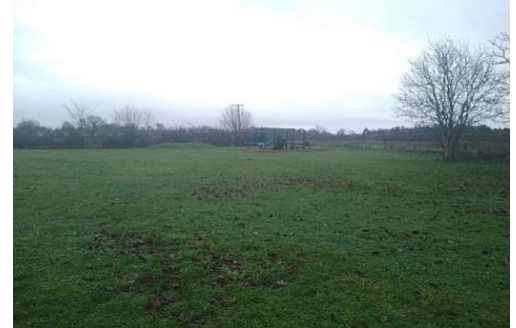
**Item:** Site General  
**Manufacturer:** Owner/Operator  
**Surface Type:** N/A  
**Item Quantity:** 1  
**Equipment Compliance:** N/A  
**Surface Area Compliance:** N/A

There are a number of molehills within the area and these may present unforeseen hazards for users - Remove moles by appropriate means, reinstate surfaces to level and maintain the area

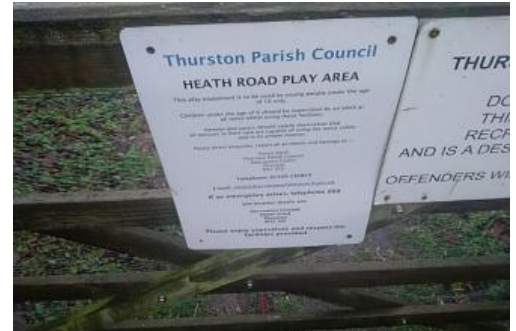
**Item:** Sign  
**Manufacturer:** Owner/Operator  
**Surface Type:** N/A  
**Item Quantity:** 1  
**Equipment Compliance:** N/A  
**Surface Area Compliance:** N/A

This item is satisfactory - no work required -

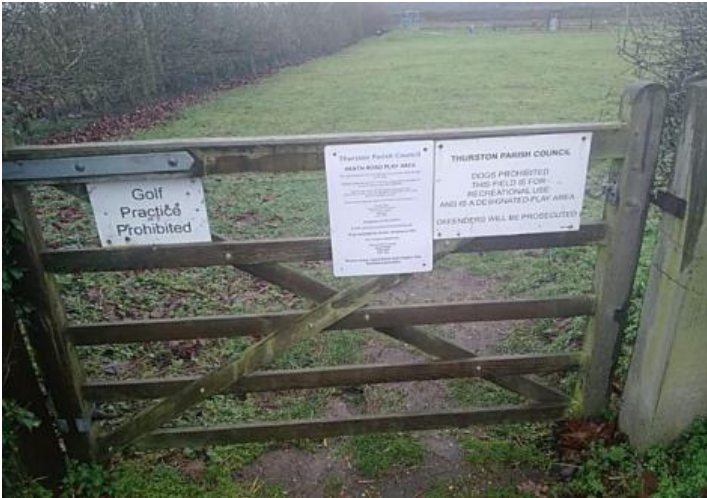
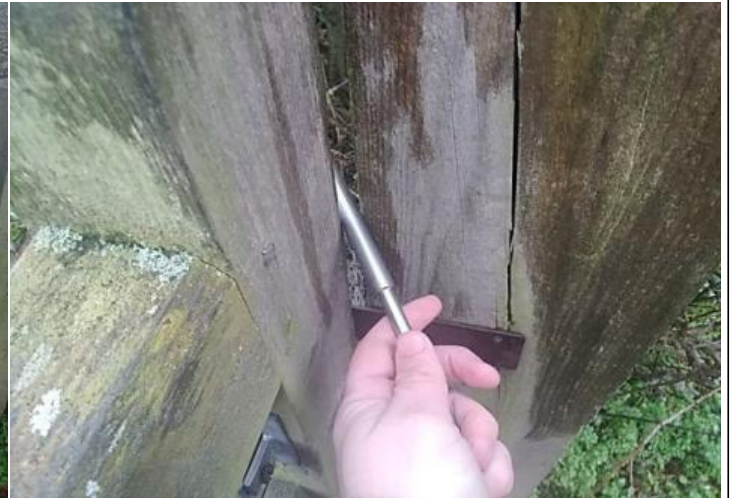
**Item:** Gates - Gate  
**Manufacturer:** Not Identified

**Finding:** There are openings that are less than 12mm that could trap or crush fingers

**Action:** Where possible a 12mm gap should be maintained on both sides or between the gate leaves

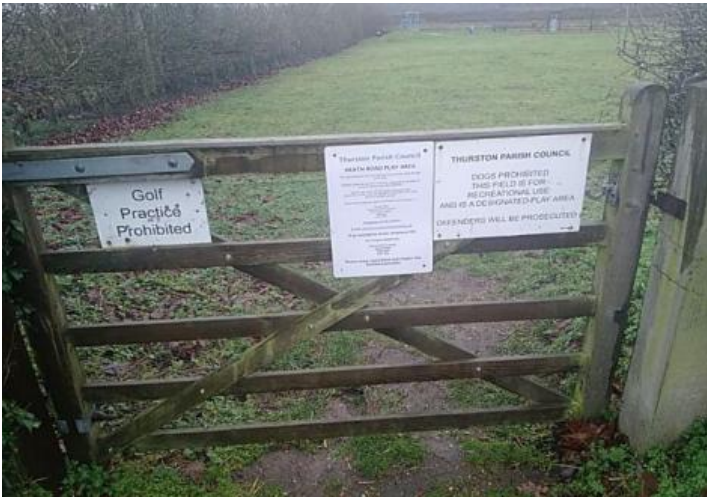
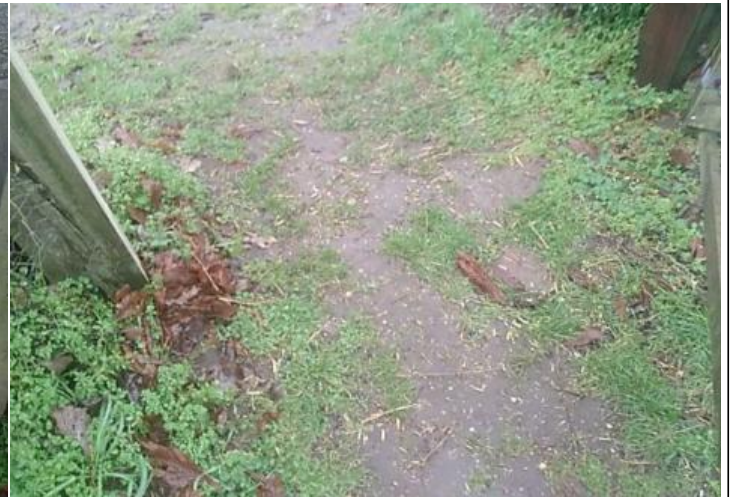
**Item:** Gates - Gate  
**Manufacturer:** Not Identified

**Finding:** The area around the item has eroded and may become slippery

**Action:** Reinstate eroded area

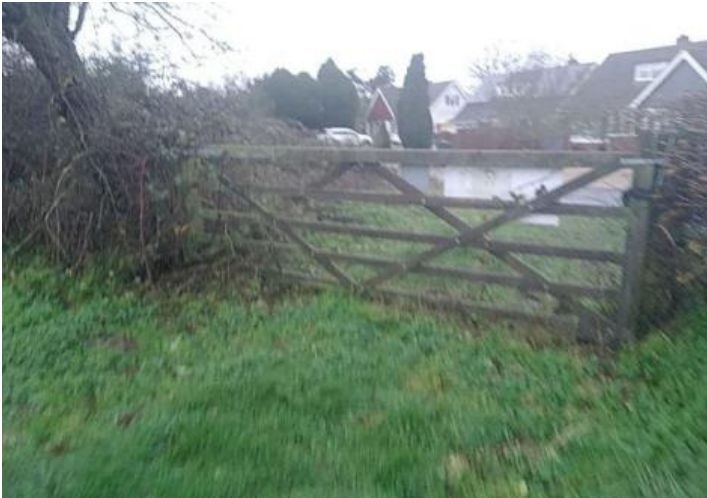
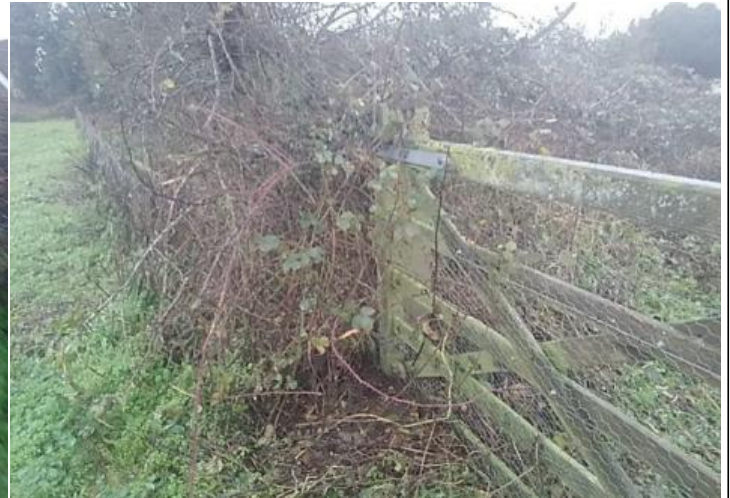
**Item:** Gates - Gate - Maintenance  
**Manufacturer:** Not Identified

**Finding:** The adjacent foliage is overhanging the gate

**Action:** Cut back and maintain

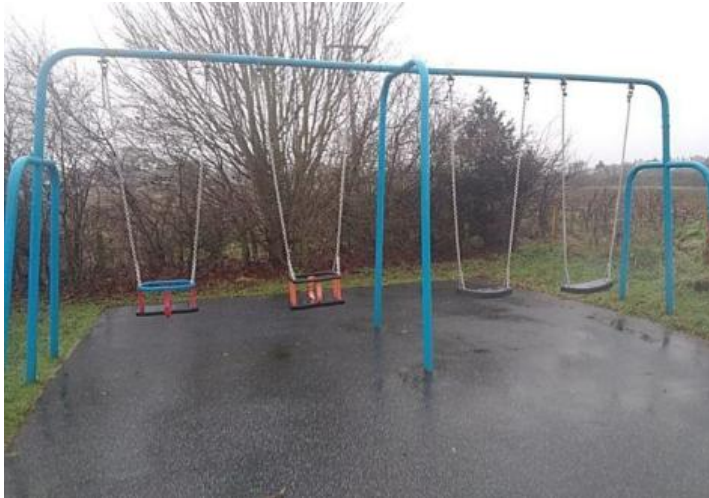
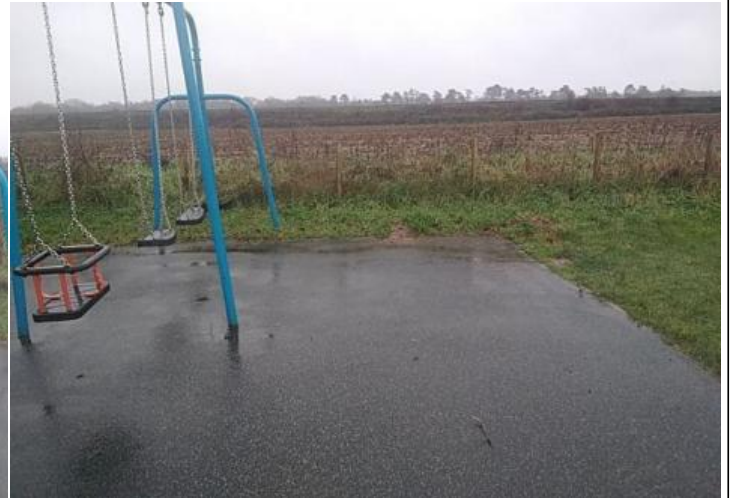
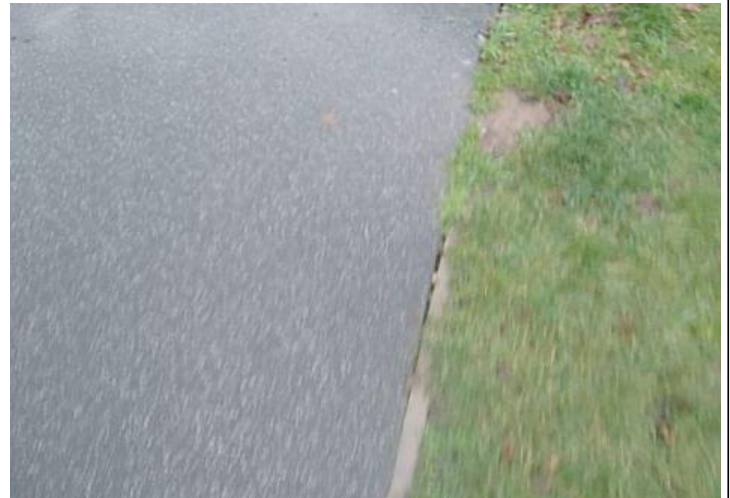
**Item:** Swings - 2 Bay (2 Flat, 2 Cradle)  
**Manufacturer:** Not Identified

**Finding 1**  
 The surfacing dimensions are short and do not meet with the requirements of the current applicable standard - Monitor - no remedial action recommended

**Finding:** The surfacing dimensions are short and do not meet with the requirements of the current applicable standard

**Action:** Monitor - no remedial action recommended

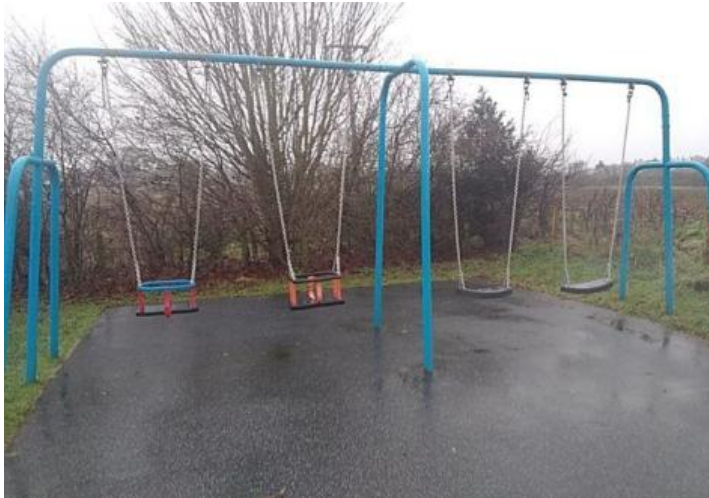
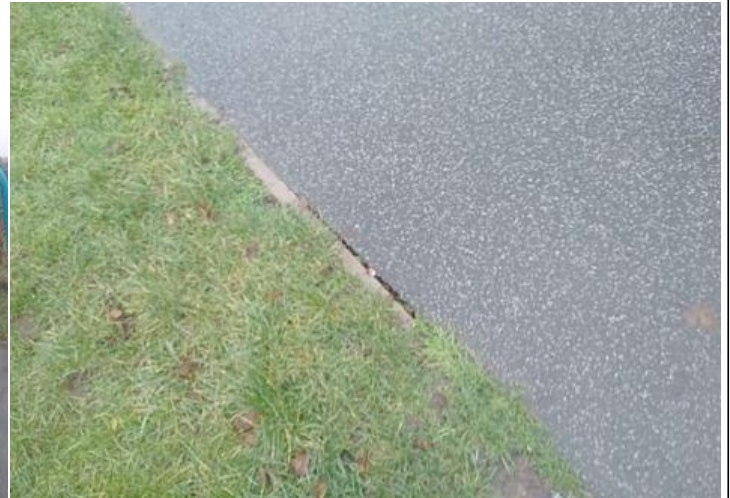
**Item:** Swings - 2 Bay (2 Flat, 2 Cradle)  
**Manufacturer:** Not Identified

**Finding 2**  
 There are gaps opening between the surfacing and the edging surround or between the joints in the surfacing - Monitor for any further deterioration and repair as required

**Finding:** There are gaps opening between the surfacing and the edging surround or between the joints in the surfacing  
**Action:** Monitor for any further deterioration and repair as required

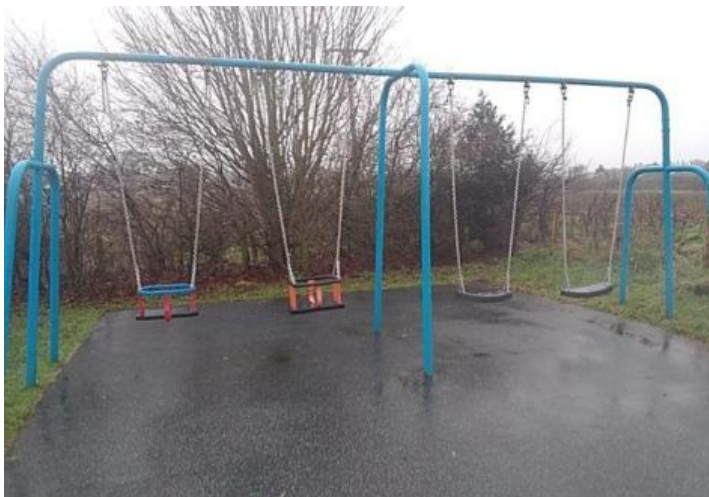
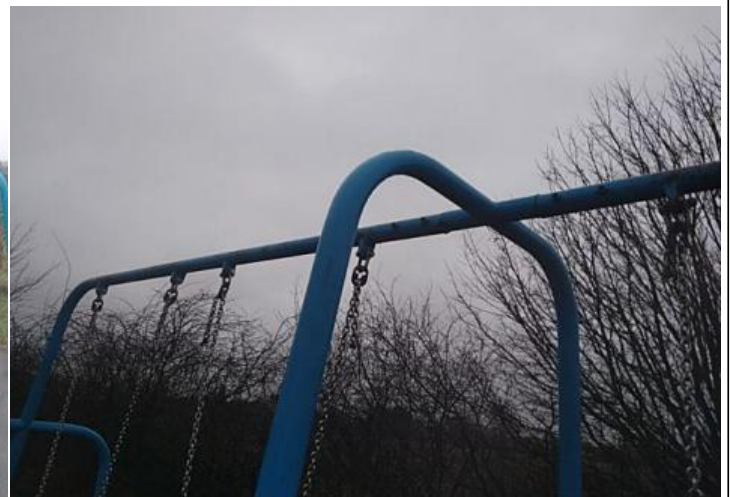
**Item:** Swings - 2 Bay (2 Flat, 2 Cradle)  
**Manufacturer:** Not Identified

**Finding 3**  
 The bushes are showing signs of wear - Monitor for any further deterioration and replace as required

**Finding:** The bushes are showing signs of wear  
**Action:** Monitor for any further deterioration and replace as required

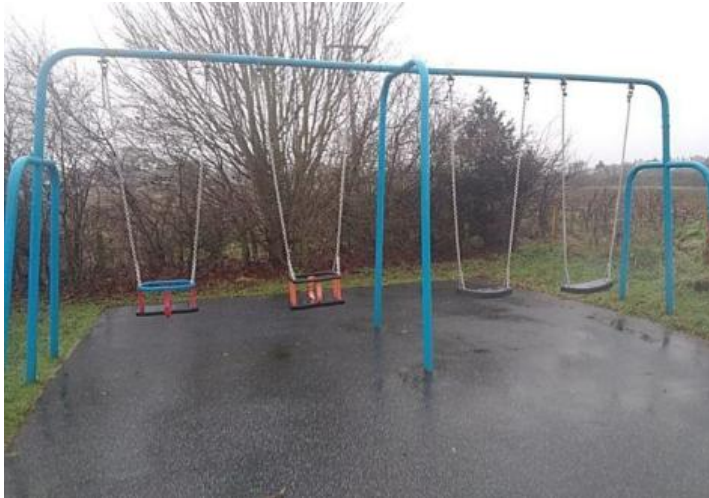
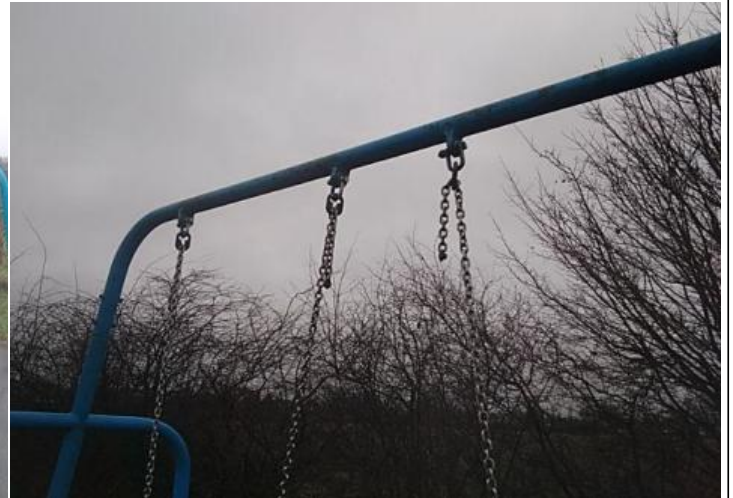
**Item:** Swings - 2 Bay (2 Flat, 2 Cradle)  
**Manufacturer:** Not Identified

**Finding:** There are excessive chain tails

**Action:** Cut back excessive chain links

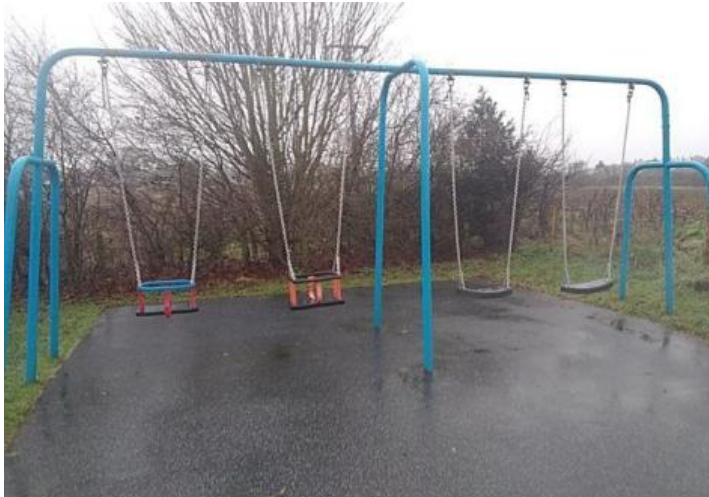
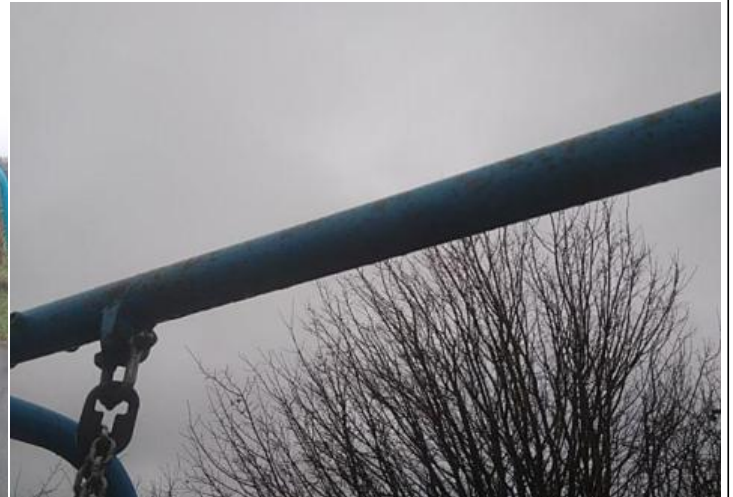
**Item:** Swings - 2 Bay (2 Flat, 2 Cradle)  
**Manufacturer:** Not Identified

**Finding 5**  
 The paintwork on this item has been damaged or worn exposing the metal underneath which is rusting - Treat any rusting components and repaint

**Finding:** The paintwork on this item has been damaged or worn exposing the metal underneath which is rusting

**Action:** Treat any rusting components and repaint

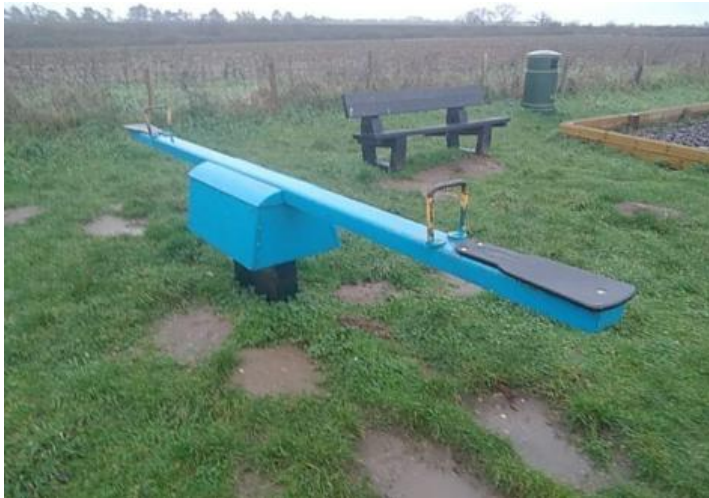
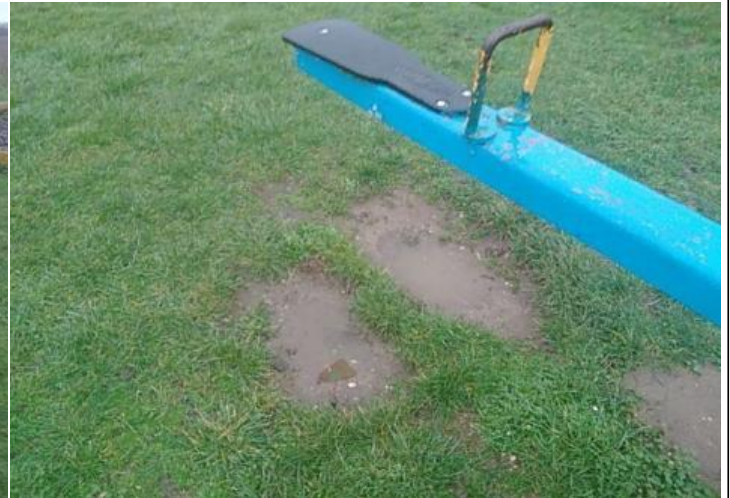
**Item:** Rocking Equipment - See Saw  
**Manufacturer:** Wicksteed Playgrounds

The area around the item has eroded and may become slippery - Reinstate eroded area

**Finding:** The area around the item has eroded and may become slippery

**Action:** Reinststate eroded area

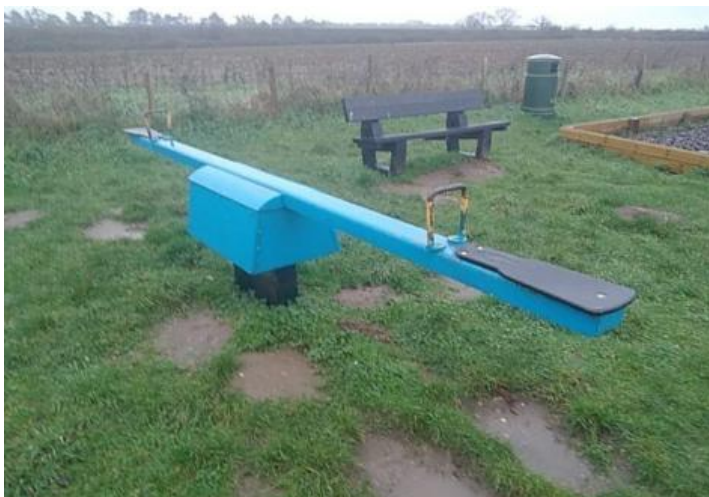
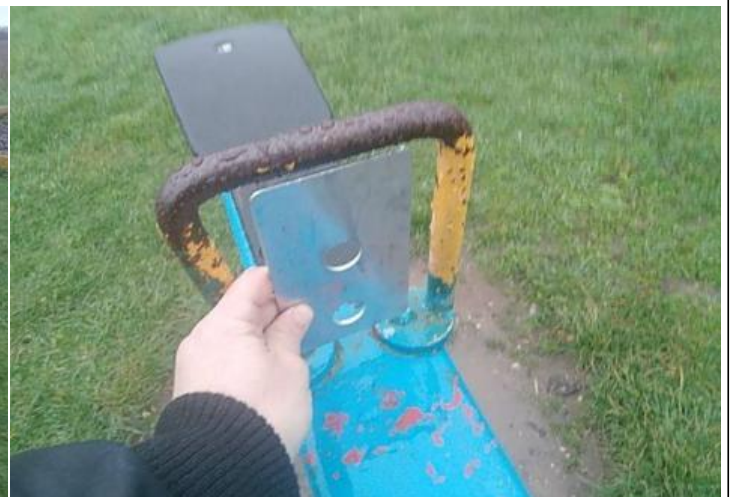
**Item:** Rocking Equipment - See Saw  
**Manufacturer:** Wicksteed Playgrounds

The item fails to meet the requirements of BS EN 1176 Part 1 4.2.7.2 for head and neck entrapment in the framework - Monitor - No remedial work recommended

**Finding:** The item fails to meet the requirements of BS EN 1176 Part 1 4.2.7.2 for head and neck entrapment in the framework

**Action:** Monitor - No remedial work recommended

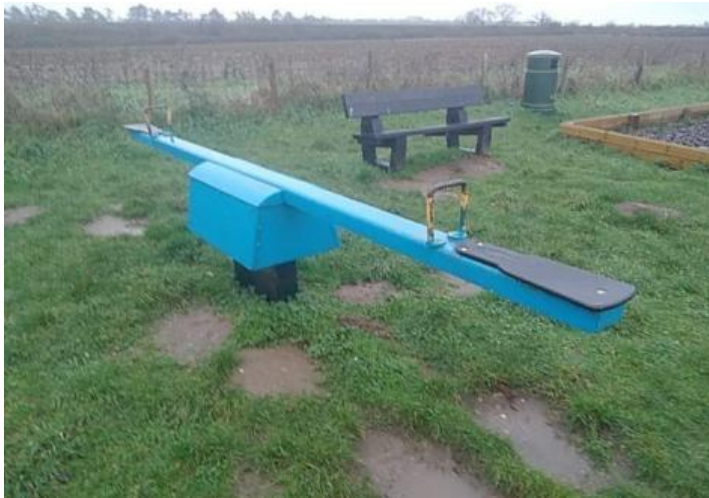
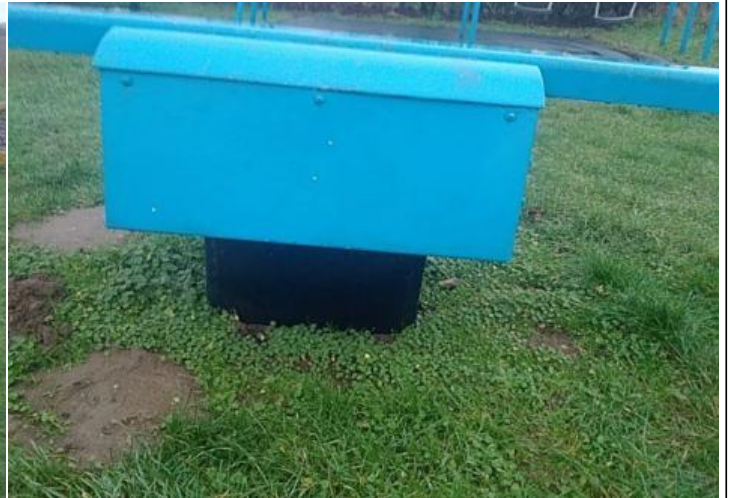
**Item:** Rocking Equipment - See Saw  
**Manufacturer:** Wicksteed Playgrounds

There is no gaiter protection for accessible moving parts (possible shear trap) as recommended in BS EN 1176 Part 1; 4.2.6 Moving Parts - Monitor - No remedial work recommended

**Finding:** There is no gaiter protection for accessible moving parts (possible shear trap) as recommended in BS EN 1176 Part 1; 4.2.6 Moving Parts

**Action:** Monitor - No remedial work recommended

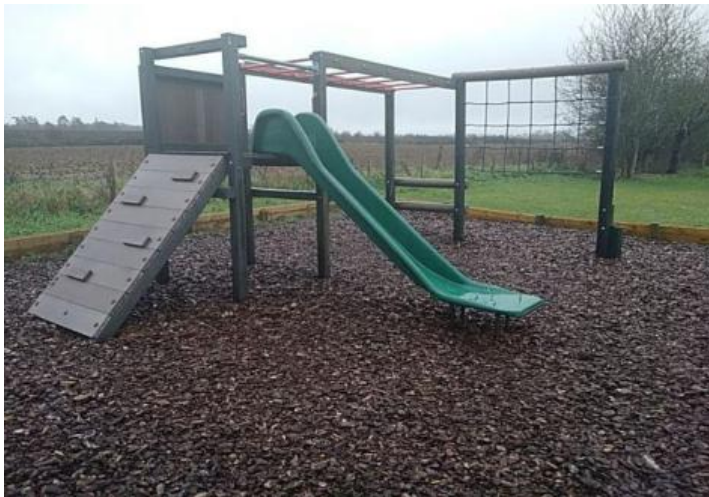
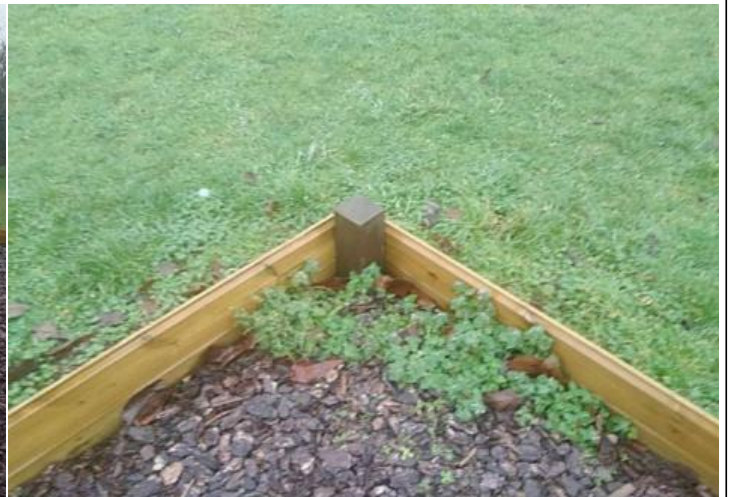
**Item:** Activity Equipment - Multi Play (Junior)  
**Manufacturer:** Not Identified

There is weed / vegetation growth on, between, or around the edges of the surfacing - Remove weed / vegetation growth

**Finding:** There is weed / vegetation growth on, between, or around the edges of the surfacing

**Action:** Remove weed / vegetation growth

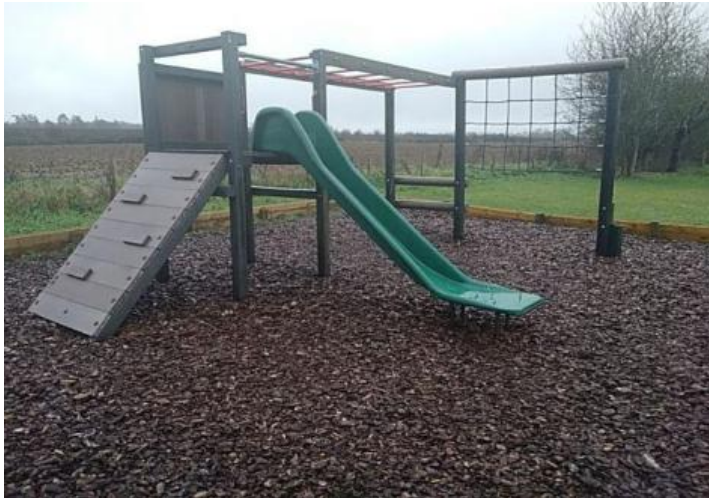
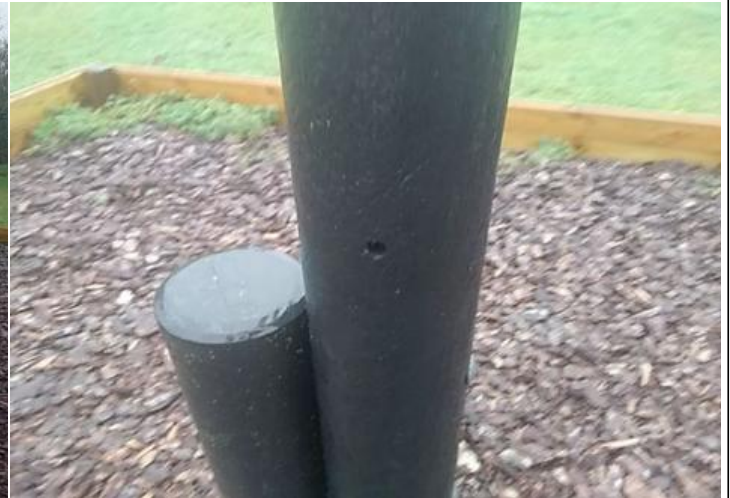
**Item:** Activity Equipment - Multi Play (Junior)  
**Manufacturer:** Not Identified

There is/are several inserts missing - Replace missing inserts

**Finding:** There is/are several inserts missing

**Action:** Replace missing inserts

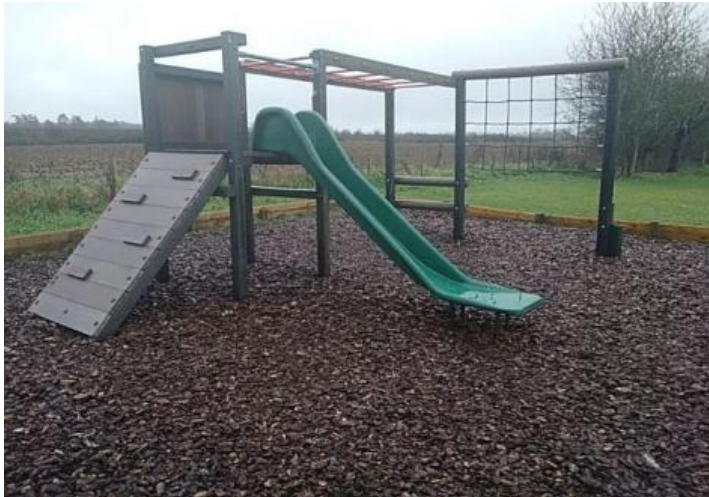
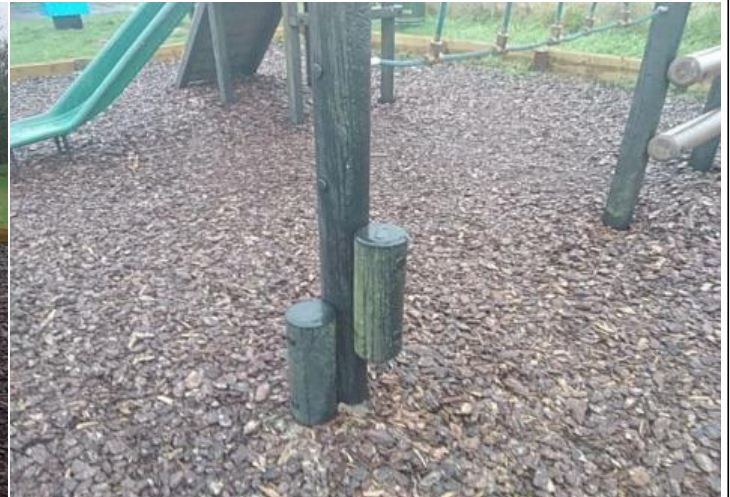
**Item:** Activity Equipment - Multi Play (Junior)  
**Manufacturer:** Not Identified

The item is slightly loose in its foundations - Monitor for any further deterioration and repair as required

**Finding:** The item is slightly loose in its foundations

**Action:** Monitor for any further deterioration and repair as required

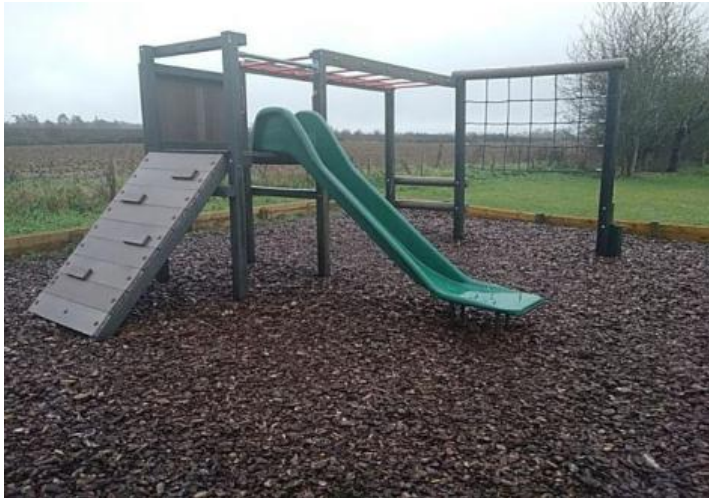
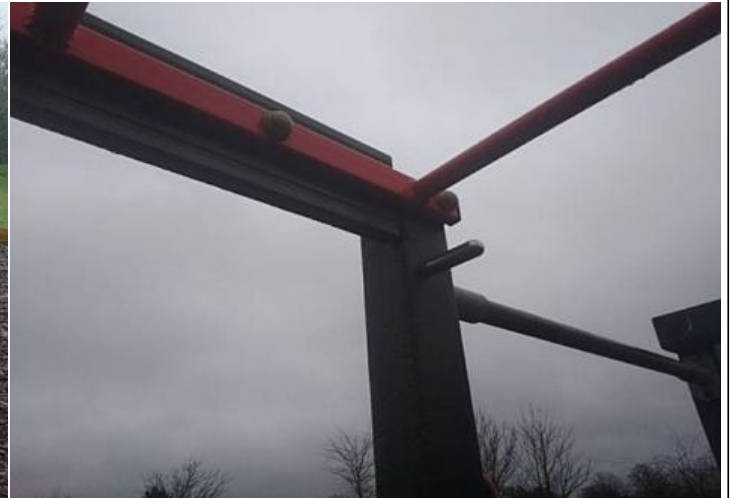
**Item:** Activity Equipment - Multi Play (Junior)  
**Manufacturer:** Not Identified

There is/are finger entrapment/s due to missing insert and the item fails to meet the requirements of BS EN 1176 Part 1 4.2.7.6 Entrapment of fingers - Replace missing inserts to remove entrapment

**Finding:** There is/are finger entrapment/s due to missing insert and the item fails to meet the requirements of BS EN 1176 Part 1 4.2.7.6 Entrapment of fingers

**Action:** Replace missing inserts to remove entrapment

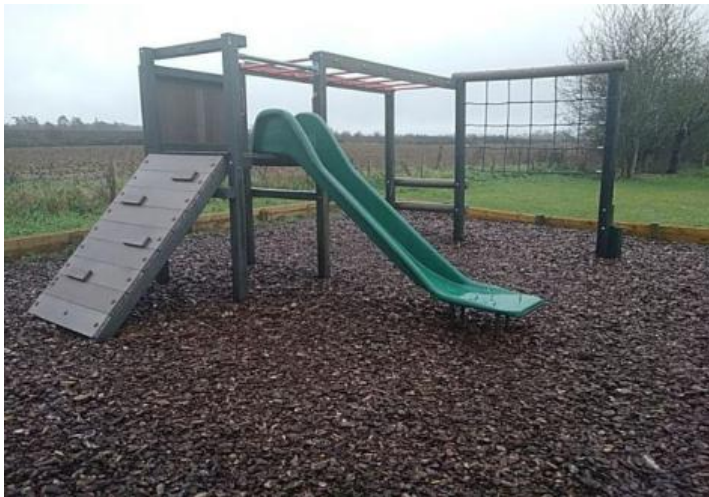
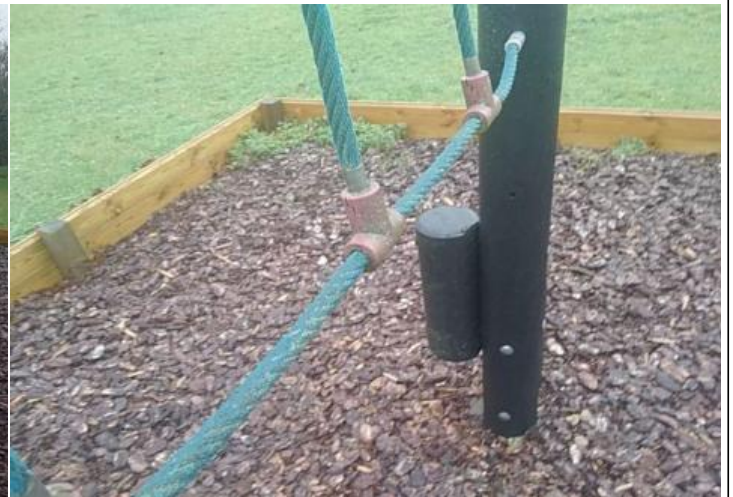
**Item:** Activity Equipment - Multi Play (Junior)  
**Manufacturer:** Not Identified

The ropes/nets are worn/damaged in places - Monitor for any further deterioration and repair or replace as required

**Finding:** The ropes/nets are worn/damaged in places

**Action:** Monitor for any further deterioration and repair or replace as required

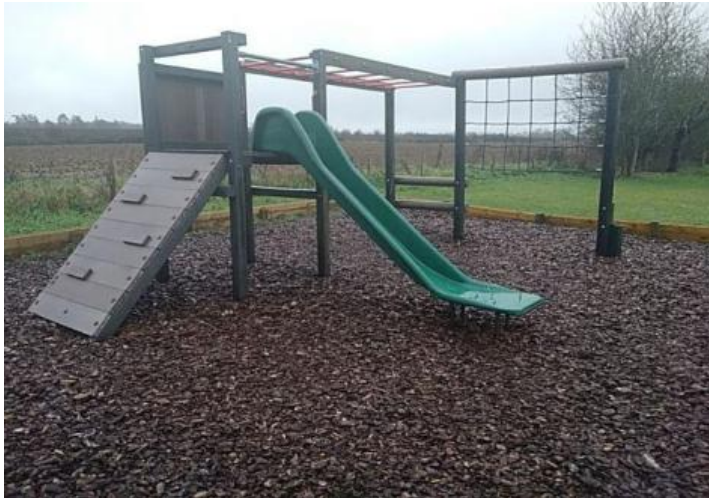
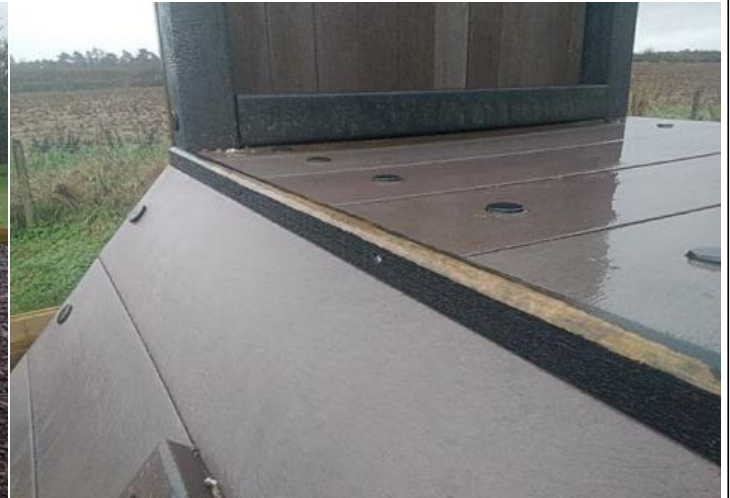
**Item:** Activity Equipment - Multi Play (Junior)  
**Manufacturer:** Not Identified

The inclined ramp edging strip is damaged - Replace the damaged edging strip

**Finding:** The inclined ramp edging strip is damaged

**Action:** Replace the damaged edging strip

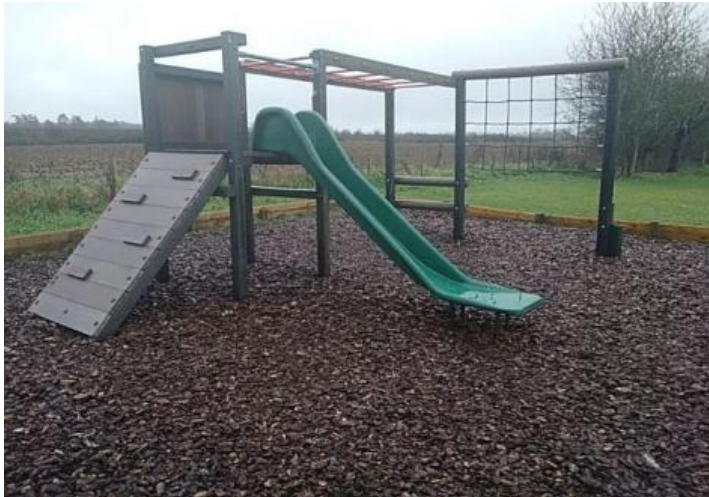
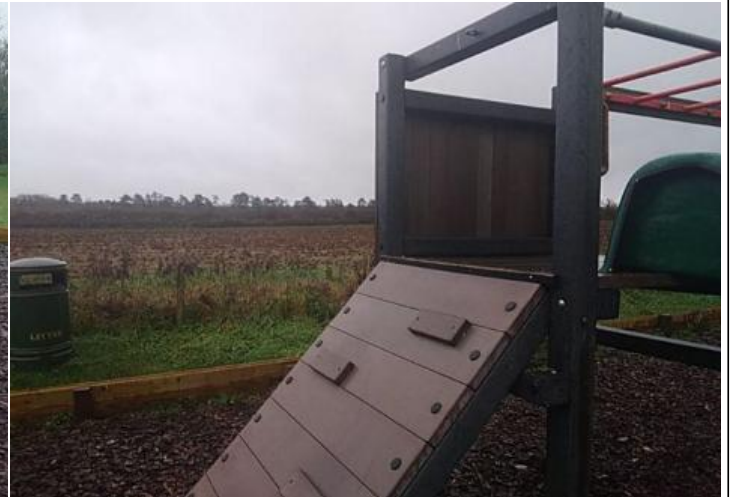
**Item:** Activity Equipment - Multi Play (Junior)  
**Manufacturer:** Not Identified

The grab rope has been removed - Replace the missing grab rope

**Finding:** The grab rope has been removed

**Action:** Replace the missing grab rope

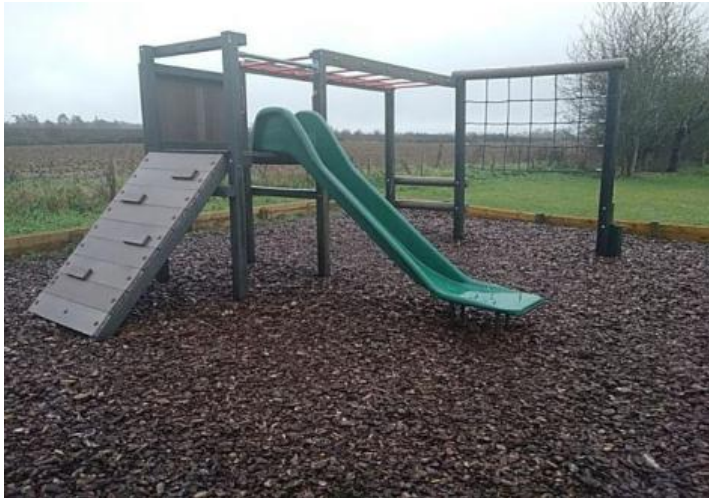
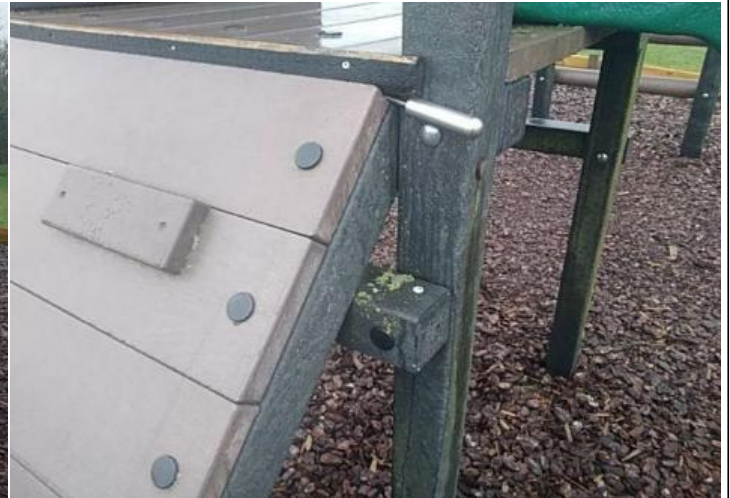
**Item:** Activity Equipment - Multi Play (Junior)  
**Manufacturer:** Not Identified

There is/are finger entrapment/s in the structure and the item fails to meet the requirements of BS EN 1176 Part 1 4.2.7.6 Entrapment of fingers - Monitor - No remedial work recommended

**Finding:** There is/are finger entrapment/s in the structure and the item fails to meet the requirements of BS EN 1176 Part 1 4.2.7.6 Entrapment of fingers

**Action:** Monitor - No remedial work recommended

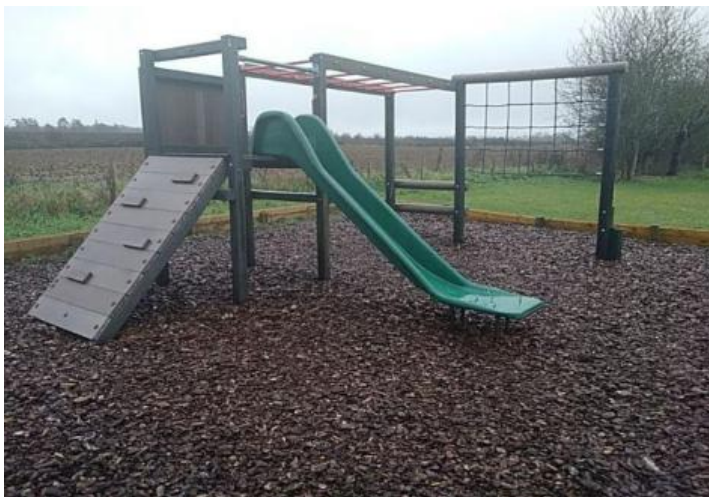
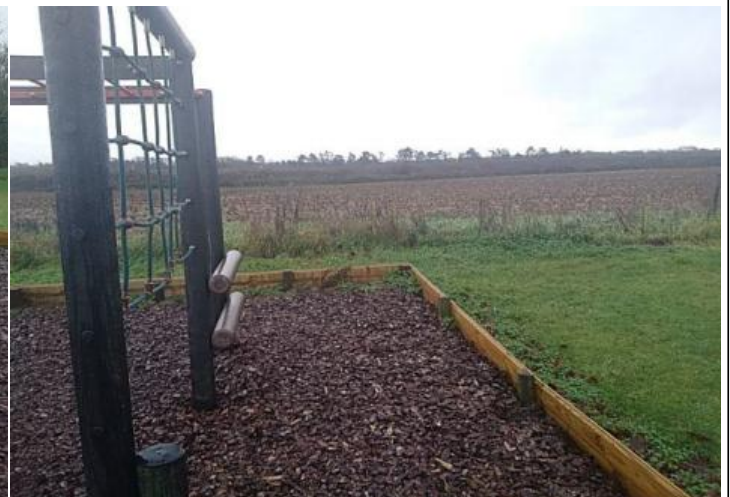
**Item:** Activity Equipment - Multi Play (Junior)  
**Manufacturer:** Not Identified

The timber edge forms a hard object within the falling space of the equipment in contravention of the requirements of BS EN 1176 Part 1 - Monitor - No remedial work recommended

**Finding:** The timber edge forms a hard object within the falling space of the equipment in contravention of the requirements of BS EN 1176 Part 1

**Action:** Monitor - No remedial work recommended

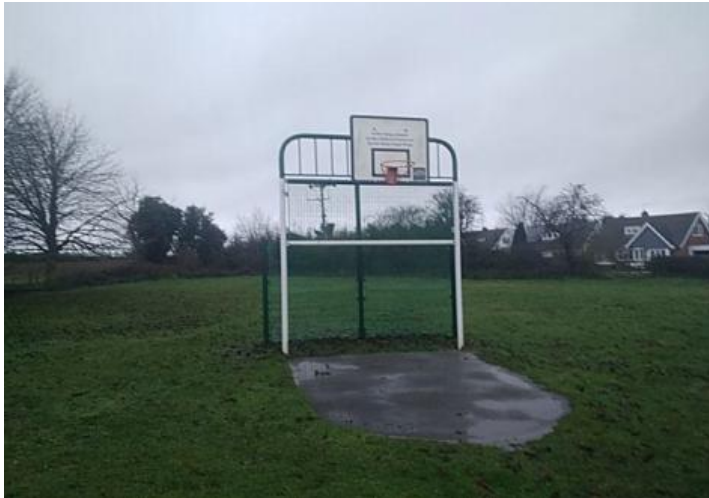
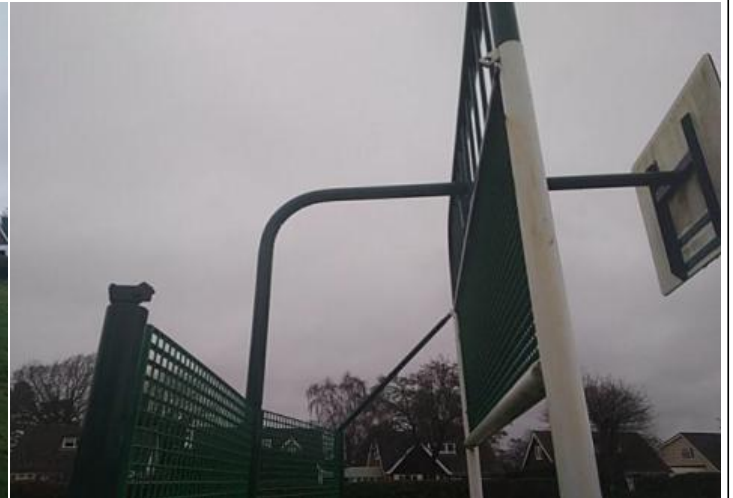
**Item:** Multi Use Games Area - Basket Ball Goal **Risk Level:** L - Low Risk  
**Manufacturer:** Playquest **Surface:** Grass

A support brace has been removed/not fitted - The frame is stable. Monitor and replace the brace if required

**Finding:** A support brace has been removed/not fitted

**Action:** The frame is stable. Monitor and replace the brace if required

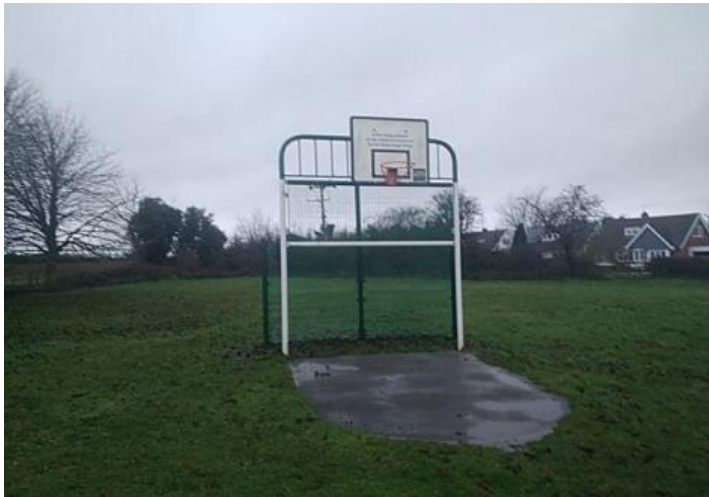
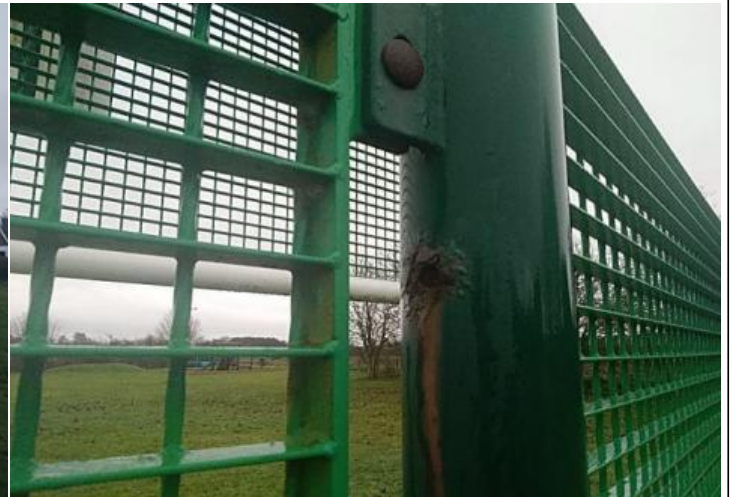
**Item:** Multi Use Games Area - Basket Ball Goal **Risk Level:** L - Low Risk  
**Manufacturer:** Playquest **Surface:** Grass

The paintwork on this item has been damaged or worn exposing the metal underneath which is rusting - Treat any rusting components and repaint

**Finding:** The paintwork on this item has been damaged or worn exposing the metal underneath which is rusting

**Action:** Treat any rusting components and repaint

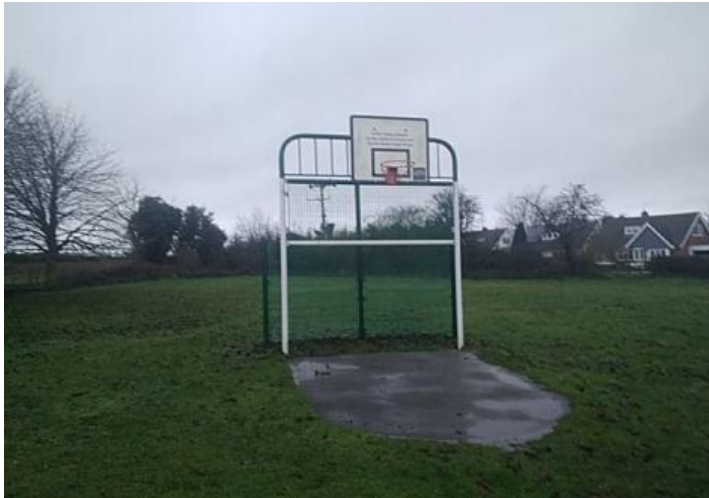
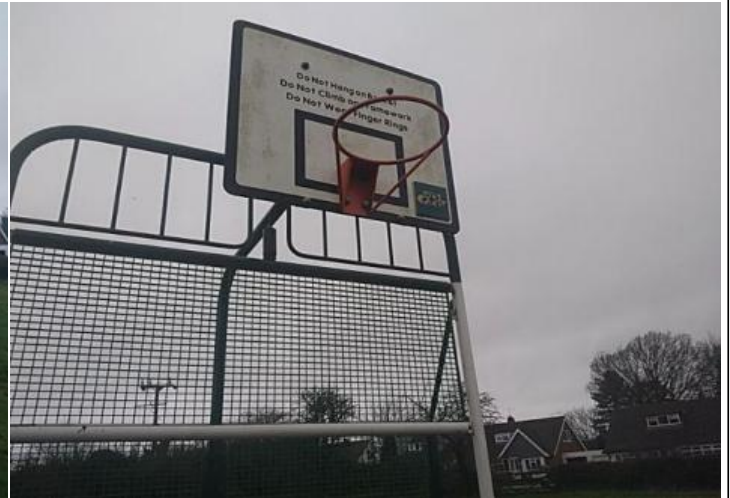
A clearly visible facility sign should be provided in a prominent position with the wording as detailed BS EN 15312- the equipment is not intended for children less than 3 years old- the warning - Do not climb on the framework or nets- the warning - Do not hang on the ring (if provided)- the warning - Do not wear rings or other jewellery- name and telephone number of the administrator- number to call in case of accident - Provide signage to BS EN 15312

**Finding:** A clearly visible facility sign should be provided in a prominent position with the wording as detailed BS EN 15312- the equipment is not intended for children less than 3 years old- the warning - Do not climb on the framework or nets- the warning - Do not hang on the ring (if provided)- the warning - Do not wear rings or other jewellery- name and telephone number of the administrator- number to call in case of accident

**Action:** Provide signage to BS EN 15312

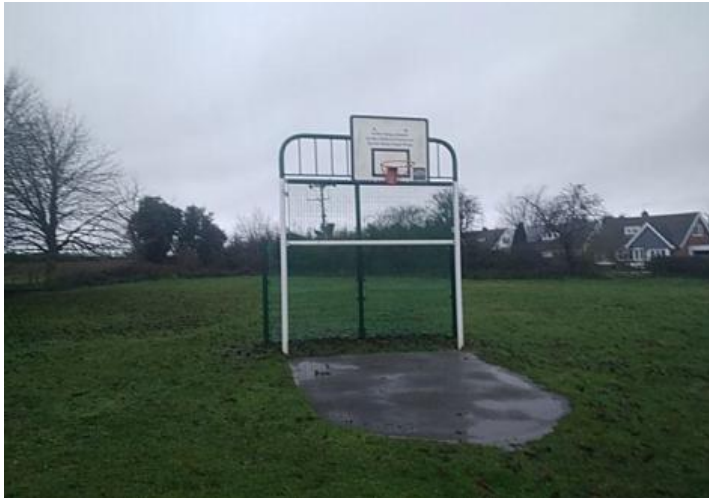
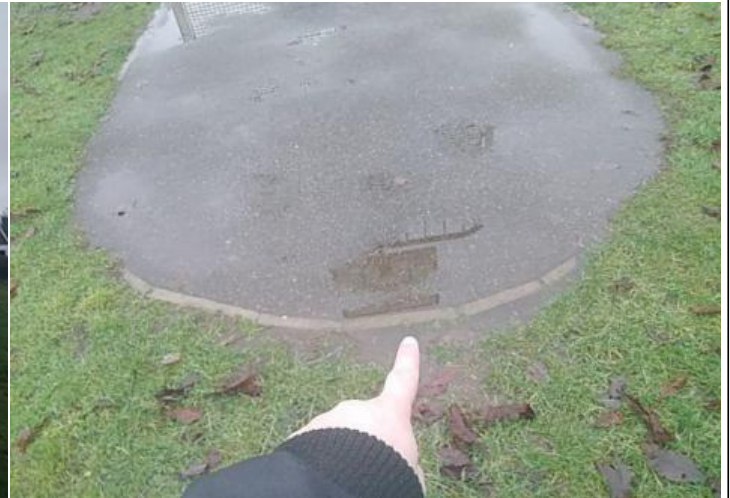
There are trip hazards at the edges of the surface - Reinstate surrounding surface levels to remove the trip points

**Finding:** There are trip hazards at the edges of the surface

**Action:** Reinstate surrounding surface levels to remove the trip points
