Annual Inspection

Mid Suffolk District Council

Thurston Recreation Ground

Church Road, Thurston, Suffolk, IP31 3RP

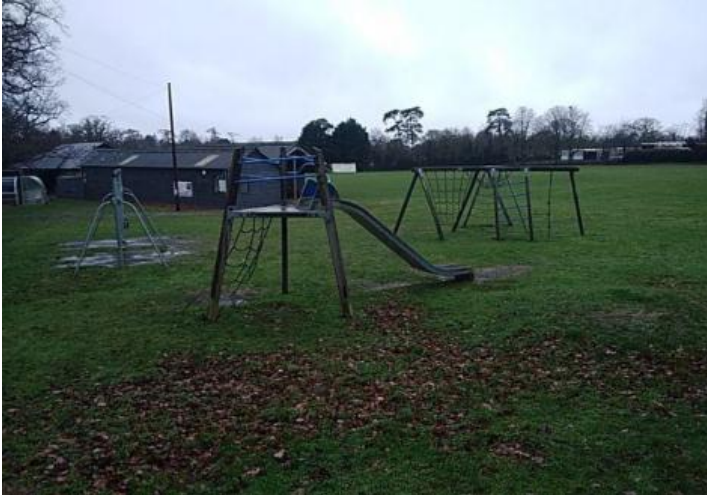
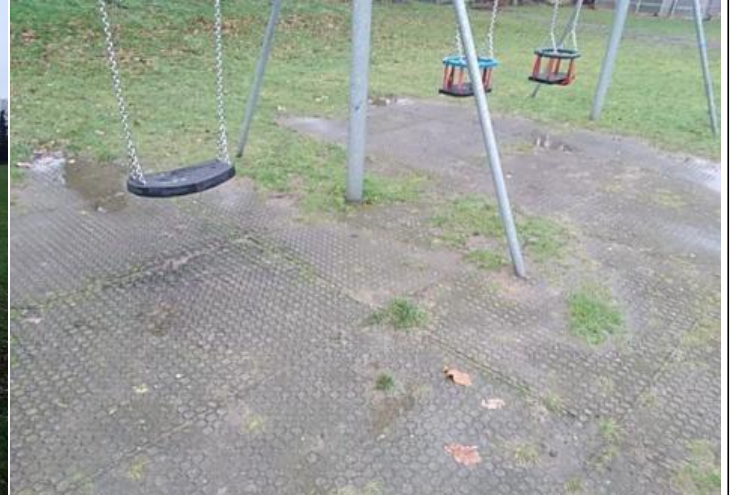
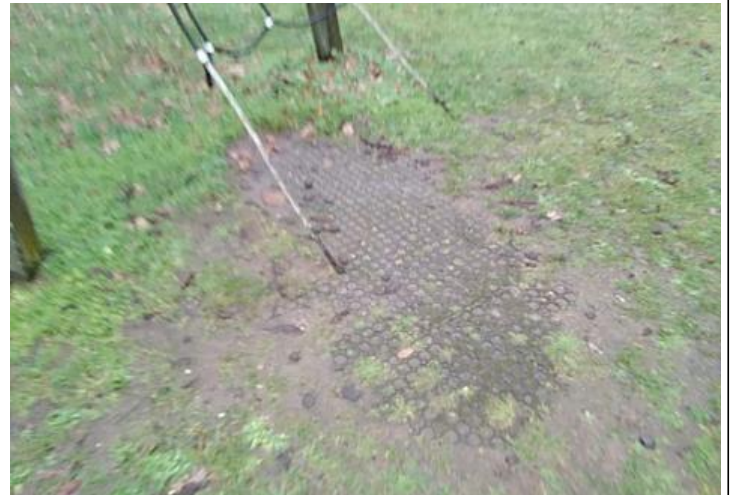
i 8 - Low Risk (Finding 1)

The grass mats are silted up and the soil is compacted; this may have an effect on the impact absorbing properties of the surface - Consider HIC testing impact absorbing properties to ensure the correct surface qualities are maintained for the equipment and replace as required

Finding: The grass mats are silted up and the soil is compacted; this may have an effect on the impact absorbing properties of the surface

Action: Consider HIC testing impact absorbing properties to ensure the correct surface qualities are maintained for the equipment and replace as required

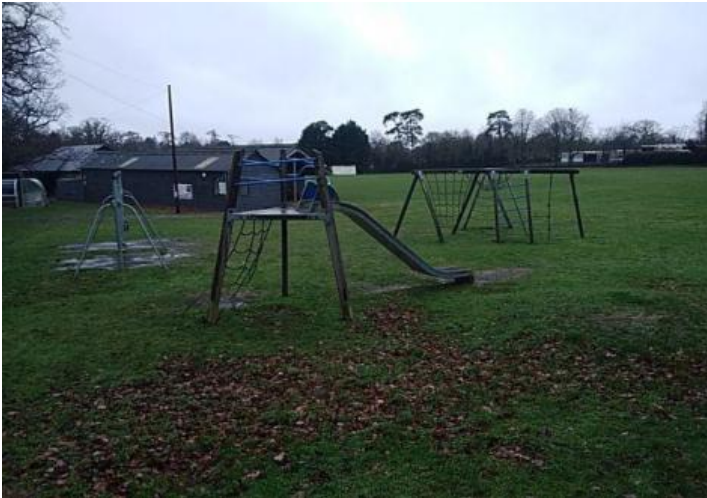
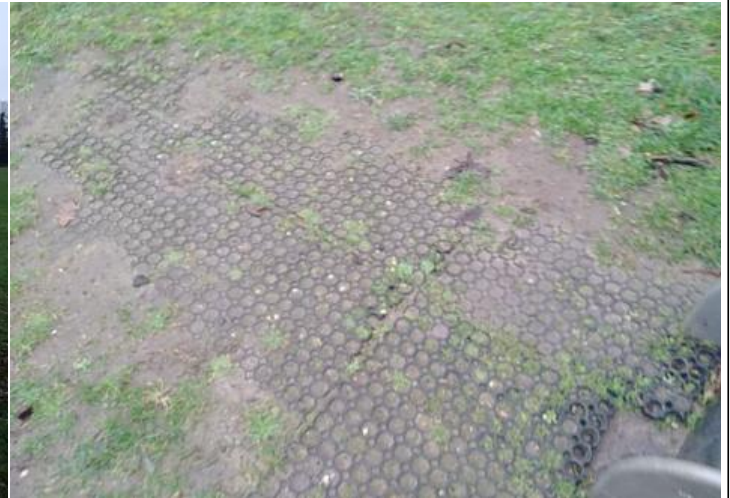
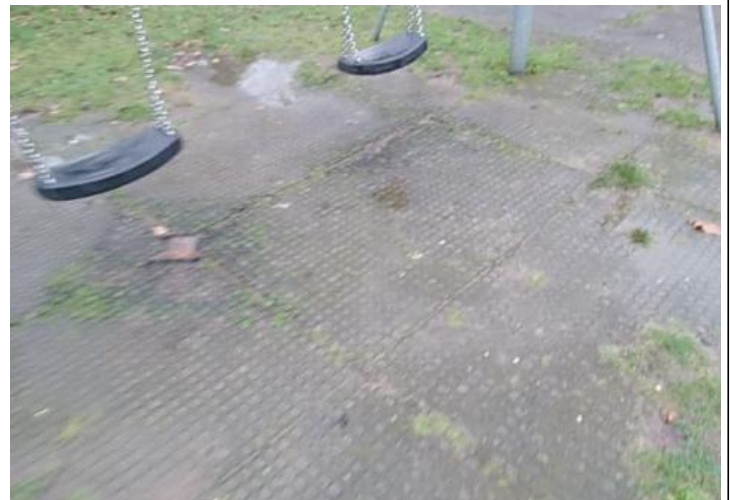
i 6 - Low Risk (Finding 2)

There are gaps opening between the grass mat tiles - Provide additional ties or secure / reinstate surface

Finding: There are gaps opening between the grass mat tiles

Action: Provide additional ties or secure / reinstate surface

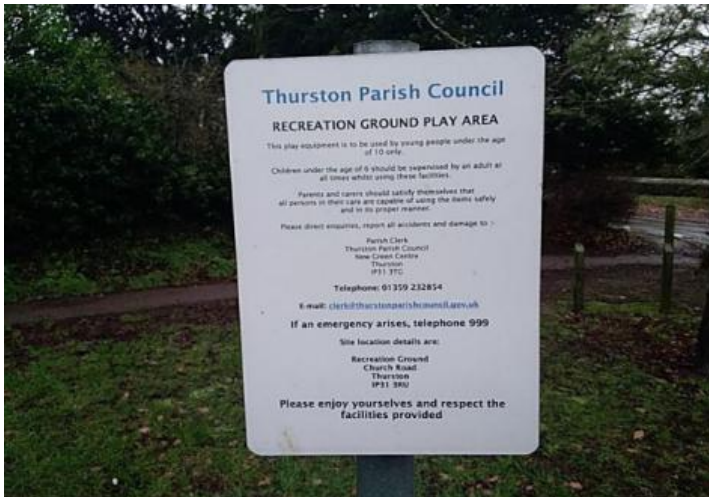
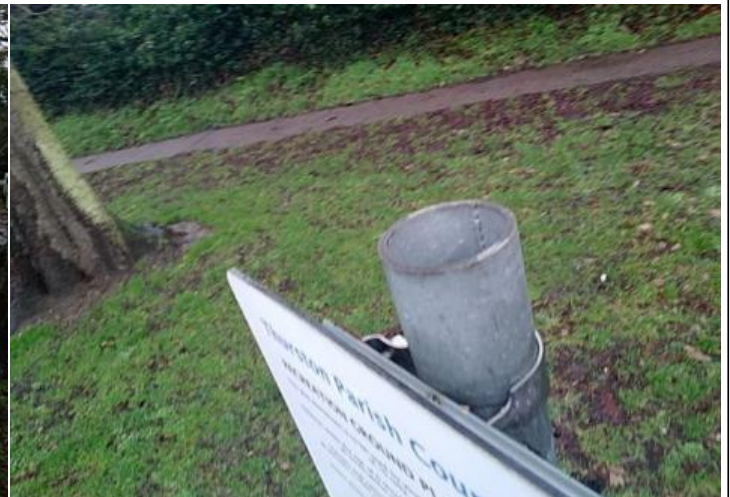
6 - Low Risk (Finding 1)

There are post / end caps missing from the item - Replace missing post caps

Finding: There are post / end caps missing from the item

Action: Replace missing post caps

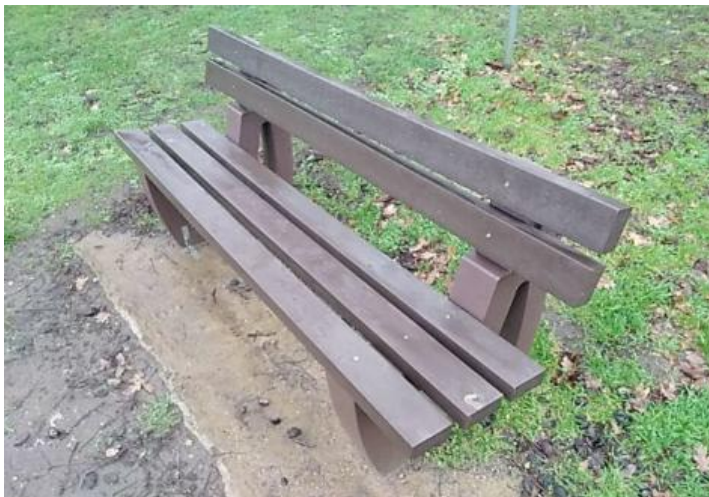
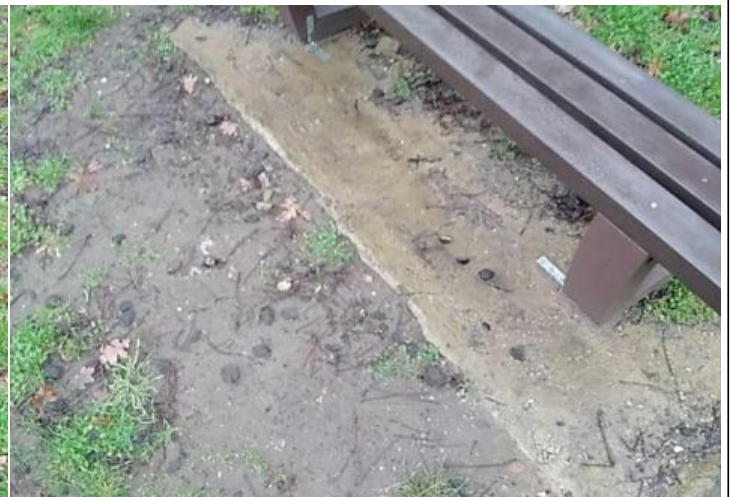
8 - Low Risk (Finding 1)

The surface has eroded and there are trip hazards at the edges of the surface - Reinstate surrounding surface levels to remove the trip points

Finding: The surface has eroded and there are trip hazards at the edges of the surface

Action: Reinstate surrounding surface levels to remove the trip points

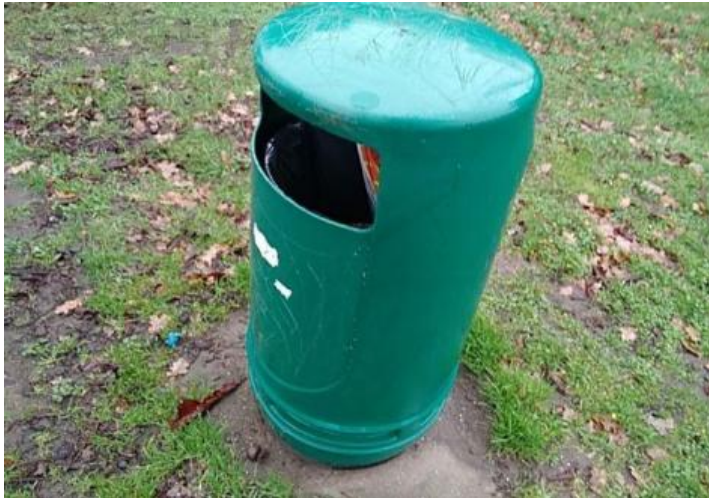
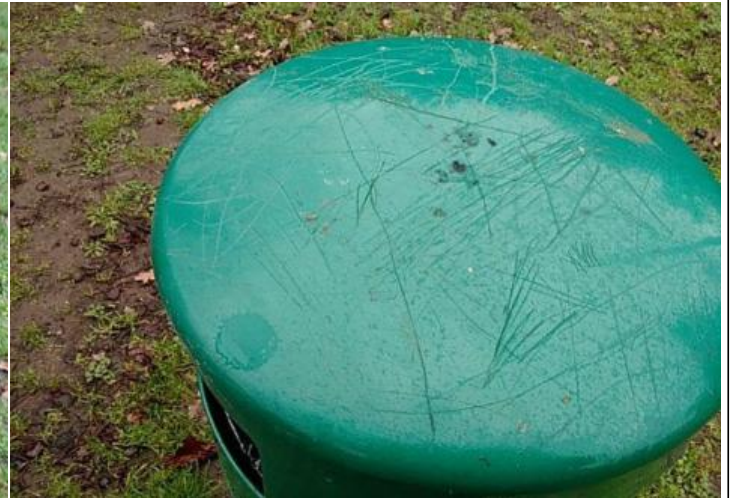
i 6 - Low Risk (Finding 1)

There is some damage/ vandalism to the bin - Monitor for any further deterioration and repair as required

Finding: There is some damage/ vandalism to the bin

Action: Monitor for any further deterioration and repair as required

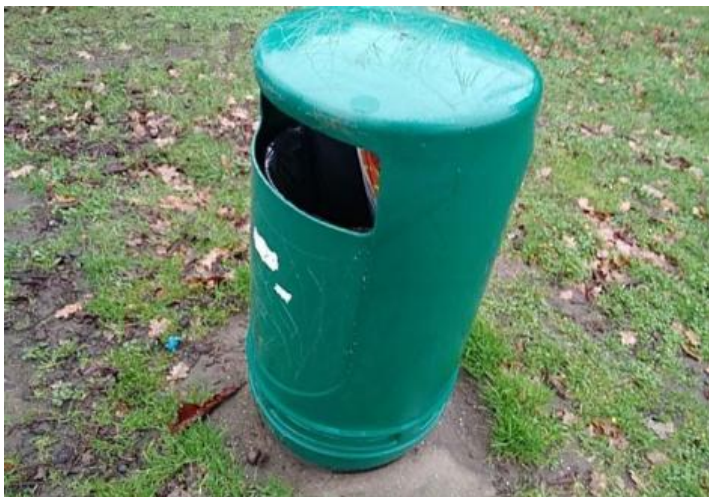
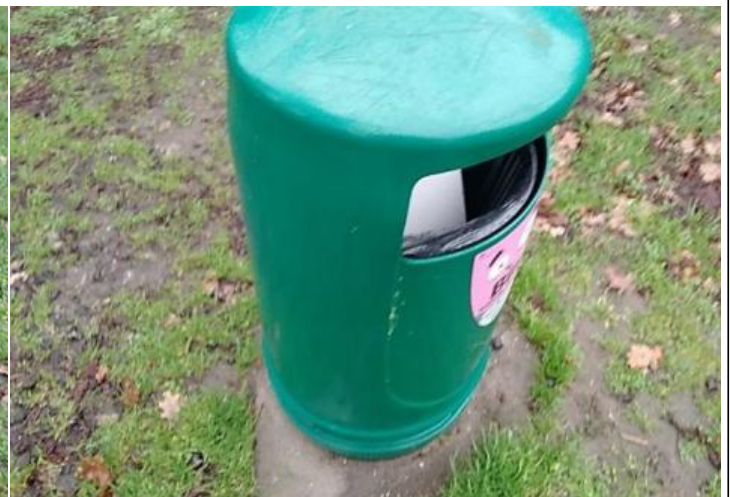
i 6 - Low Risk (Finding 2)

The lid or door of the litter bin is not secured - Ensure the lid or door is kept locked

Finding: The lid or door of the litter bin is not secured

Action: Ensure the lid or door is kept locked

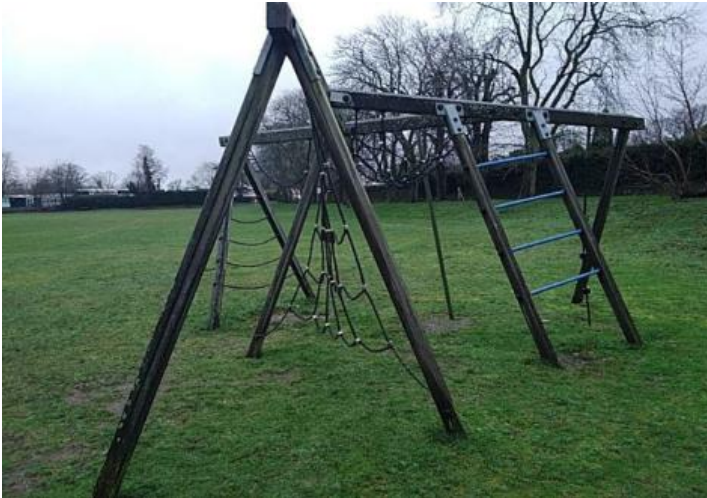
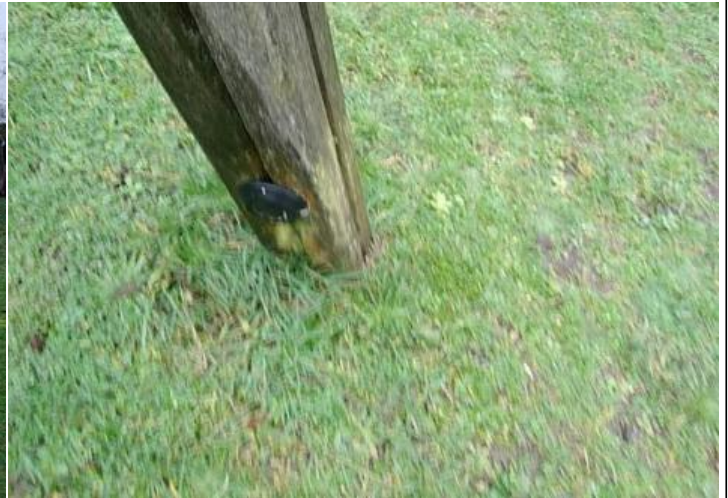
i 6 - Low Risk (Finding 1)

There is some strimmer / machinery damage apparent on the posts, this can penetrate the preservative applied to the timber and accelerate the rotting process - Monitor for any deterioration (rot) and replace as required

Finding: There is some strimmer / machinery damage apparent on the posts, this can penetrate the preservative applied to the timber and accelerate the rotting process

Action: Monitor for any deterioration (rot) and replace as required

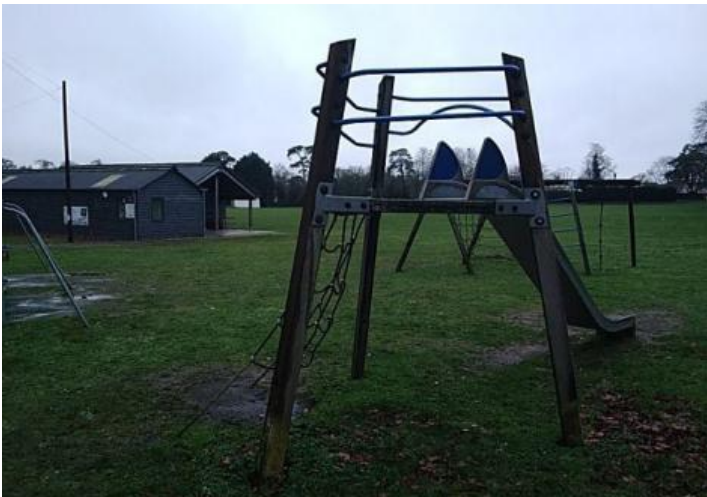
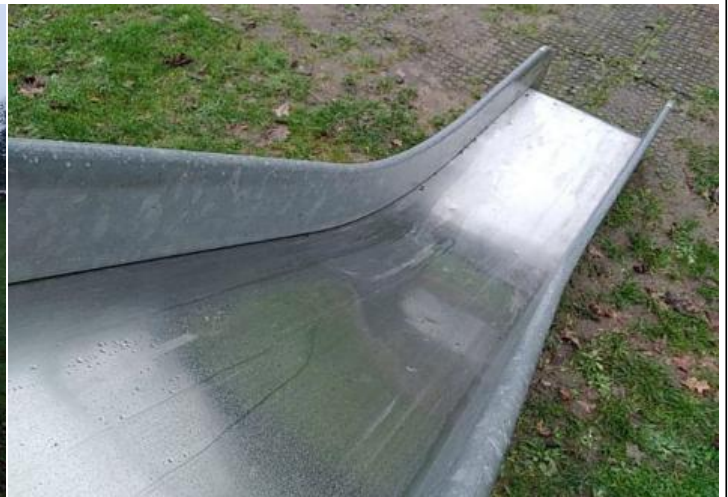
i 4 - Very Low Risk (Finding 1)

There are a number of dents in the slide surface - Monitor for any further deterioration and repair as required

Finding: There are a number of dents in the slide surface

Action: Monitor for any further deterioration and repair as required

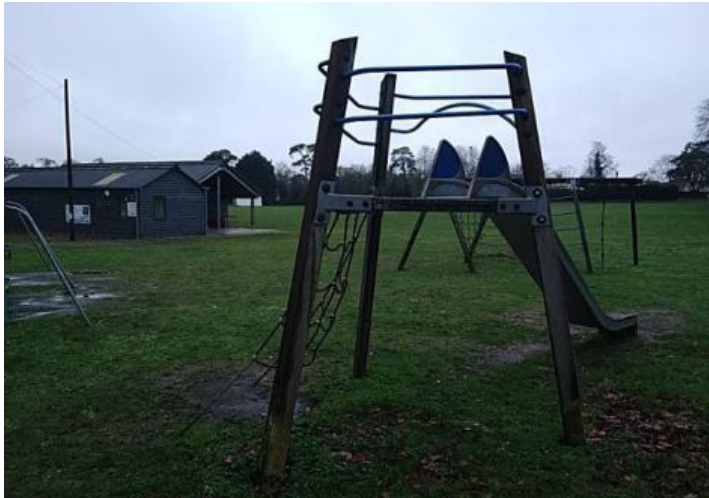
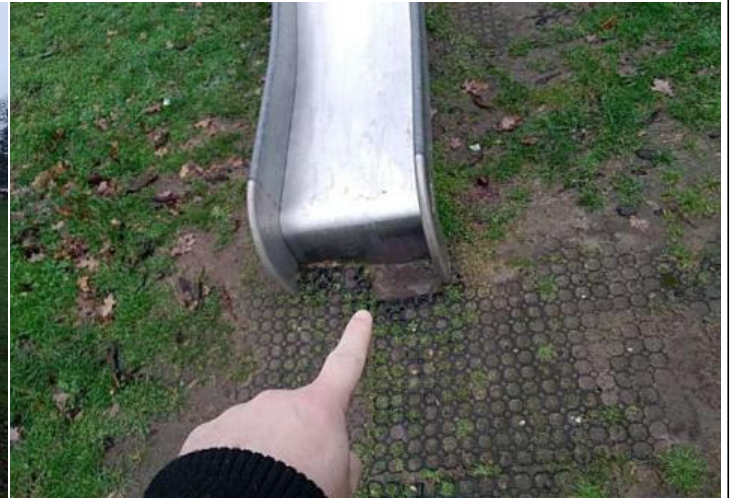
i 8 - Low Risk (Finding 2)

There is moderate damage to the surface - Repair the damaged areas of surfacing

Finding: There is moderate damage to the surface

Action: Repair the damaged areas of surfacing

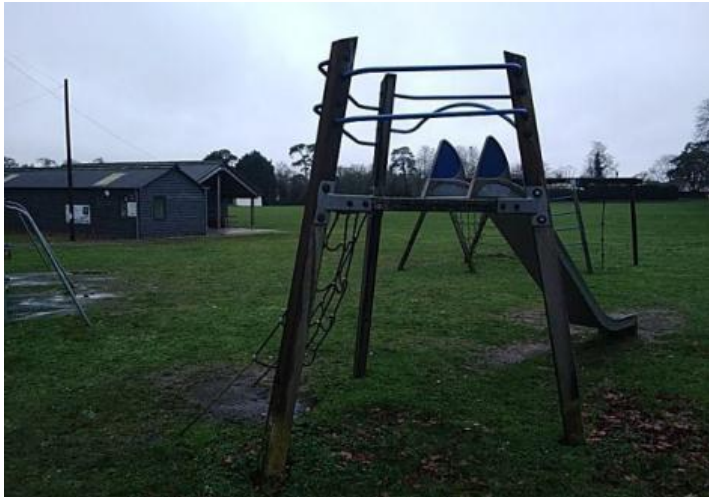
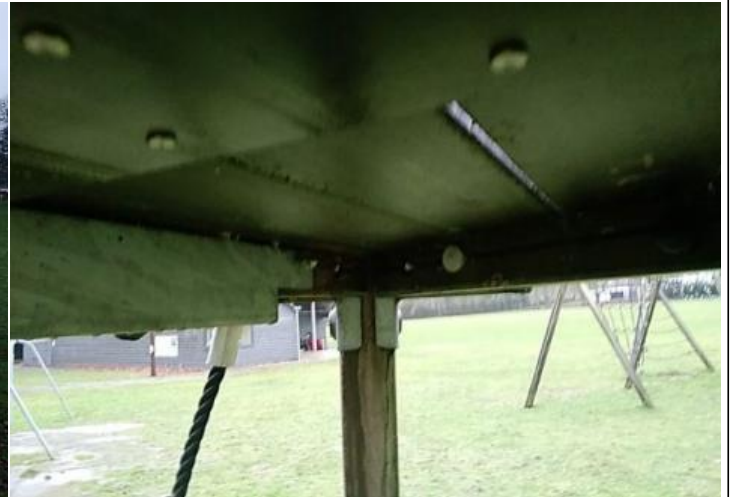
i 4 - Very Low Risk (Finding 3)

There is/are bolt cap covers missing or damaged on the item - Replace missing or damaged bolt cap covers

Finding: There is/are bolt cap covers missing or damaged on the item

Action: Replace missing or damaged bolt cap covers

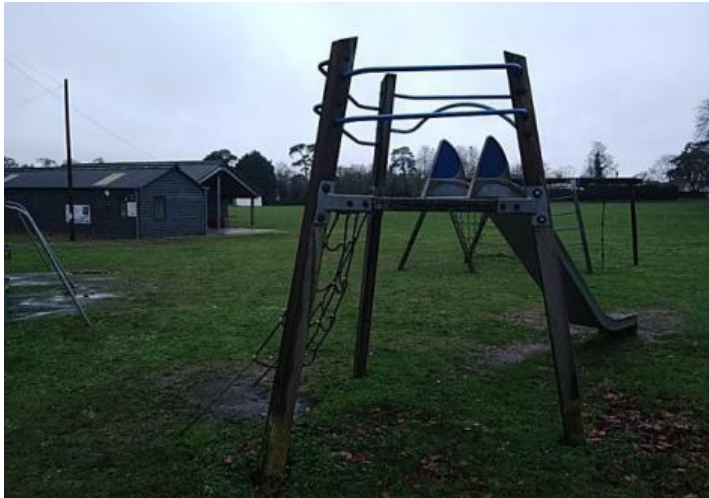
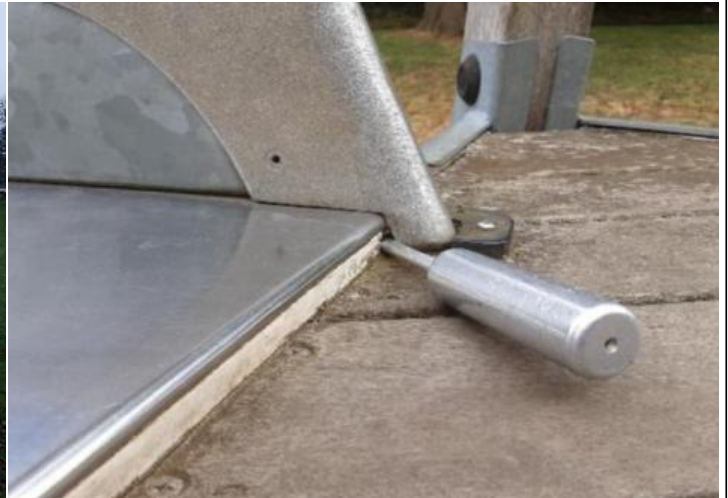
i 5 - Very Low Risk (Finding 4)

There is/are finger entrapment/s adjacent to the slide entry and the item fails to meet the requirements of BS EN 1176 Part 1 4.2.7.6 Entrapment of fingers - Monitor - No remedial work recommended

Finding: There is/are finger entrapment/s adjacent to the slide entry and the item fails to meet the requirements of BS EN 1176 Part 1 4.2.7.6 Entrapment of fingers

Action: Monitor - No remedial work recommended

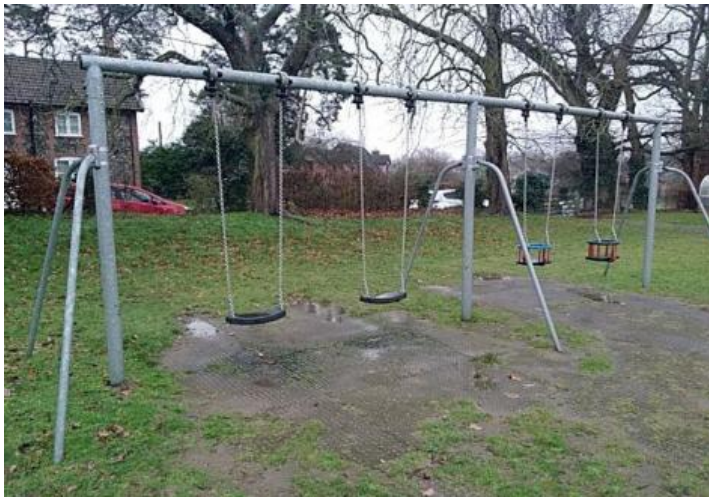
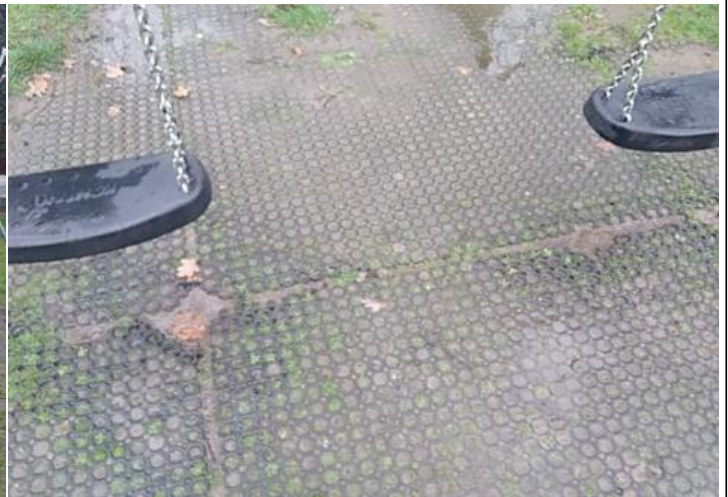
i 8 - Low Risk (Finding 1)

There is moderate damage to the surface - Repair the damaged areas of surfacing

Finding: There is moderate damage to the surface

Action: Repair the damaged areas of surfacing

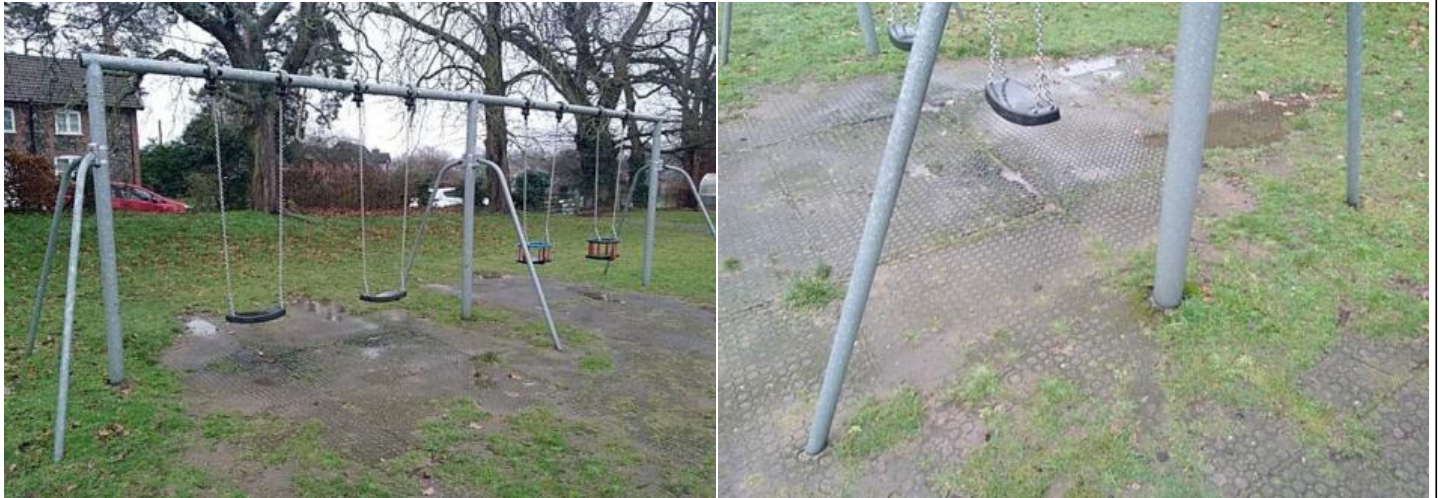
i 6 - Low Risk (Finding 2)

There is weed / vegetation growth on, between, or around the edges of the surfacing - Remove weed / vegetation growth

Finding: There is weed / vegetation growth on, between, or around the edges of the surfacing
Action: Remove weed / vegetation growth

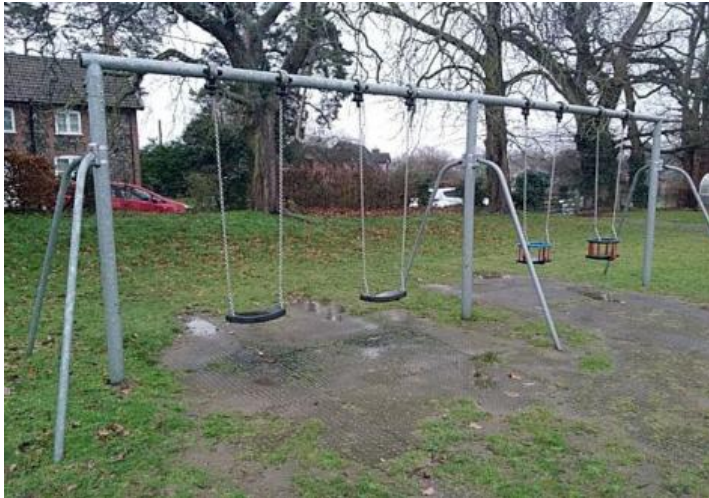
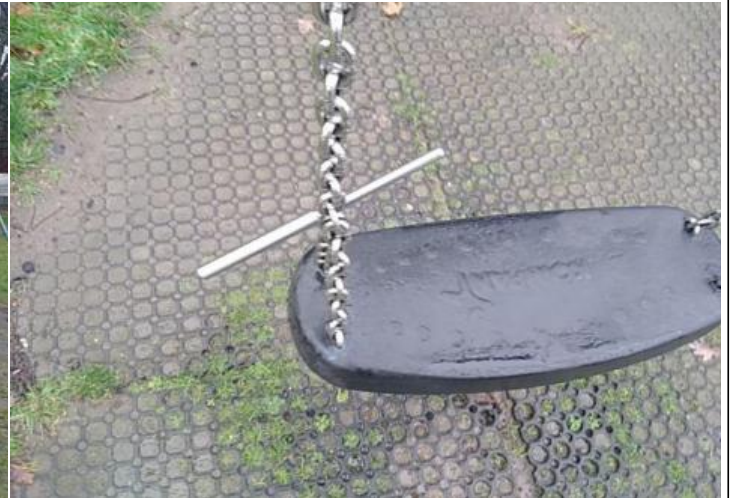
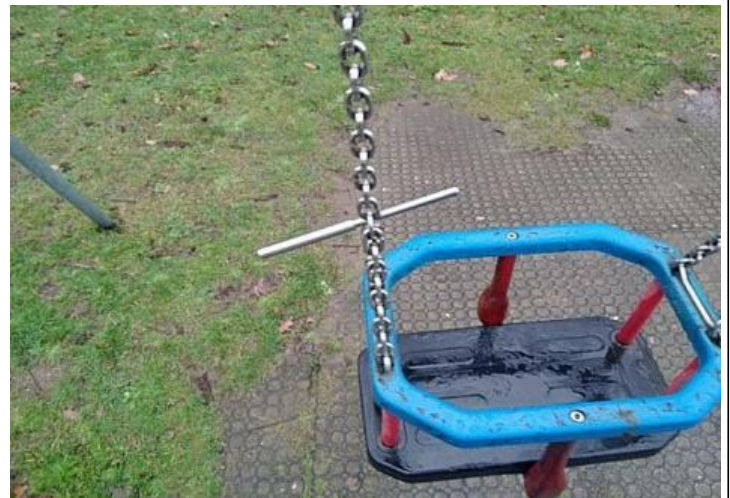
i 5 - Very Low Risk (Finding 3)

The connecting links are in excess of 8.6mm and less than 12mm and fail the requirements of BS EN 1176 Part 1; clause 4.2.13, Chains - Monitor use and replace with compliant links at the next maintenance cycle

Finding: The connecting links are in excess of 8.6mm and less than 12mm and fail the requirements of BS EN 1176 Part 1; clause 4.2.13, Chains

Action: Monitor use and replace with compliant links at the next maintenance cycle

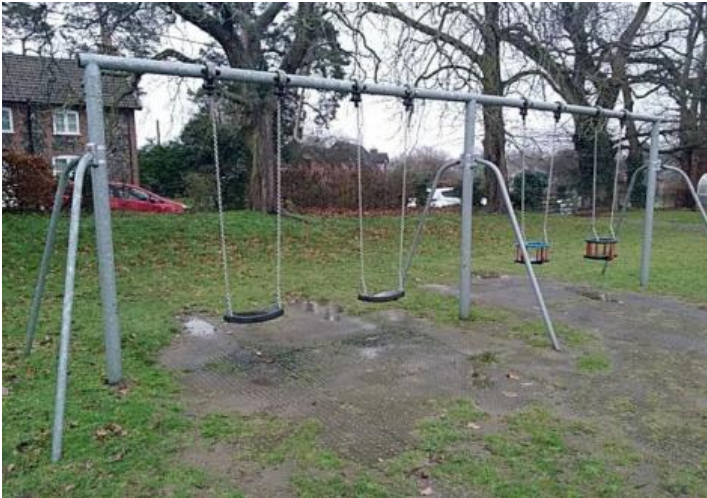
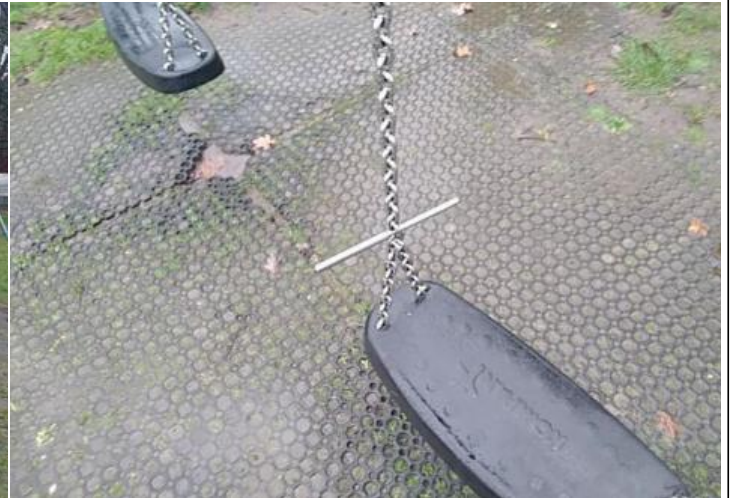
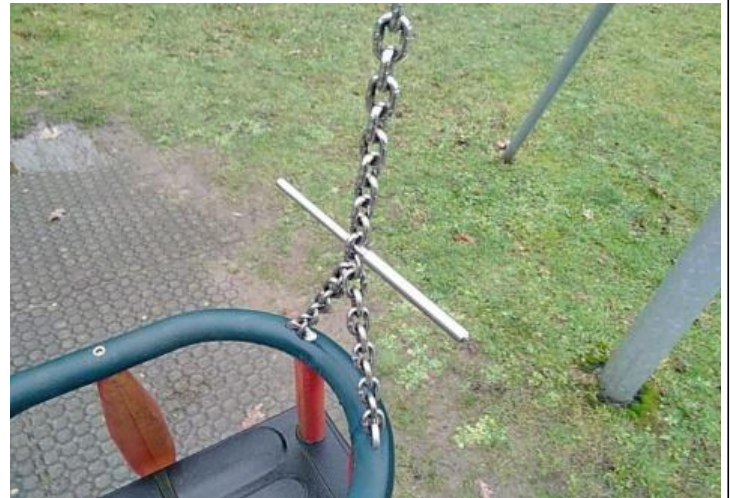
i 5 - Very Low Risk (Finding 4)

The chain openings are in excess of 8.6mm and do not meet the recommendations of BS EN 1176 Part 1 - Monitor - No remedial work recommended

Finding: The chain openings are in excess of 8.6mm and do not meet the recommendations of BS EN 1176 Part 1

Action: Monitor - No remedial work recommended

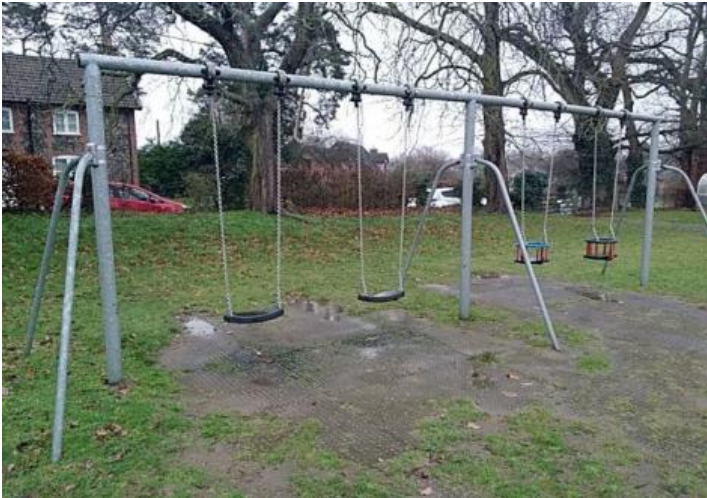
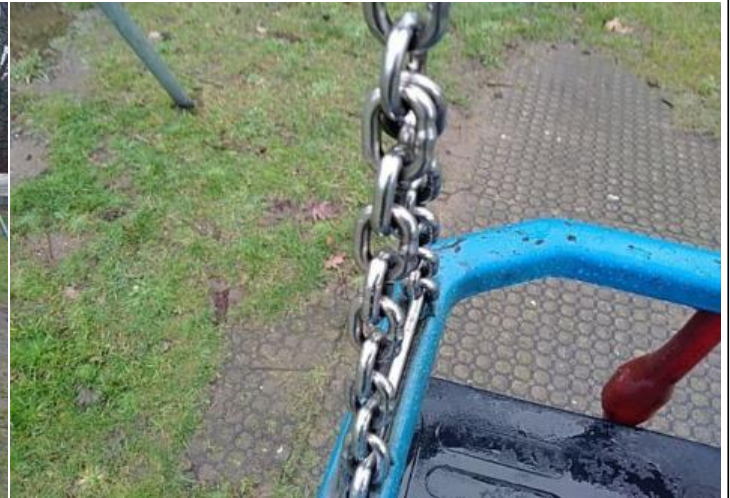
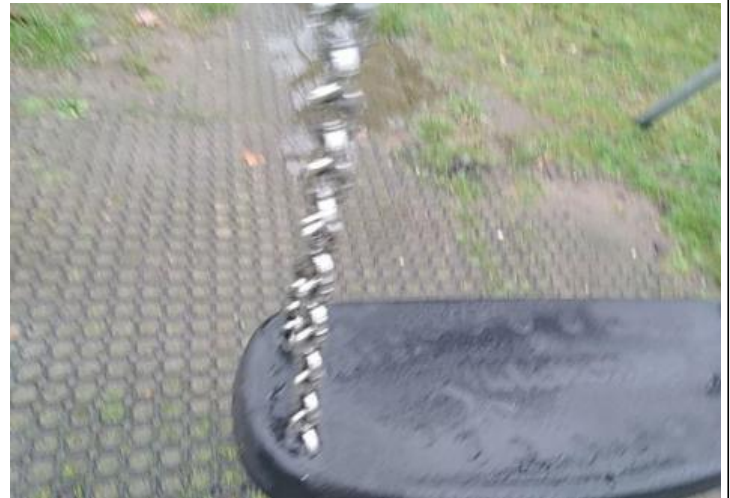
i 6 - Low Risk (Finding 5)

There is some notable evidence of chain wear - Monitor for any further deterioration and replace when 40% worn

Finding: There is some notable evidence of chain wear

Action: Monitor for any further deterioration and replace when 40% worn
