Operational Inspection

Thurston Parish Council

New Green Centre
New Green Ave, Thurston, IP31 3TG

Inspection Ref: 2245029

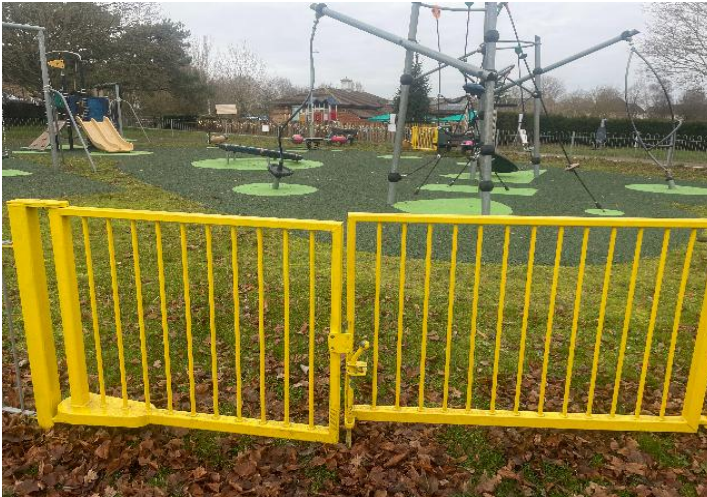
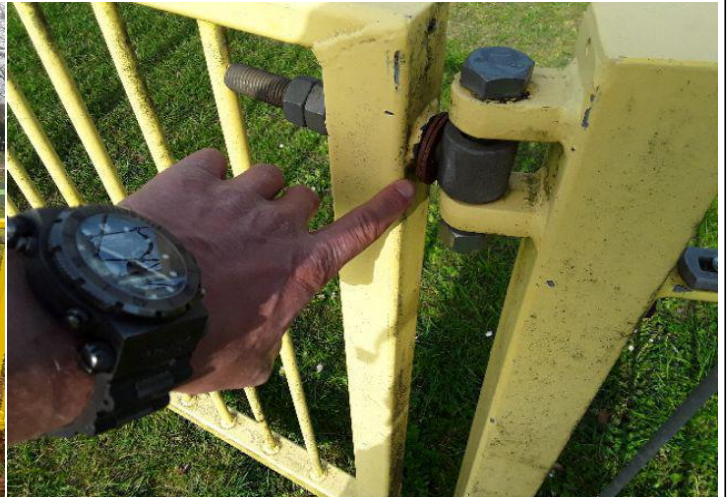
Item: Gates - Gate - Combination
Manufacturer: I.A.E. Fencing

Finding: The paintwork on this item has been damaged or worn exposing the metal underneath which is rusting

Action: Treat any rusting components and repaint

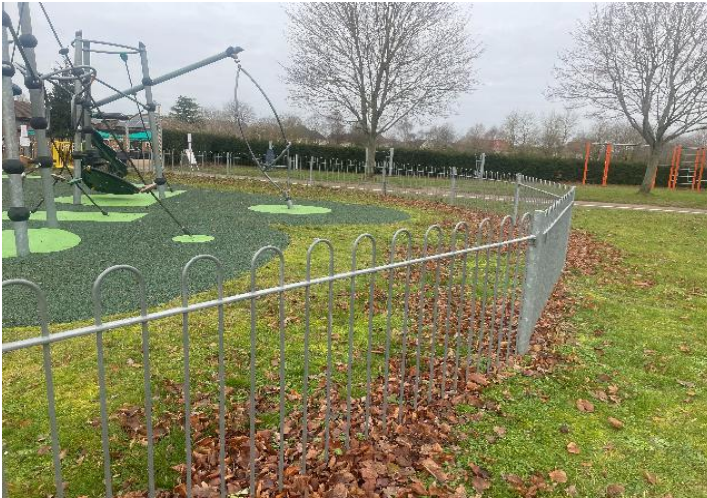
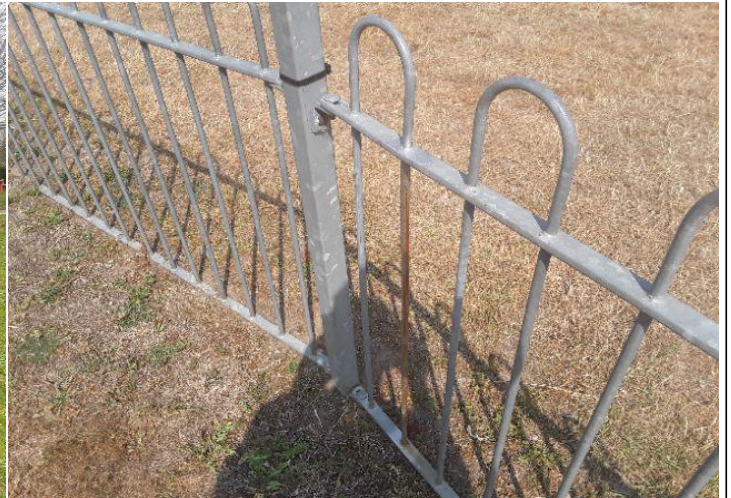
Item: Fences - Fence - Bow Top
Manufacturer: I.A.E. Fencing

Finding: The paintwork on this item has been damaged or worn exposing the metal underneath which is rusting

Action: Treat any rusting components and repaint

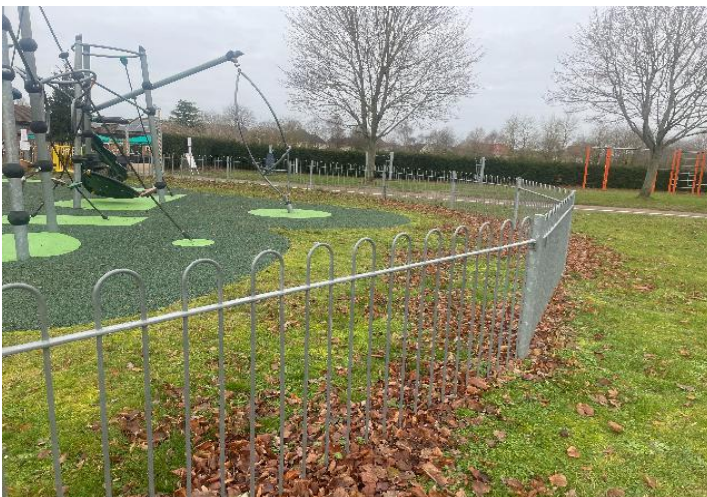
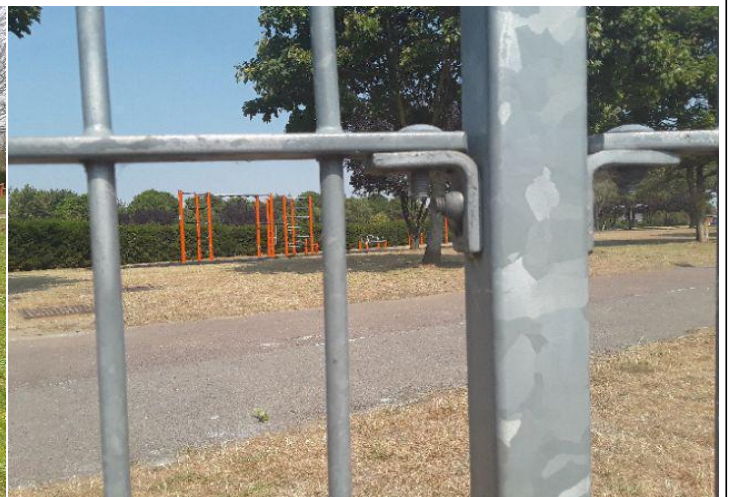
Item: Fences - Fence - Bow Top
Manufacturer: I.A.E. Fencing

Finding: There is or are fixings missing on the item

Action: Replace 2 missing fixings

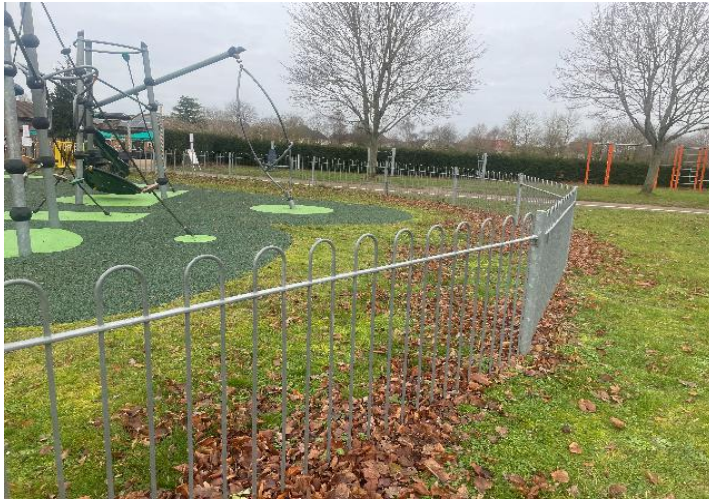
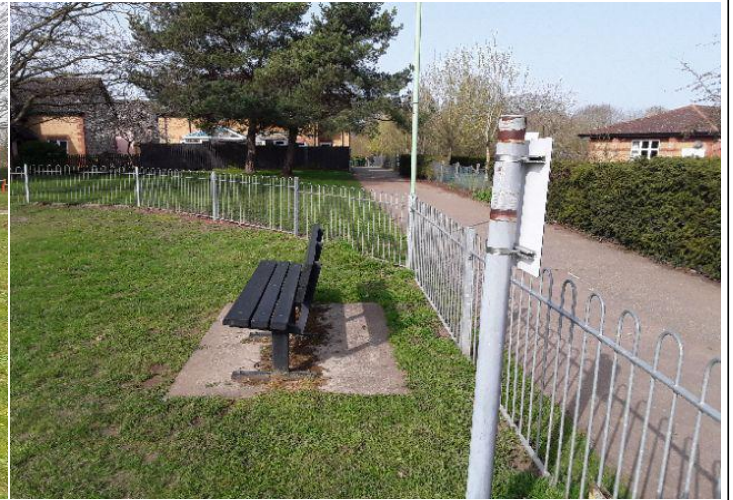
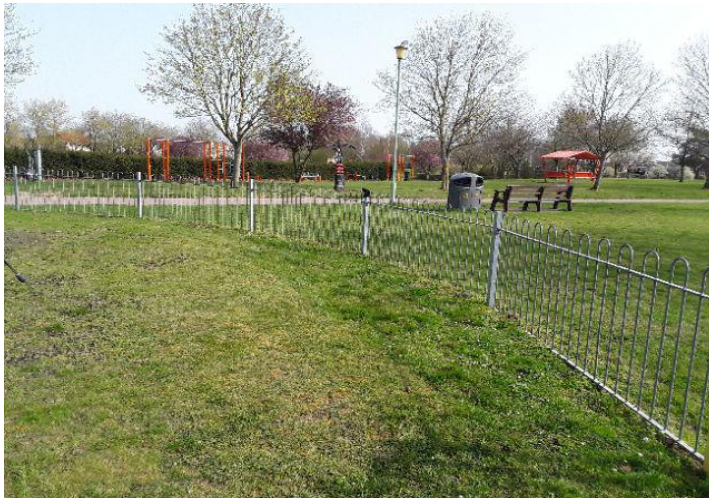
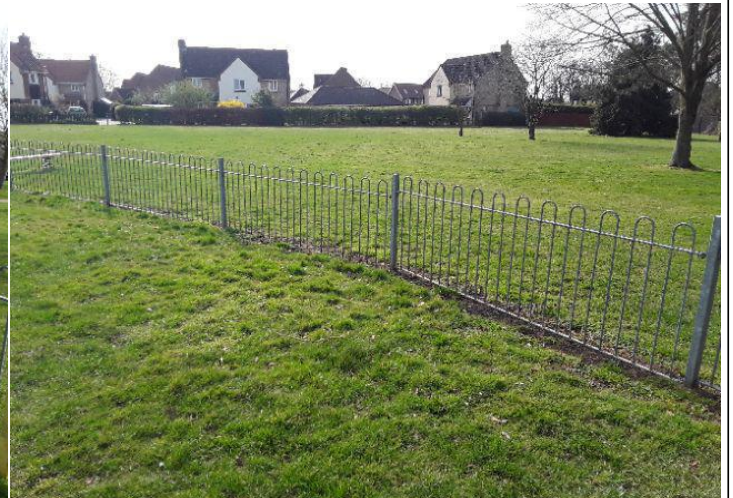
Item: Fences - Fence - Bow Top
Manufacturer: I.A.E. Fencing

Finding: There are 4 loose posts around the fence

Action: Monitor for any further deterioration and reset as required

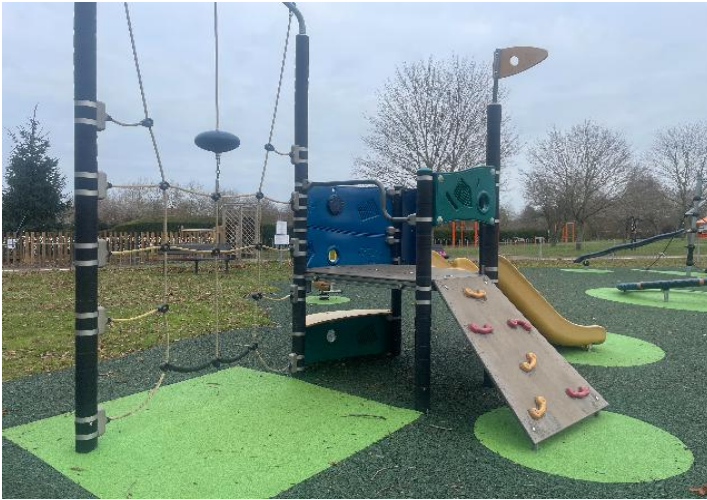
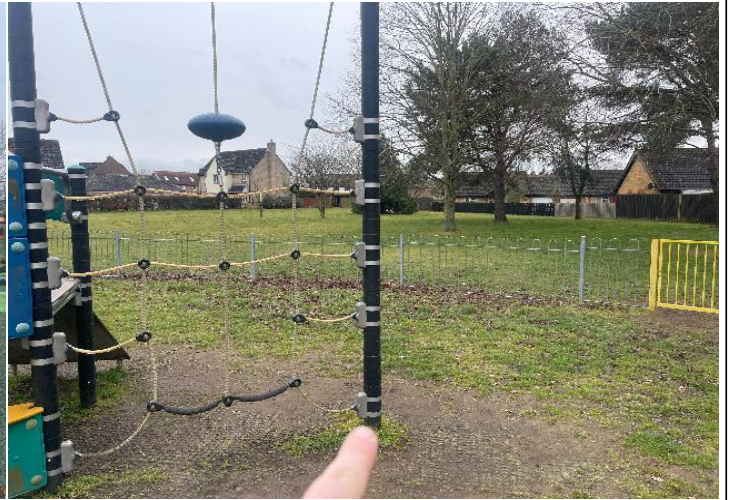
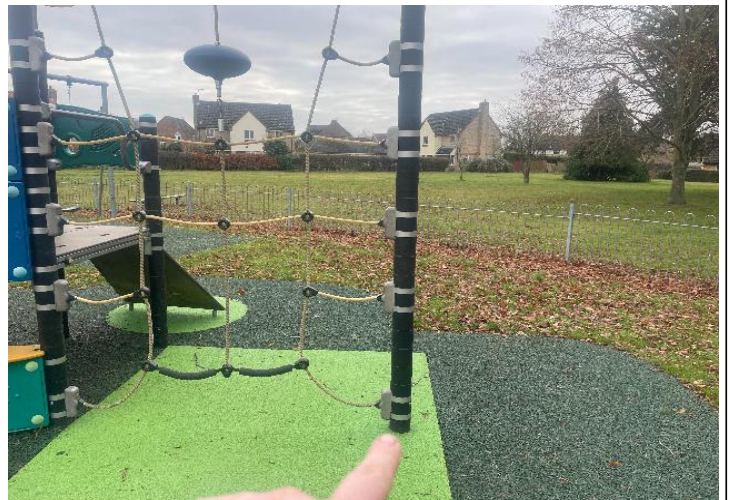
Item: Activity Equipment - Multi Play (Senior)
Manufacturer: Kompan Ltd

Finding: The item is slightly loose in its foundations

Action: Monitor for any further deterioration and repair as required

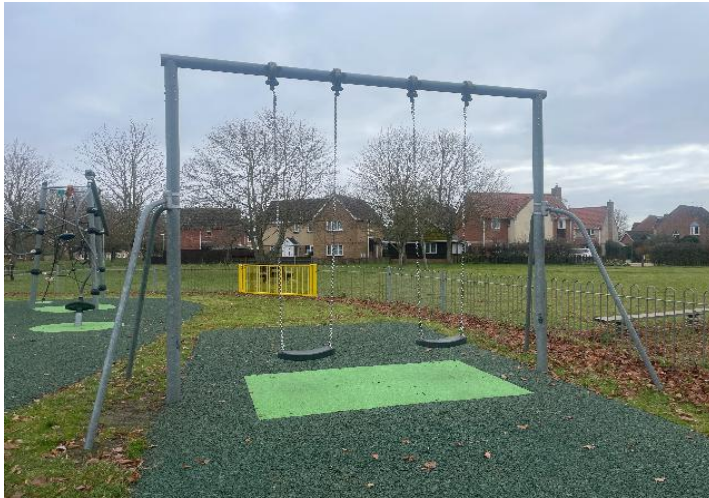
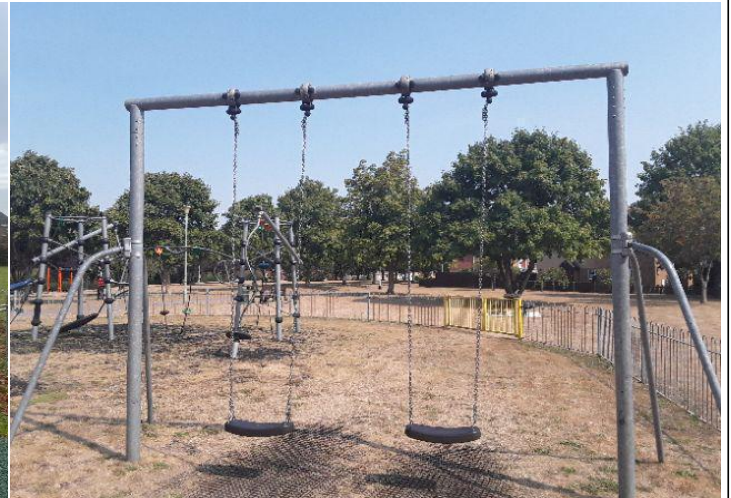
Item: Swings - 1 Bay 2 Seat (Flat)
Manufacturer: Kompan Ltd

Finding: There is some notable evidence of chain wear

Action: Monitor for any further deterioration and replace when 40% worn

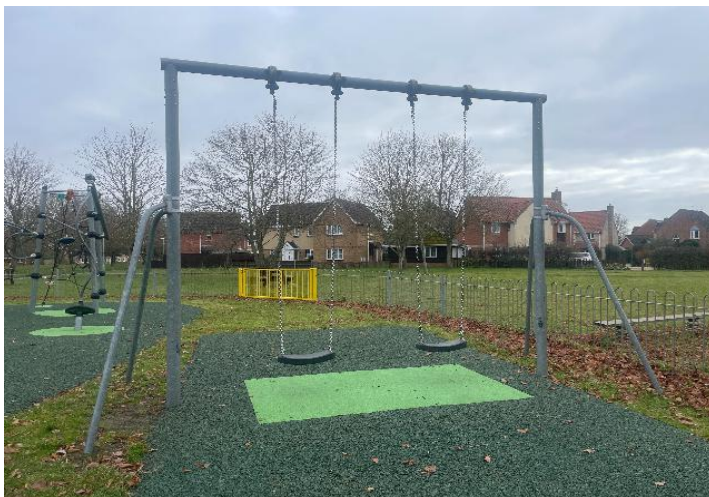
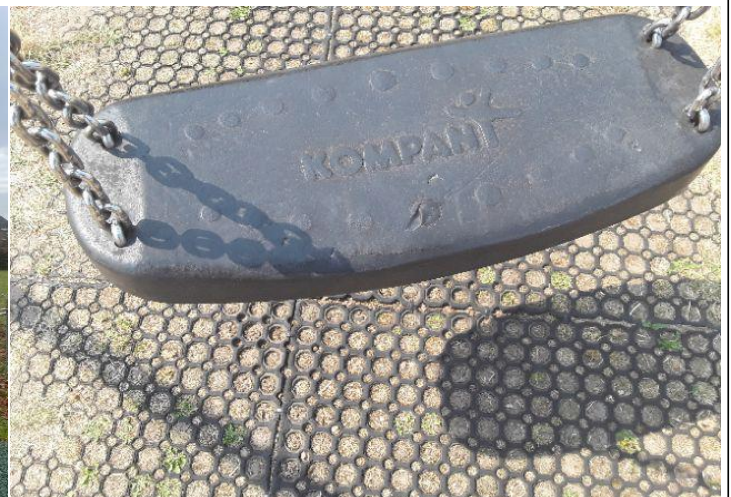
Item: Swings - 1 Bay 2 Seat (Flat)
Manufacturer: Kompan Ltd

Finding: The seat has minor damage or wear

Action: Monitor for any further deterioration and replace as required

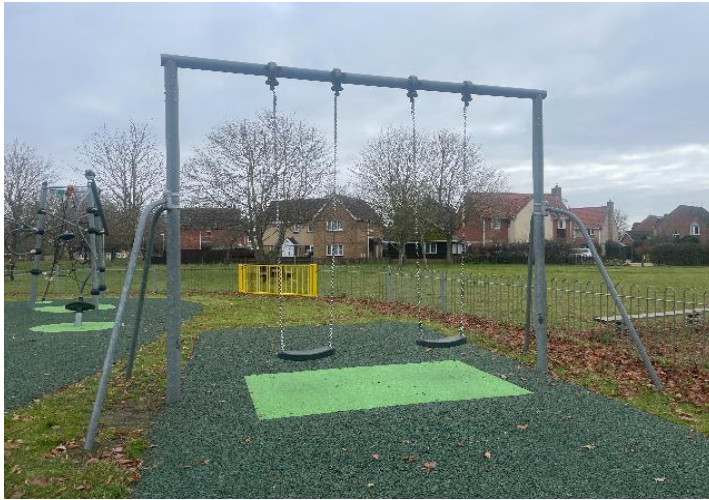
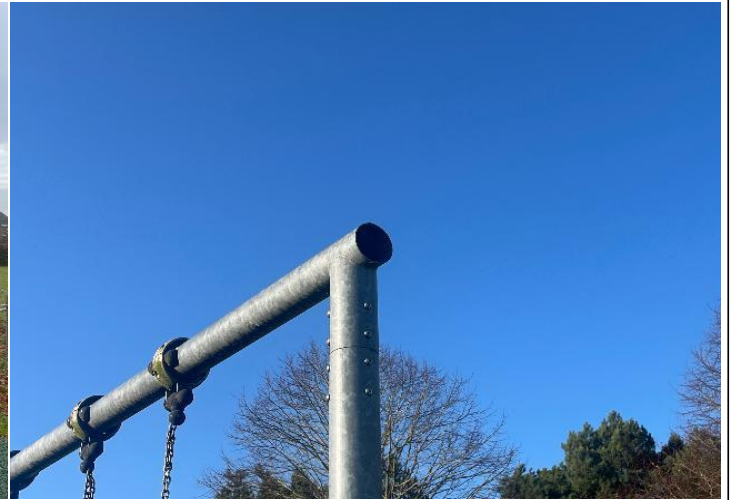
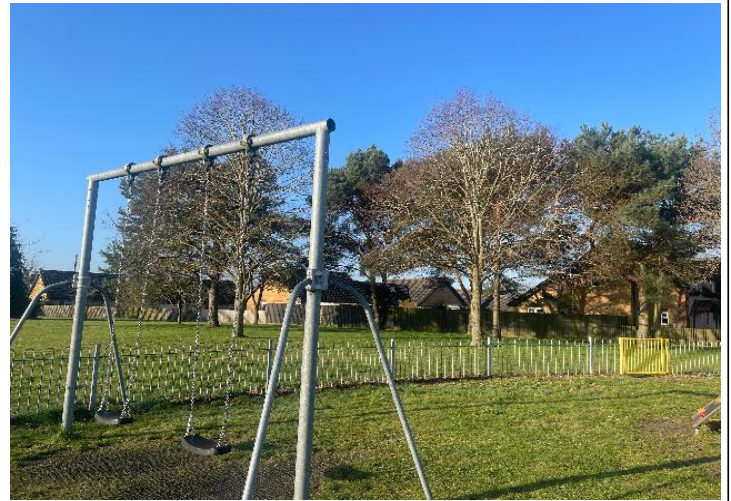
Item: Swings - 1 Bay 2 Seat (Flat)
Manufacturer: Kompan Ltd

Finding: There is/are bolt cap covers missing or damaged on the item

Action: Replace missing or damaged bolt cap covers

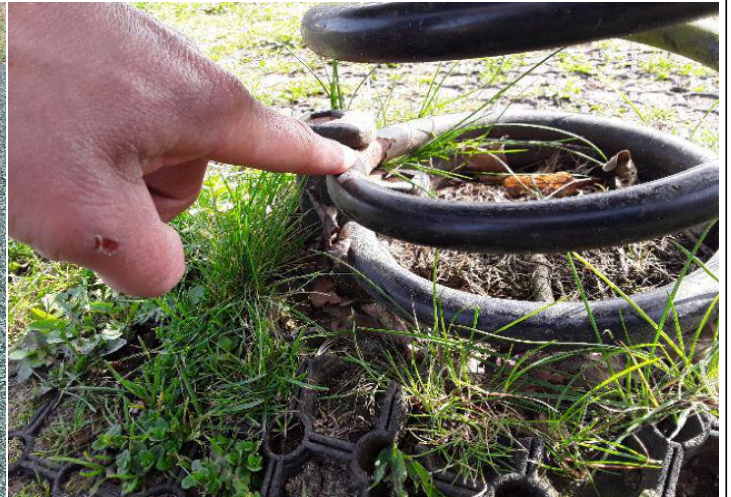
Item: Rocking Equipment - Misc Springer
Manufacturer: Kompan Ltd

Finding: The paintwork on the spring has been damaged or worn exposing the metal underneath which is rusting

Action: Treat any rusting components and repaint

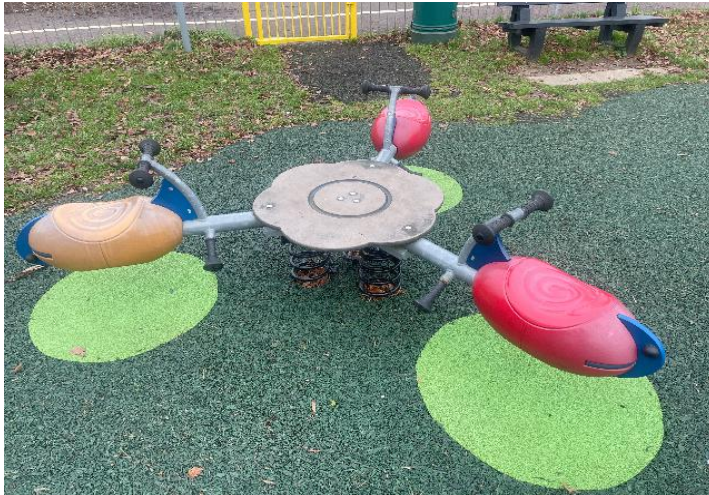
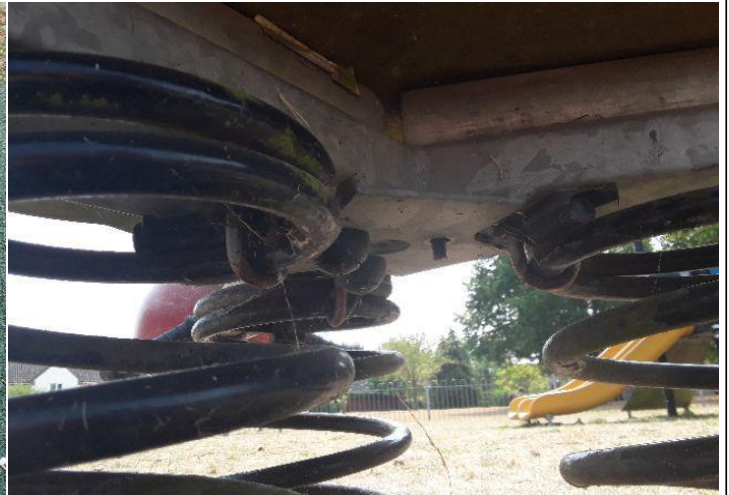
Item: Rocking Equipment - Three Way Springer
Manufacturer: Kompan Ltd

Finding: There is or are fixings missing on the item

Action: Replace all missing fixings

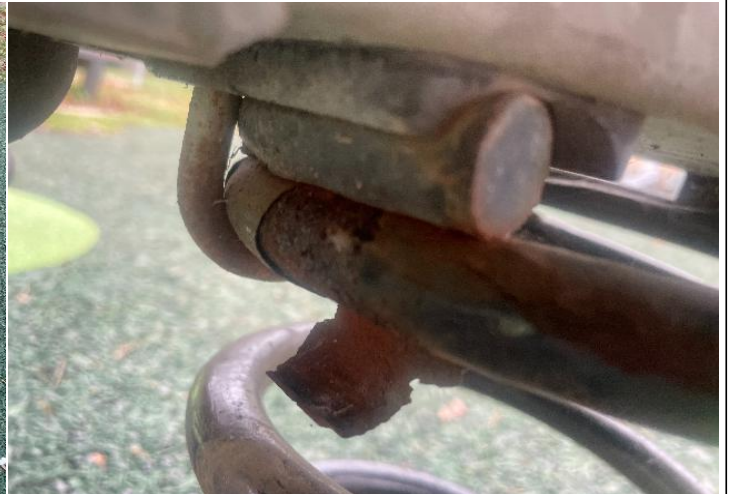
Item: Rocking Equipment - Three Way Springer
Manufacturer: Kompan Ltd

Finding: The paintwork on the spring has been damaged or worn exposing the metal underneath which is rusting

Action: Treat any rusting components and repaint

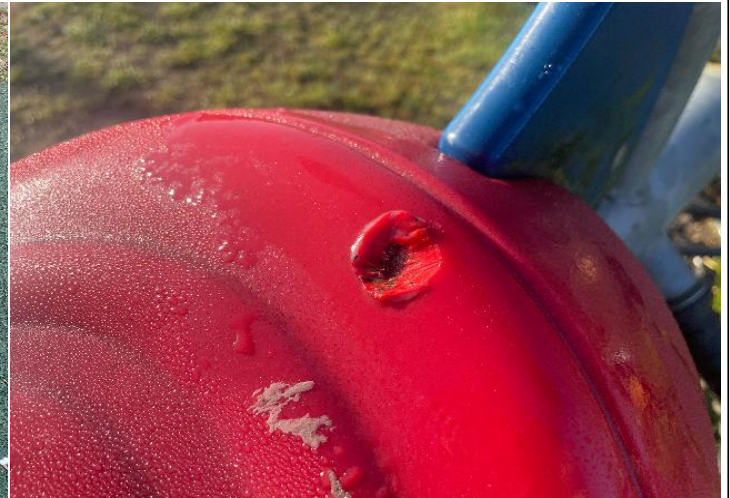
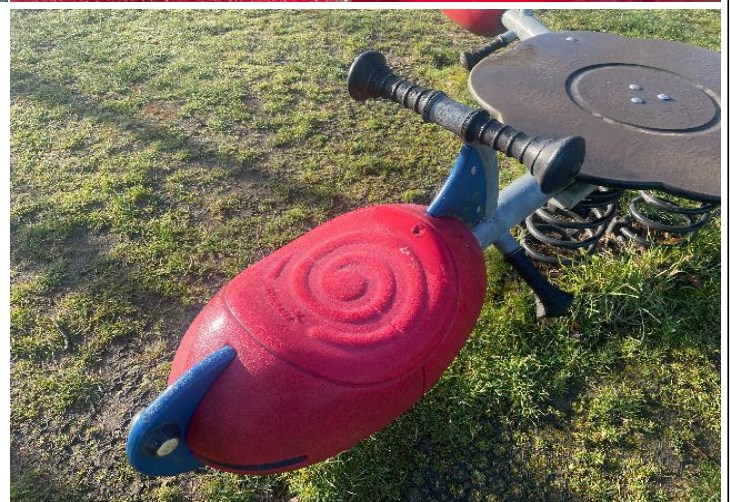
Item: Rocking Equipment - Three Way Springer
Manufacturer: Kompan Ltd

Finding: There is some evidence of fire damage to the item **Action:** Monitor for any further deterioration and repair as required

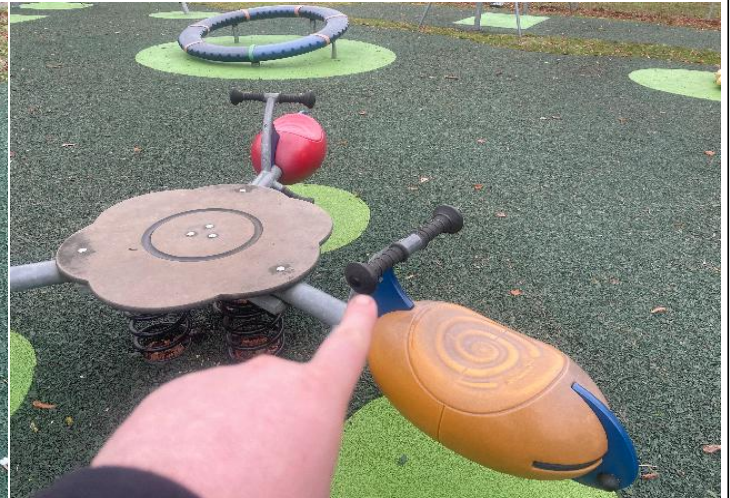
Item: Rocking Equipment - Three Way Springer
Manufacturer: Kompan Ltd

Finding: A number of Inaccessible fixing(s) have worked loose

Action: Secure all loose fixings

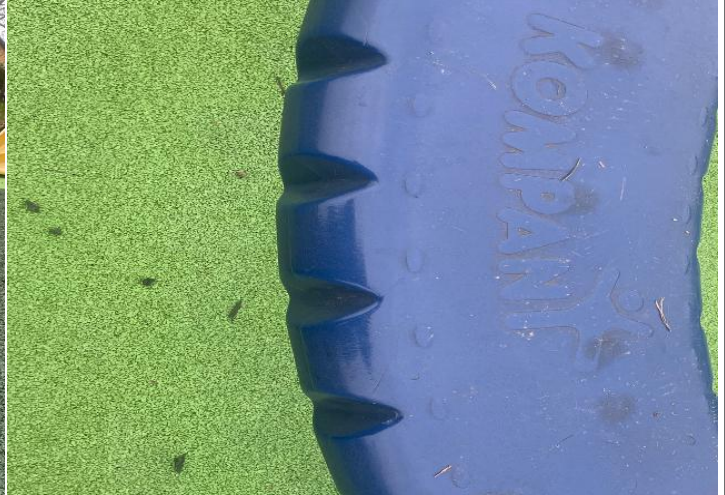
Item: Rotor Play - Supernova
Manufacturer: Kompan Ltd

Finding: Some segments have minor damage

Action: Monitor

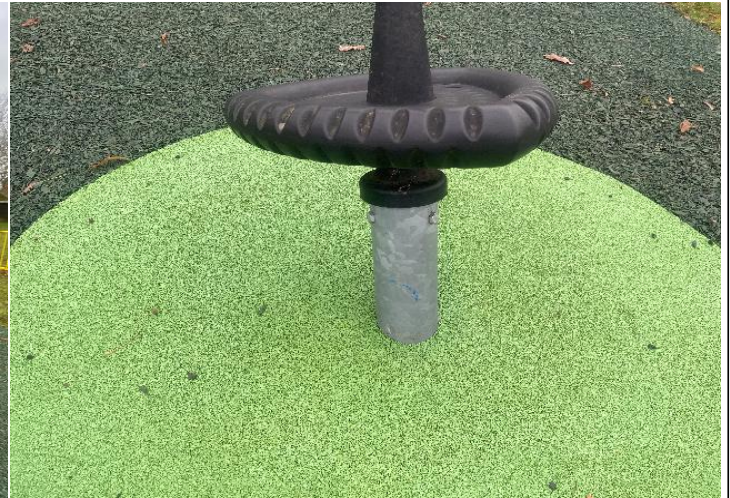
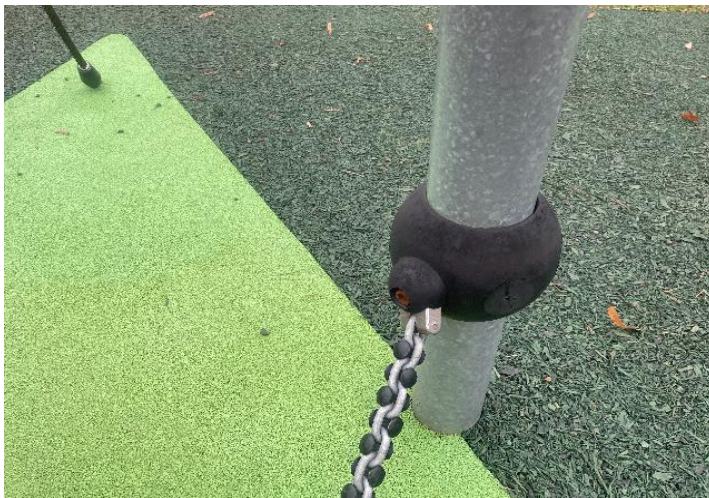
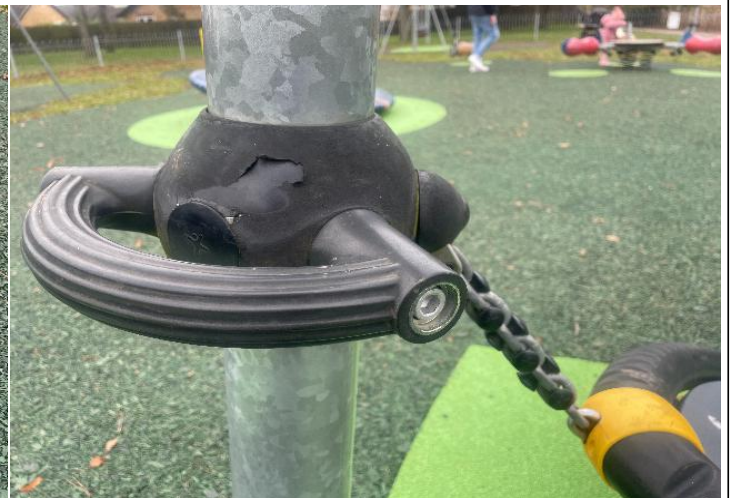
Item: Activity Equipment - Multi Play (Senior)
Manufacturer: Kompan Ltd

Finding: There is/are bolt cap covers missing or damaged on the item

Action: Replace missing or damaged bolt cap covers

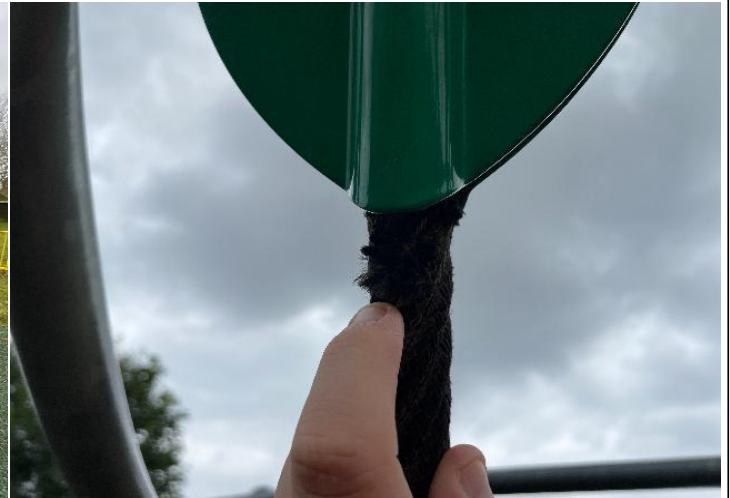
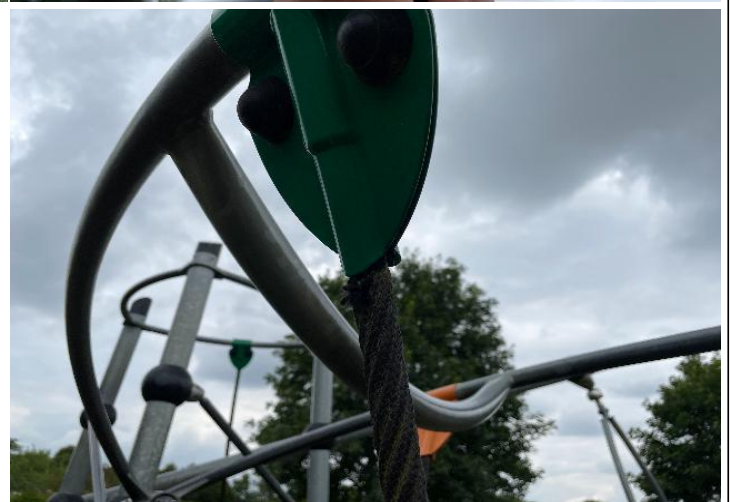
Item: Activity Equipment - Multi Play (Senior)
Manufacturer: Kompan Ltd

Finding: The ropes/nets are worn/damaged in places

Action: Monitor for any further deterioration and repair or replace as required

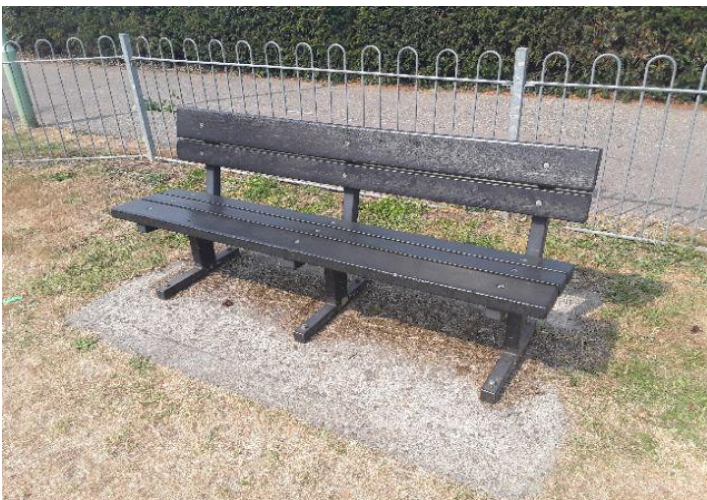
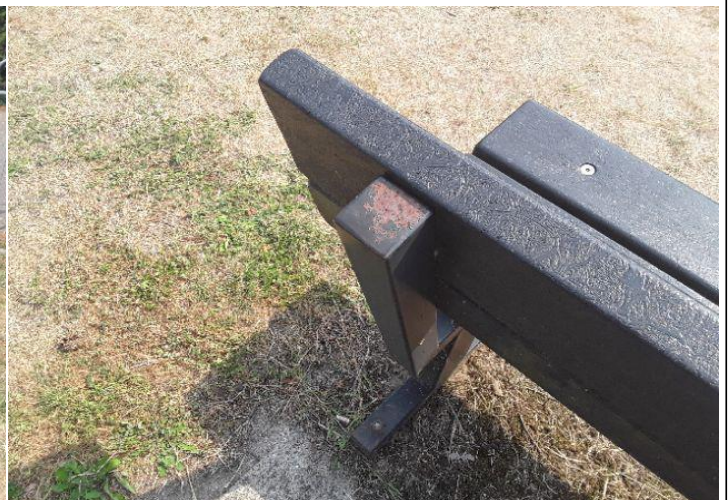
Item: Ancillary Items - Bench
Manufacturer: Unknown

Finding: The paintwork on this item has been damaged or worn exposing the metal underneath which is rusting

Action: Treat any rusting components and repaint

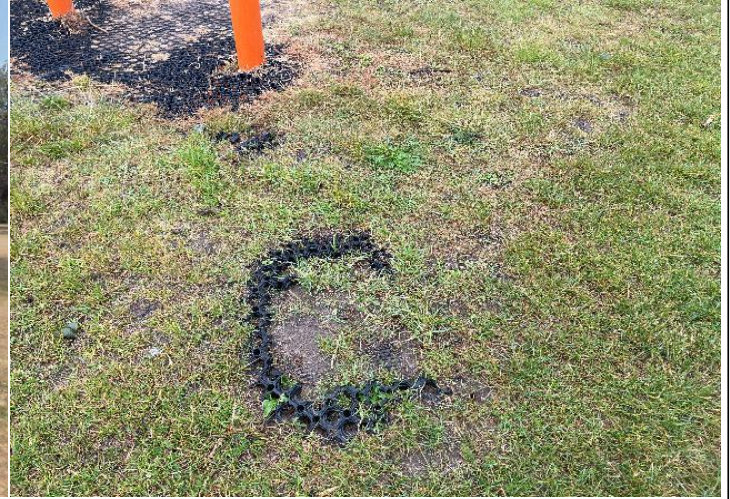
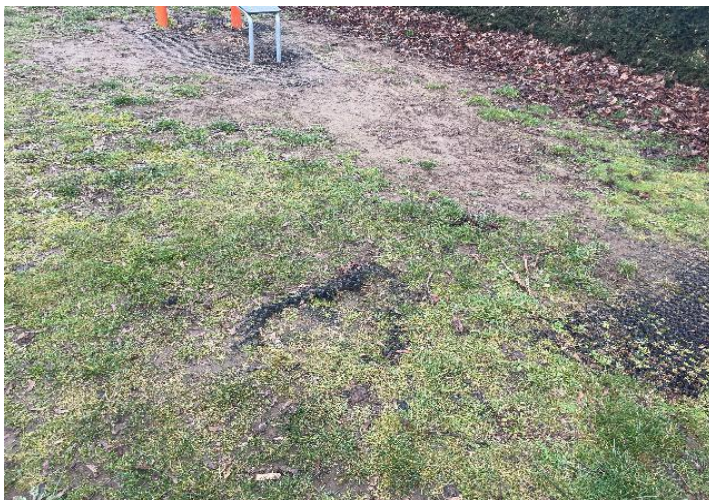
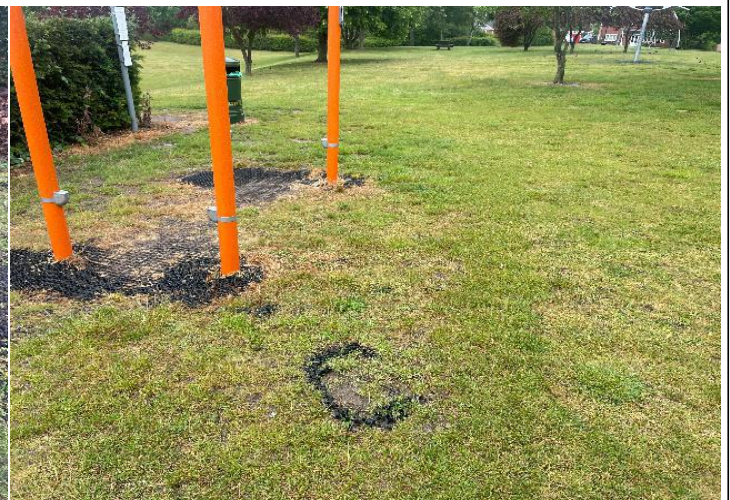
Item: Outdoor Fitness Equipment - Overhead Bars
Manufacturer: Kompan Ltd

Finding: The surfacing around the item is damaged

Action: Repair the damaged areas of surfacing

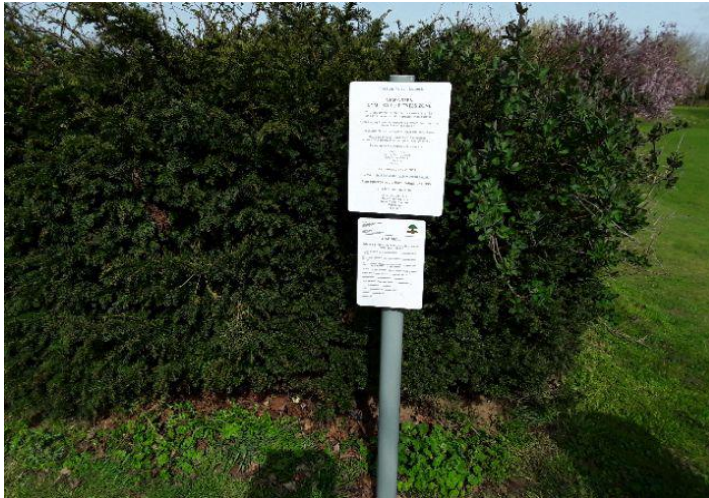
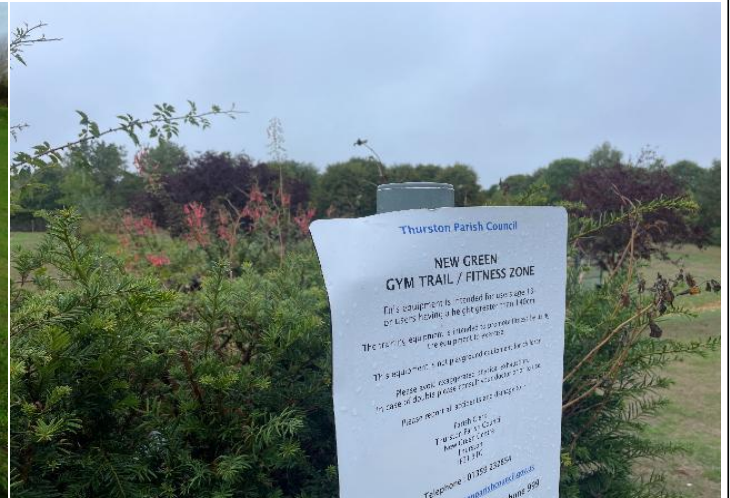
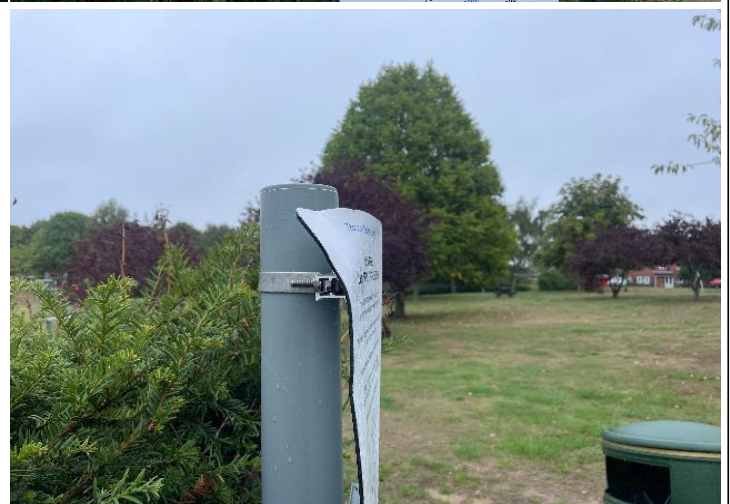
Item: Ancillary Items - Sign
Manufacturer: Unknown

Finding: The item has been damaged

Action: Monitor for any further deterioration and replace as required

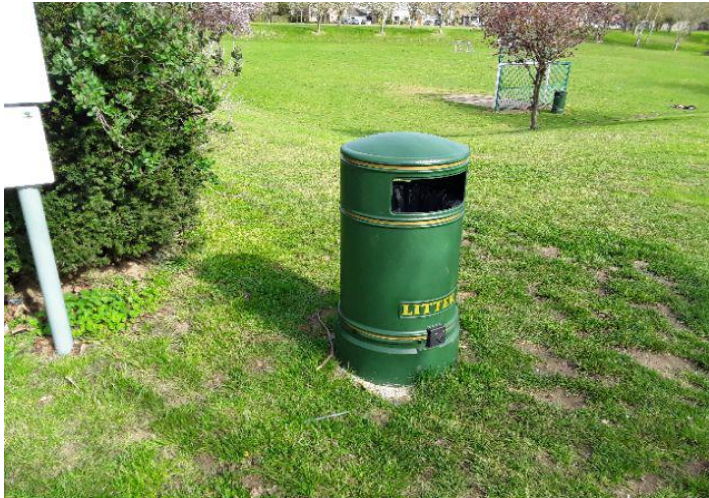
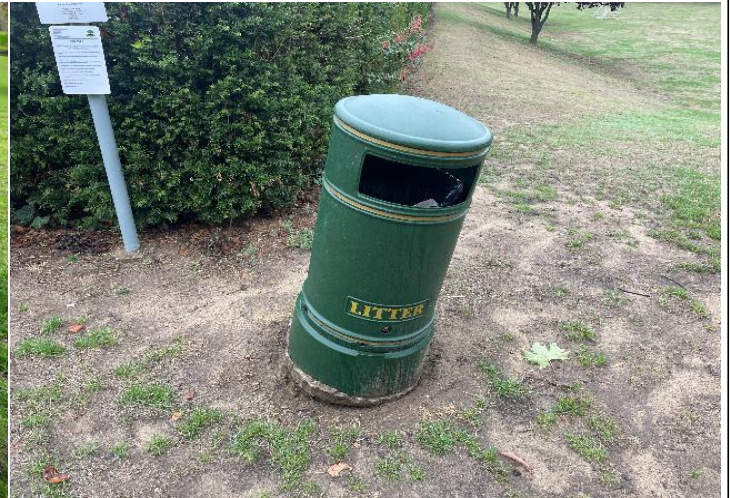
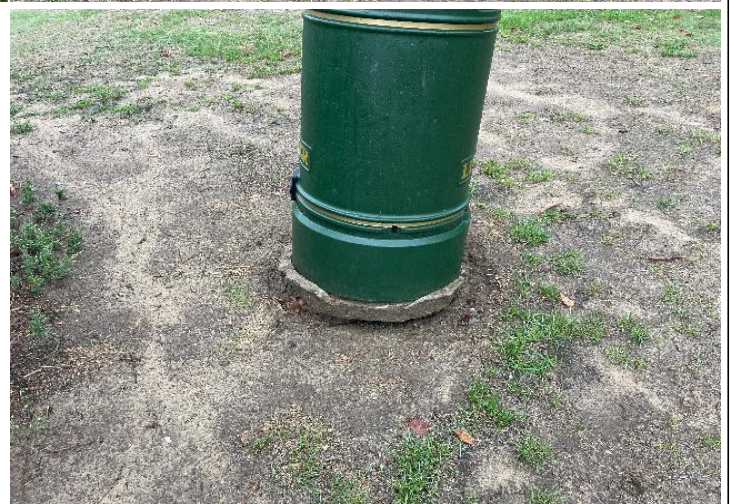
Item: Ancillary Items - Litter Bin
Manufacturer: Glasdon

Finding: The item is loose in its foundations

Action: Reinstall item to secure

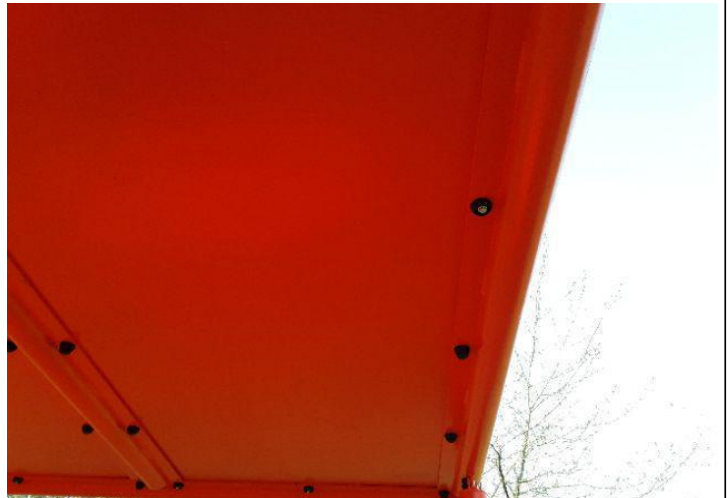
Item: Ancillary Items - Shelter
Manufacturer: Caloo

Finding: There is/are bolt cap covers missing or damaged on the item

Action: Replace 9 missing or damaged bolt cap covers

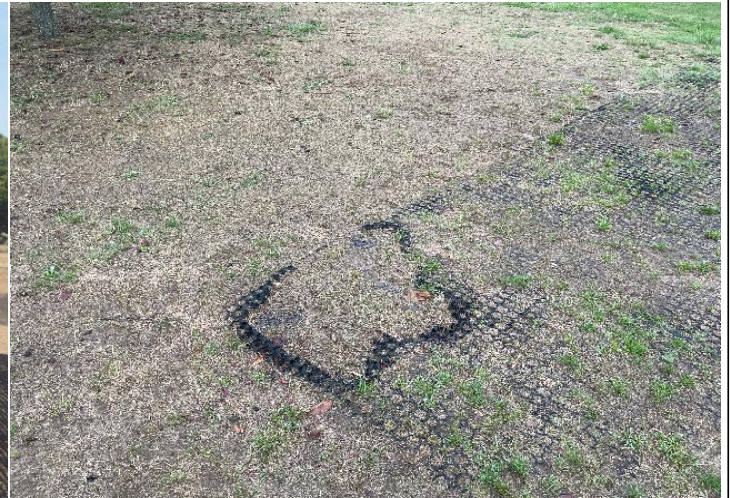
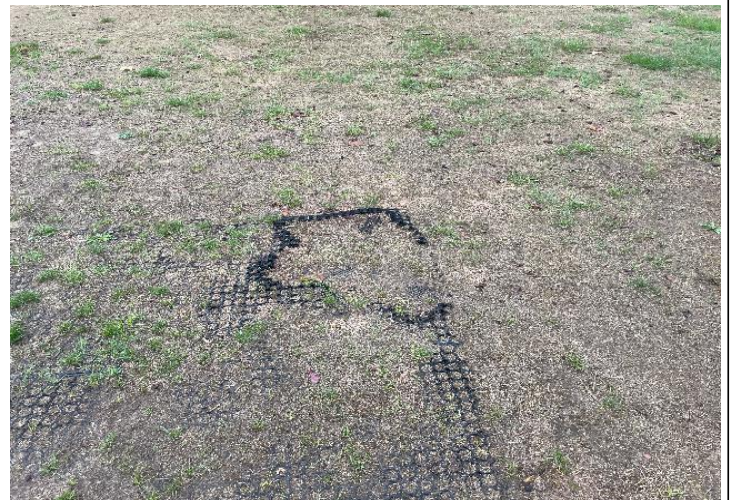
Item: Activity Equipment - Overhead Rotator
Manufacturer: Kompan Ltd

Finding: The surfacing around the item is damaged

Action: Repair the damaged areas of surfacing

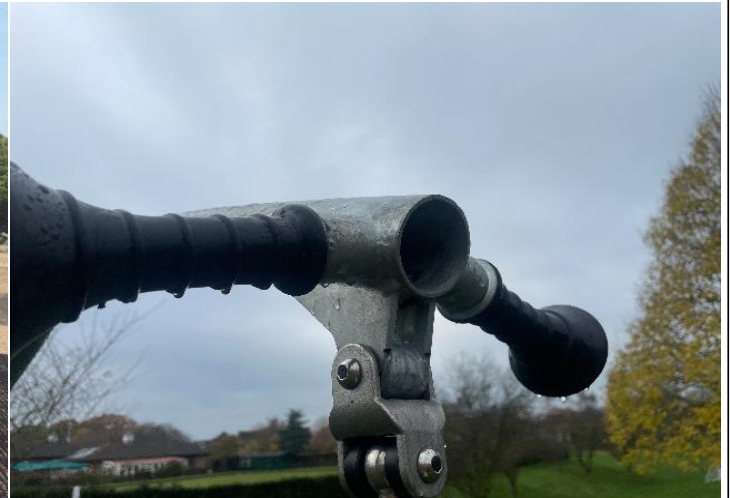
Item: Activity Equipment - Overhead Rotator
Manufacturer: Kompan Ltd

Finding: There is/are bolt cap covers missing or damaged on the item

Action: Replace missing or damaged bolt cap covers

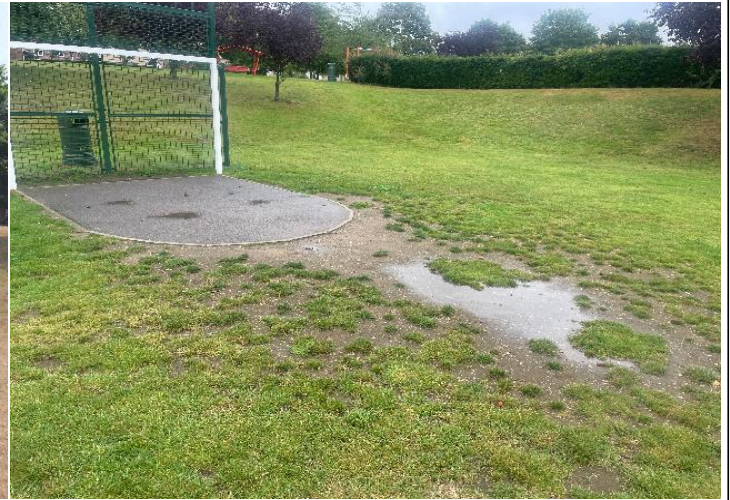
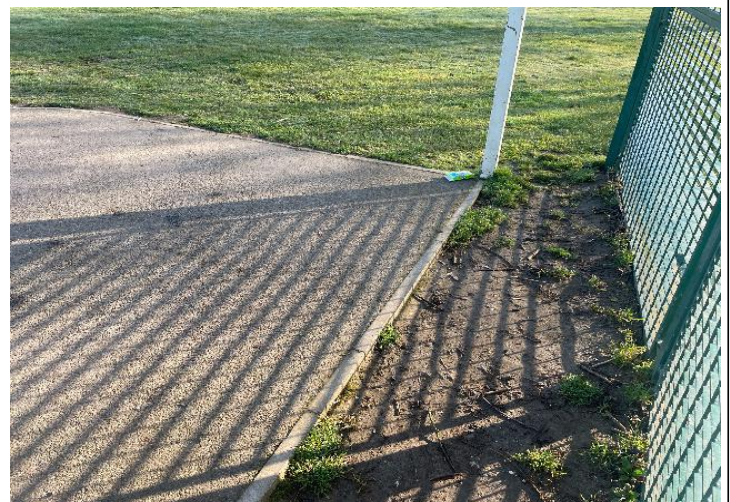
Item: Multi Use Games Area - Goal End
Manufacturer: Unknown

Finding: There are trip hazards at the edges of the surface

Action: Reinstate surrounding surface levels to remove the trip points

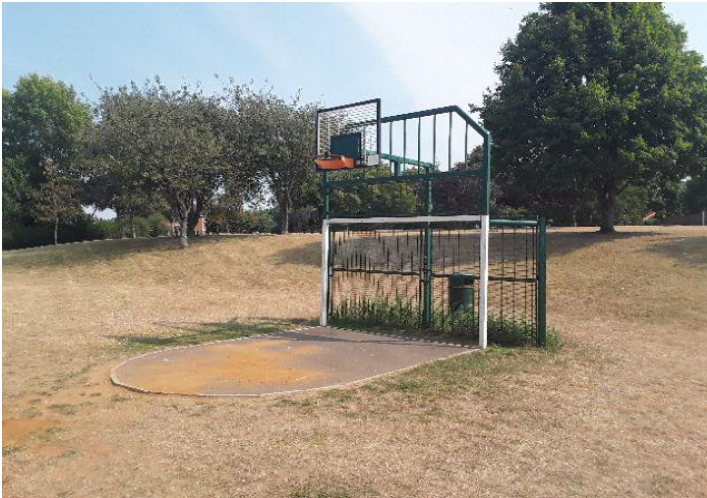
Item: Multi Use Games Area - Goal End
Manufacturer: Unknown

Finding: There is surface corrosion present on the item

Action: Consider treating and repainting the item

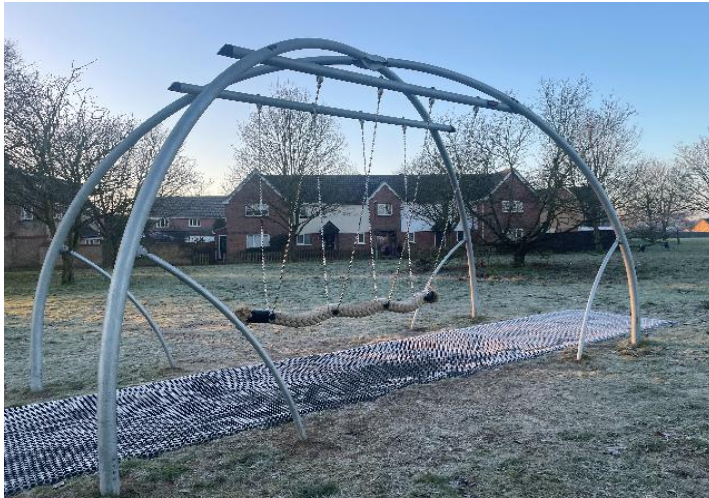
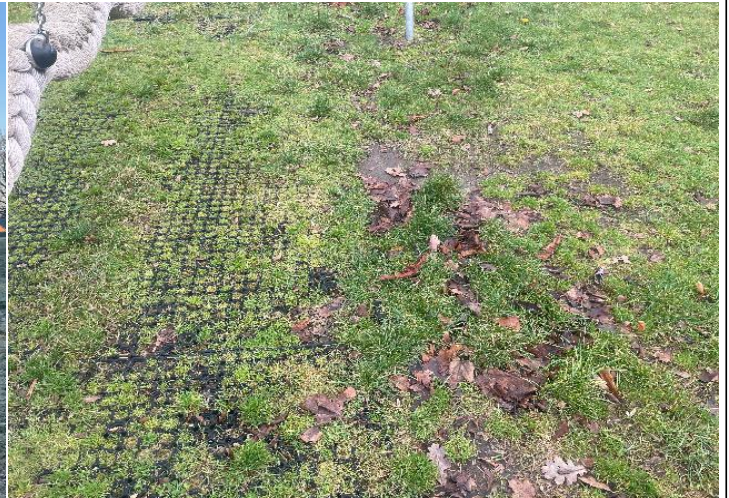
Item: Swings - Giant Rope Swing
Manufacturer: Kompan Ltd

Finding: The surfacing around the item is damaged

Action: Repair the damaged areas of surfacing

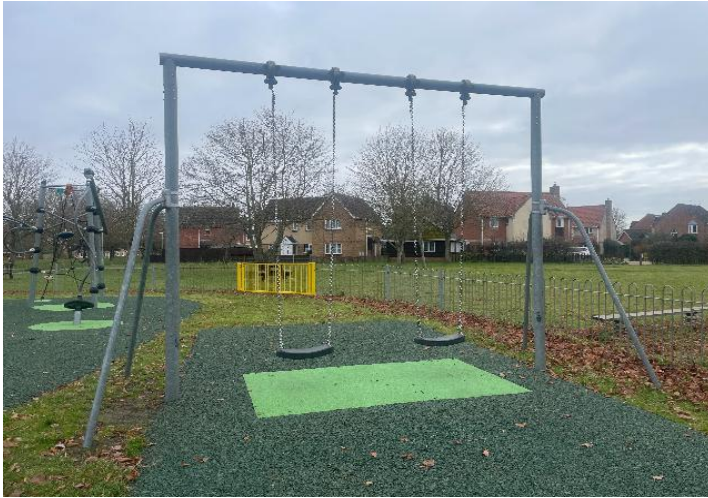
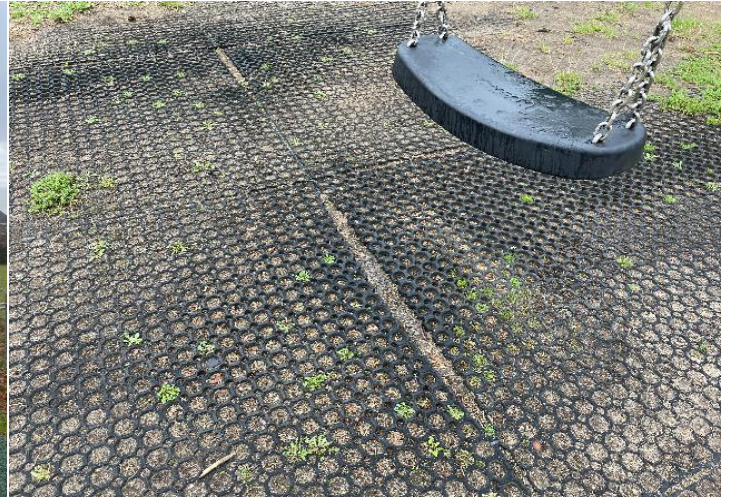
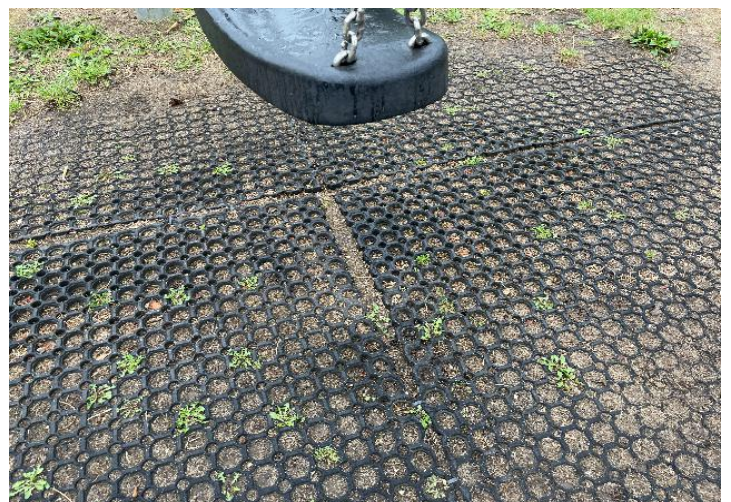
Item: Swings - 1 Bay 2 Seat (Flat)
Manufacturer: Kompan Ltd

Finding: There are gaps opening in between the tiles

Action: Monitor for any further deterioration and repair as required

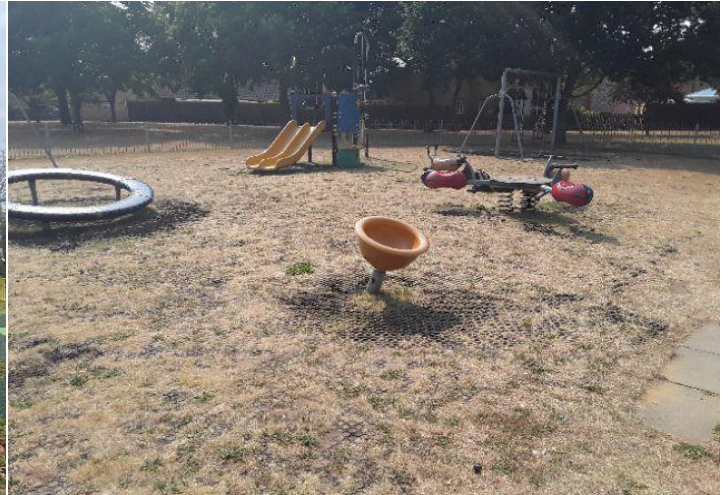
Item: Ancillary Items - Site General
Manufacturer: Unknown

Finding: The grass mats are silted up and the soil is compacted; this may have an effect on the impact absorbing properties of the surface

Action: Consider HIC testing impact absorbing properties to ensure the correct surface qualities are maintained for the equipment and replace as required

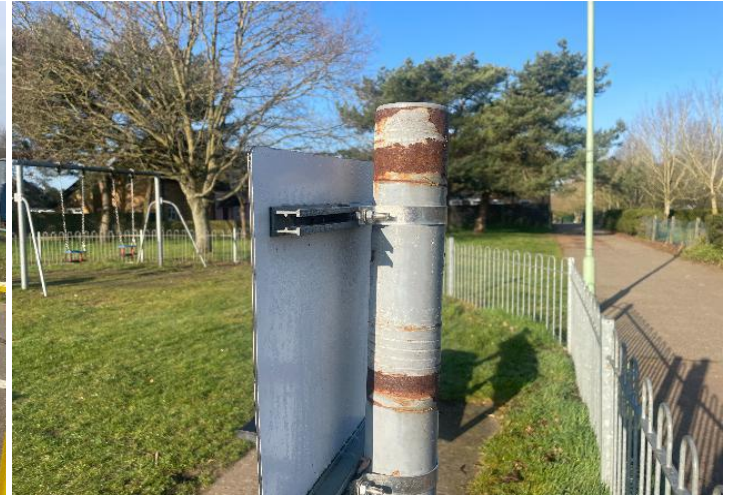
Item: Ancillary Items - Sign
Manufacturer: Unknown

Finding: The paintwork on this item has been damaged or worn exposing the metal underneath which is rusting

Action: Treat any rusting components and repaint
