Operational Inspection

Thurston Parish Council

Thurst Coffee Shop Playground

Inspection Ref: 2245030

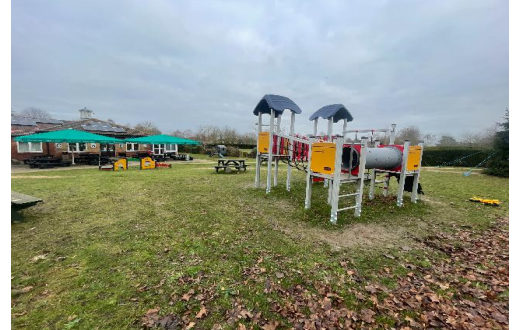
Finding 1

Item: Multi Play (Junior)
Manufacturer: Kompan Ltd
Surface Type: Grass Matrix Tiles
Item Quantity: 1
Equipment Compliance: N/A
Surface Area Compliance: N/A

This item is satisfactory - no work required -

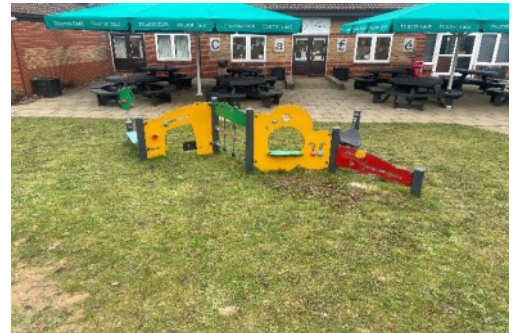
Finding 1

Item: Activity Trail
Manufacturer: Kompan Ltd
Surface Type: Grass
Item Quantity: 1
Equipment Compliance: N/A
Surface Area Compliance: N/A

This item is satisfactory - no work required -

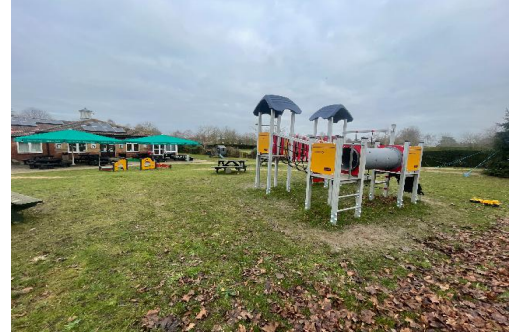
Finding 1

Item: Site General
Manufacturer: Not Identified
Surface Type: Grass
Item Quantity: 1
Equipment Compliance: N/A
Surface Area Compliance: N/A

This item is satisfactory - no work required -
