Annual Inspection

Mid Suffolk District Council

Thurston - Thedwastre Park

Inspection Ref: 2273556

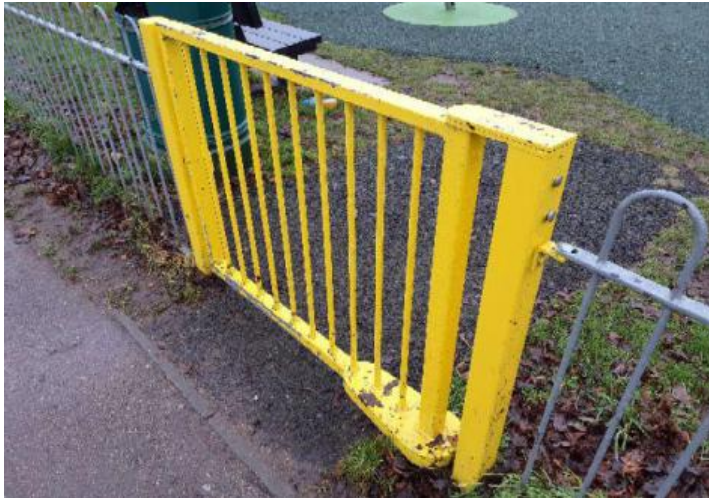
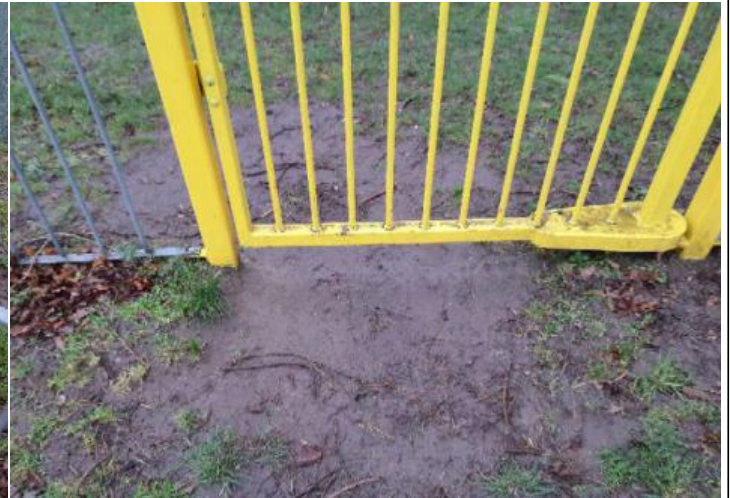
Item: Gates - Gate - Self Closing
Manufacturer: I.A.E. Fencing

Finding: The surface has eroded in some areas and may be slippery in wet conditions
Action: Reinststate the surface

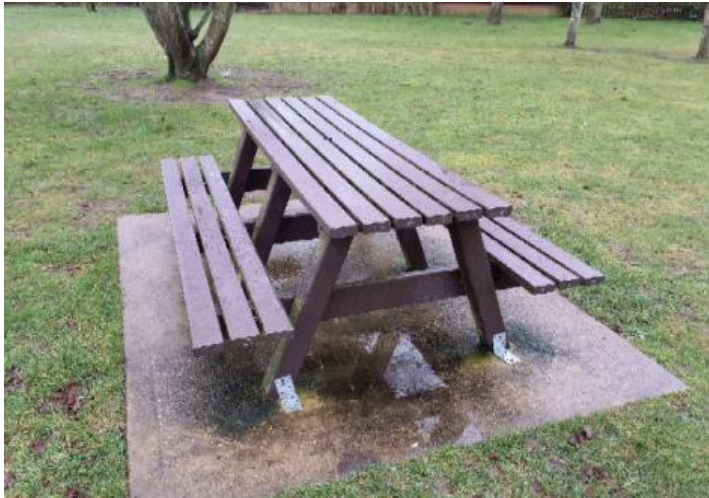
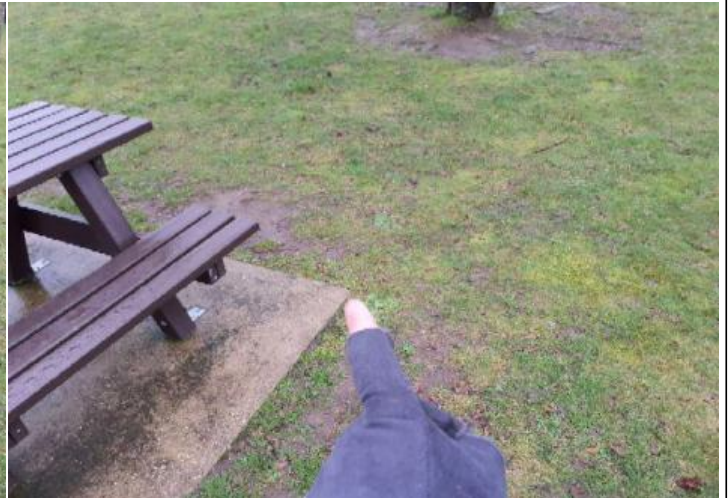
Item: Ancillary Items - Picnic Table
Manufacturer: Not Identified

Finding: There are trip hazards at the edges of the surface

Action: Reinstate surrounding surface levels to remove the trip points

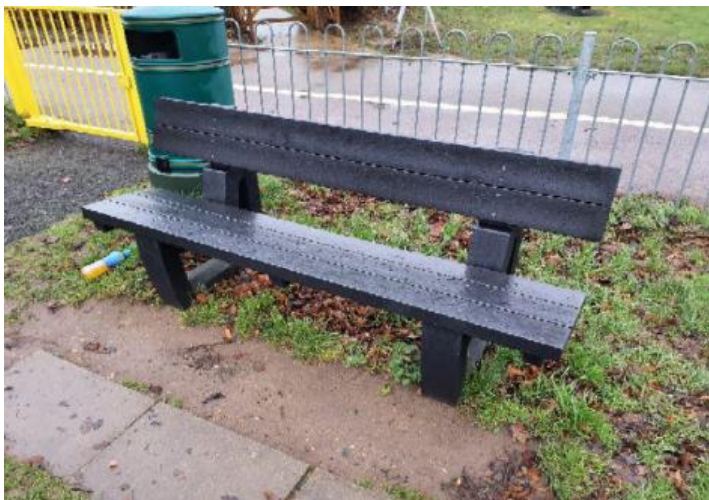
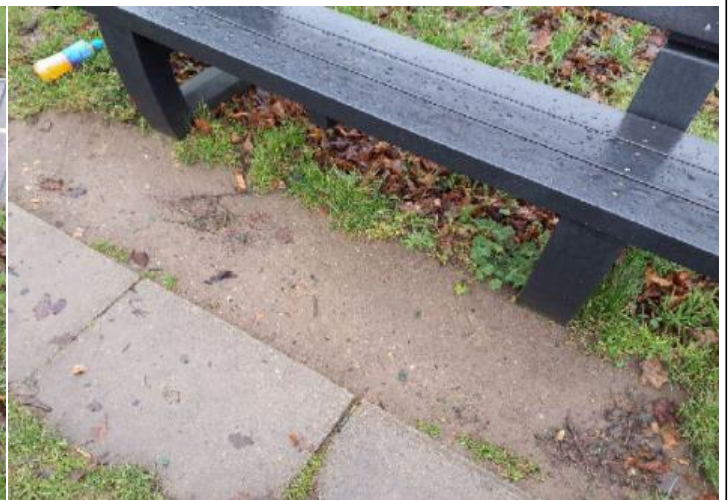
Item: Ancillary Items - Bench
Manufacturer: Not Identified

Finding: The surface has eroded in some areas and may be slippery in wet conditions

Action: Reinstate the surface

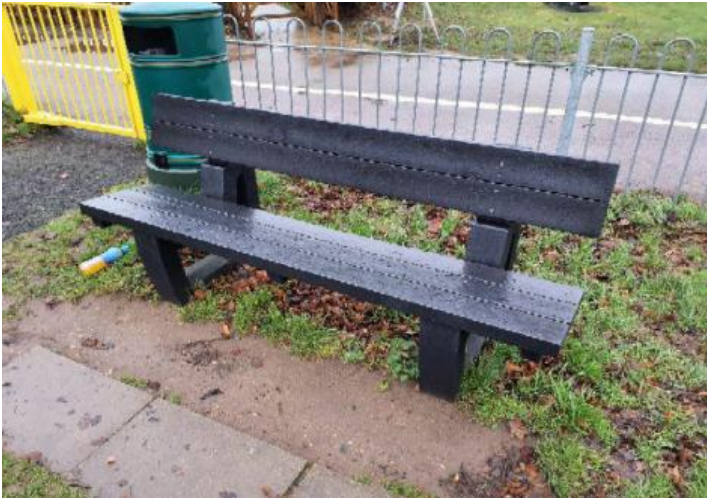
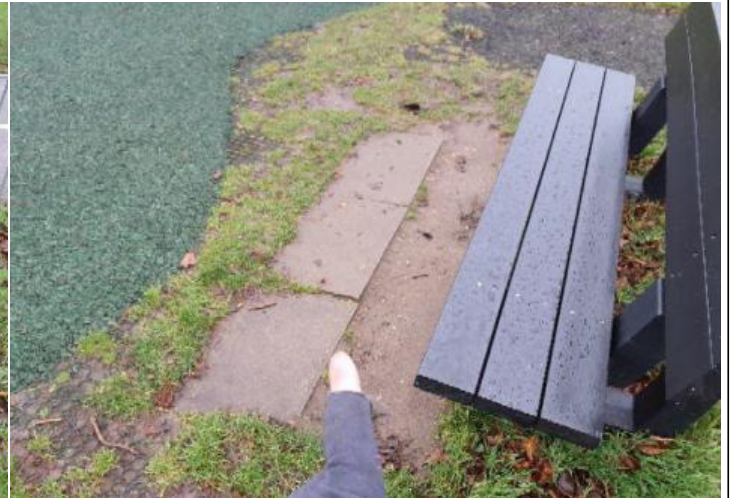
Item: Ancillary Items - Bench
Manufacturer: Not Identified
Risk Level: L - Low Risk
Surface: Paving Slabs

Finding: There are trip hazards at the edges of the surface
Action: Reinstate surrounding surface levels to remove the trip points

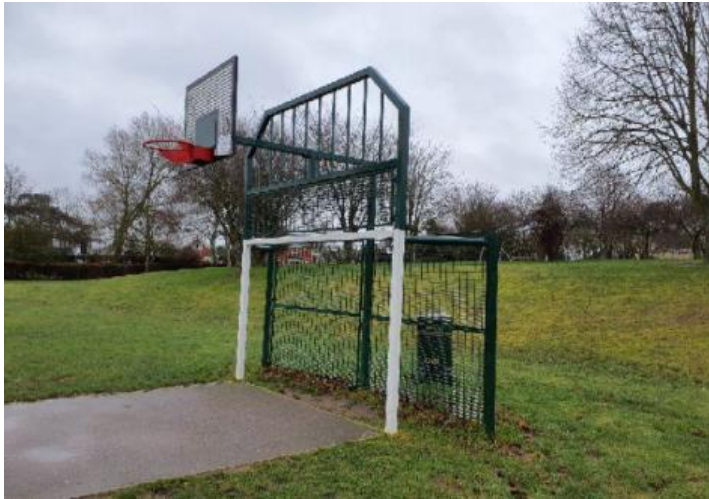
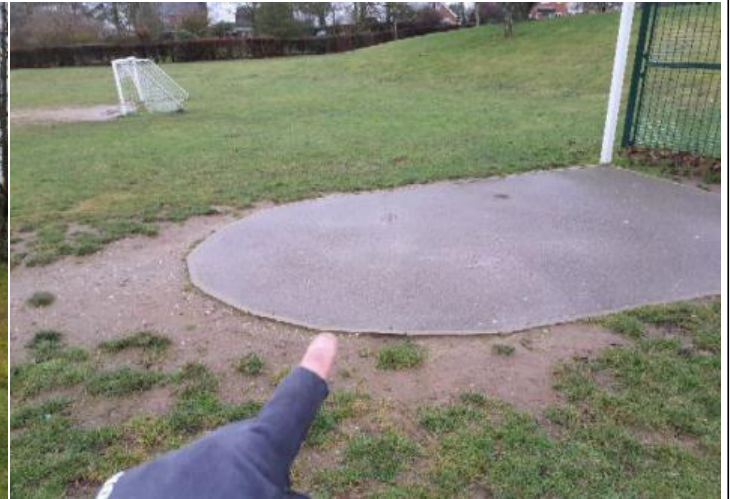
Item: Multi Use Games Area - Goalmouth and Basketball Post
Manufacturer: Monster Play Systems
Risk Level: L - Low Risk
Surface: Bitmac

Finding: There are trip hazards at the edges of the surface
Action: Reinstate surrounding surface levels to remove the trip points

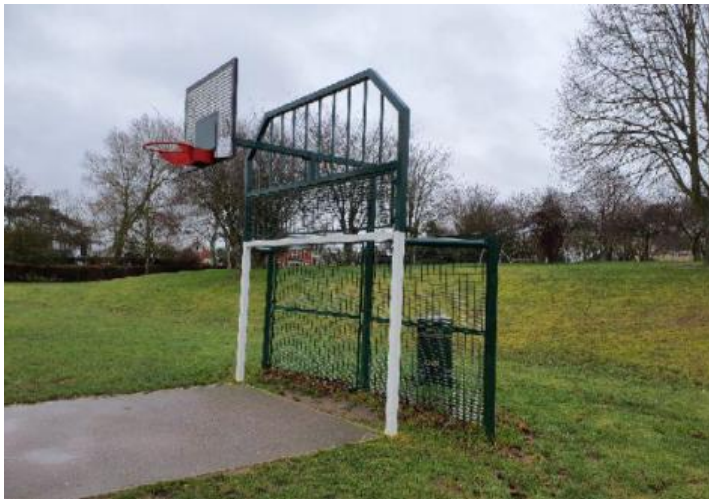
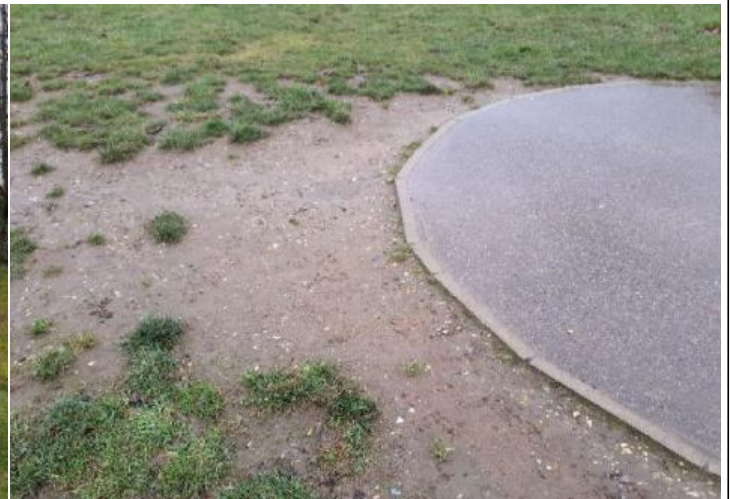
Item: Multi Use Games Area - Goalmouth and Basketball Post
Manufacturer: Monster Play Systems
Risk Level: L - Low Risk
Surface: Bitmac

Finding: The surface has eroded in some areas and may be slippery in wet conditions
Action: Reinstate the surface

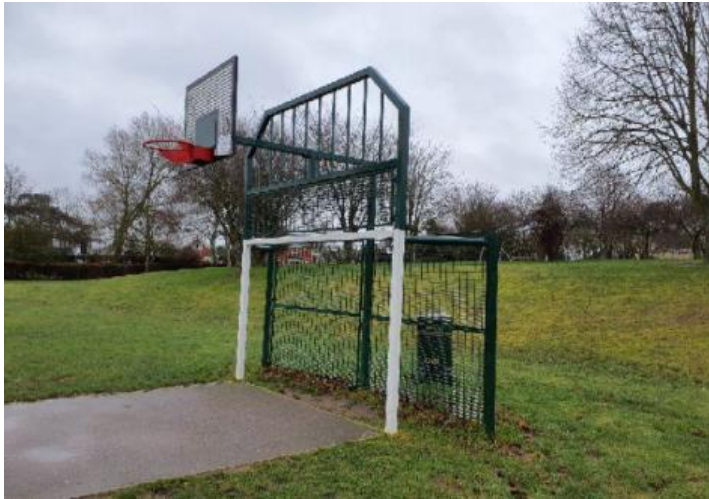
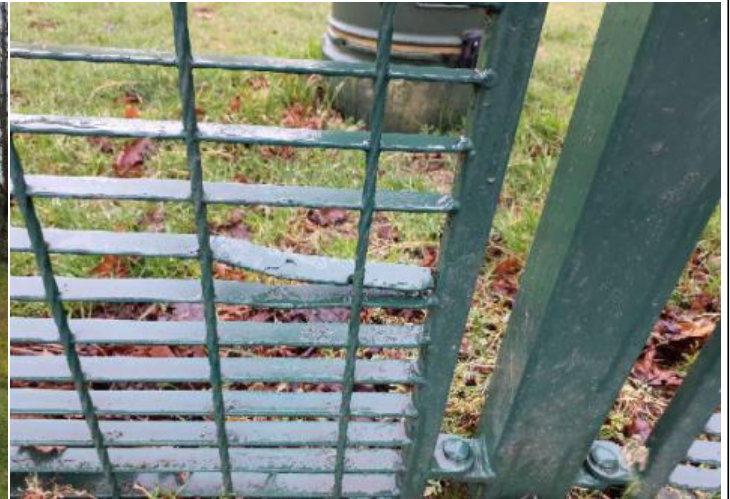
Item: Multi Use Games Area - Goalmouth and Basketball Post
Risk Level: L - Low Risk
Manufacturer: Monster Play Systems
Surface: Bitmac

Finding: The weld(s) on this item have failed

Action: Repair item

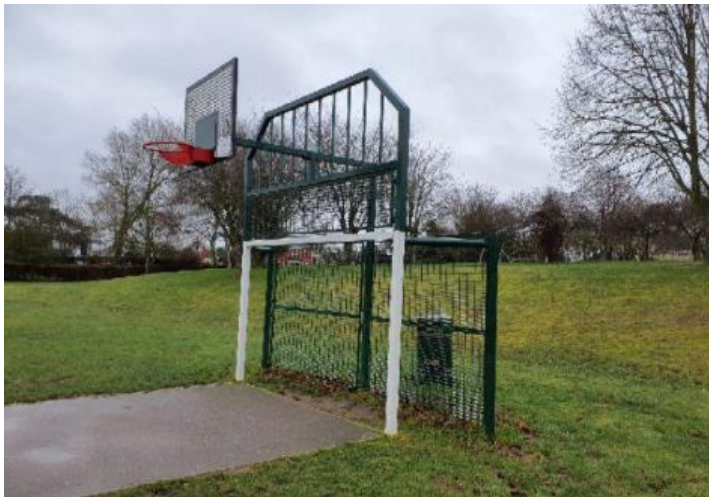
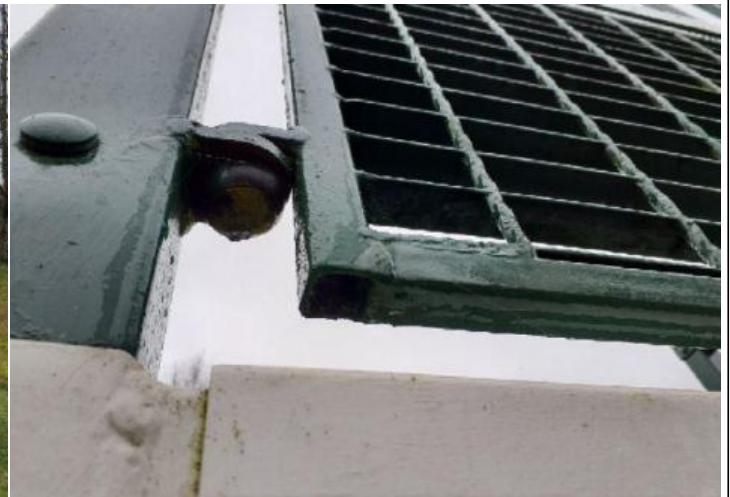
Item: Multi Use Games Area - Goalmouth and Basketball Post
Risk Level: V - Very Low Risk
Manufacturer: Monster Play Systems
Surface: Bitmac

Finding: There is/are inserts missing

Action: Replace missing inserts

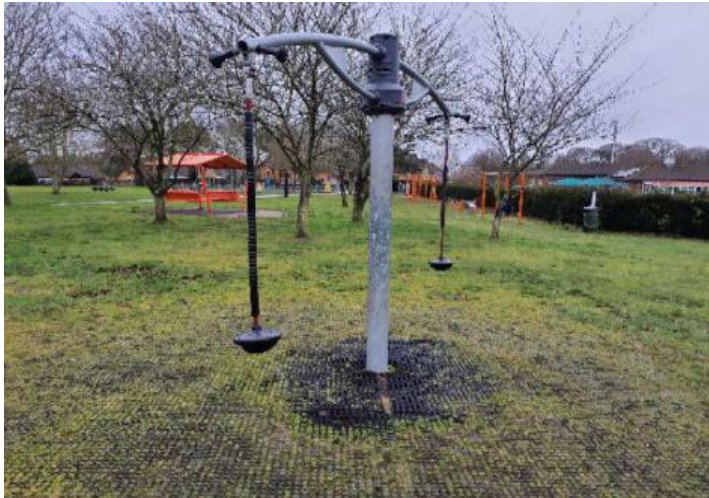
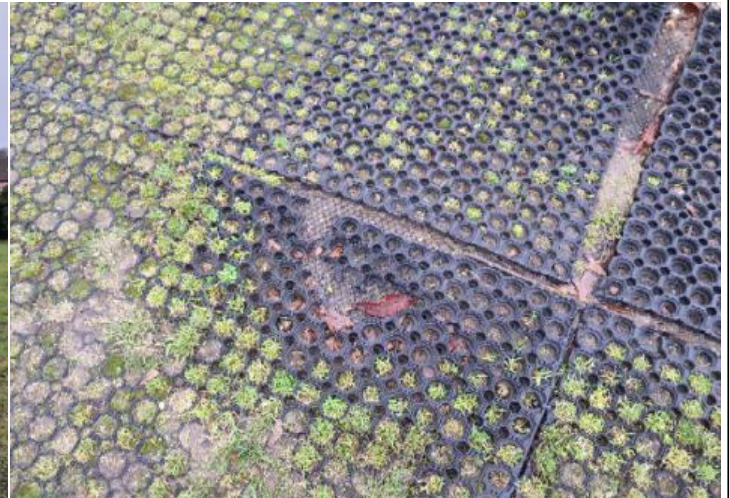
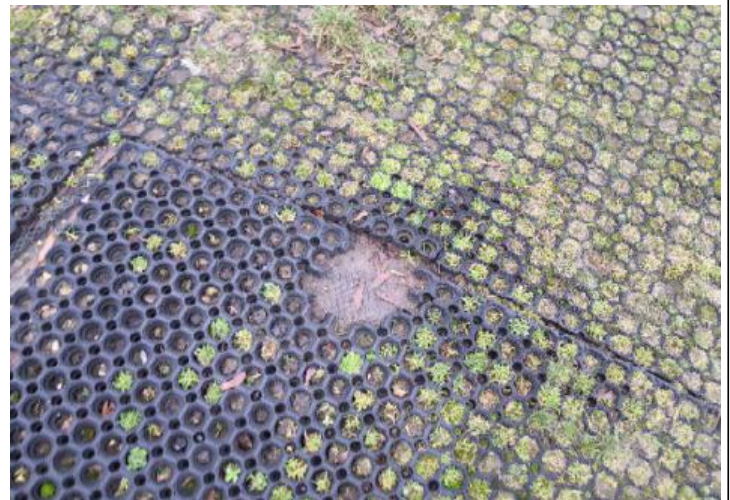
Item: Rotor Play - Overhead Rotator
Manufacturer: Kompan Ltd

Finding: There is moderate damage to the surface

Action: Repair the damaged areas of surfacing

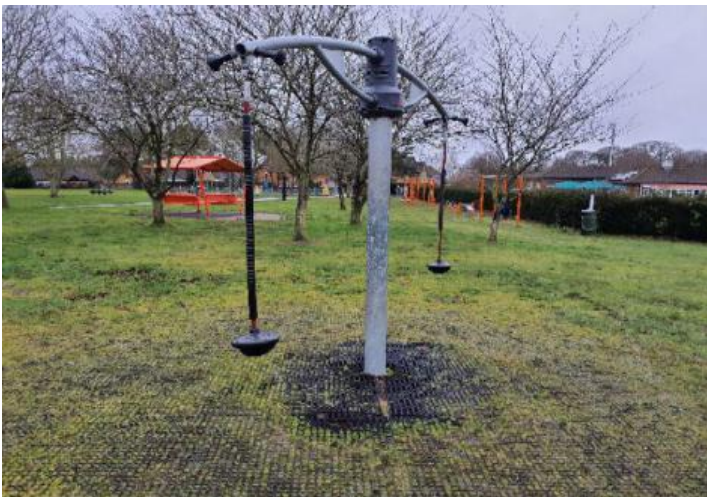
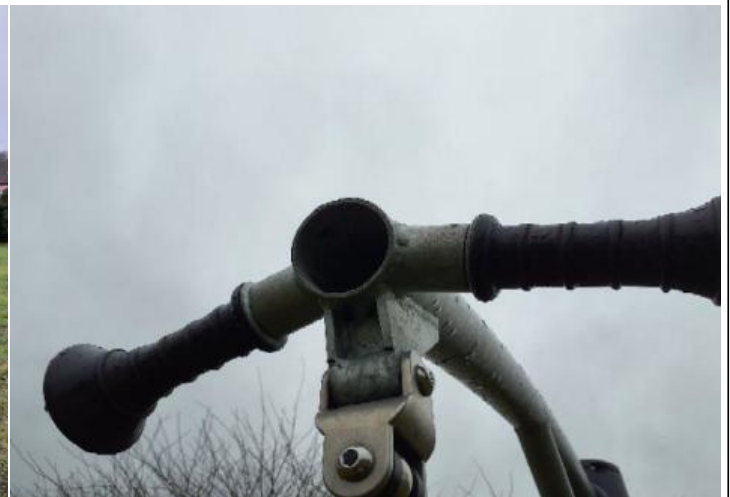
Item: Rotor Play - Overhead Rotator
Manufacturer: Kompan Ltd

Finding: There are post / end caps missing from the item

Action: Replace missing post caps

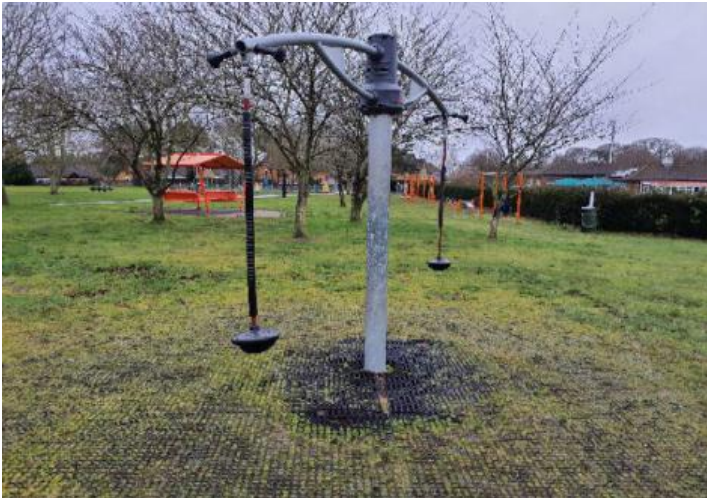
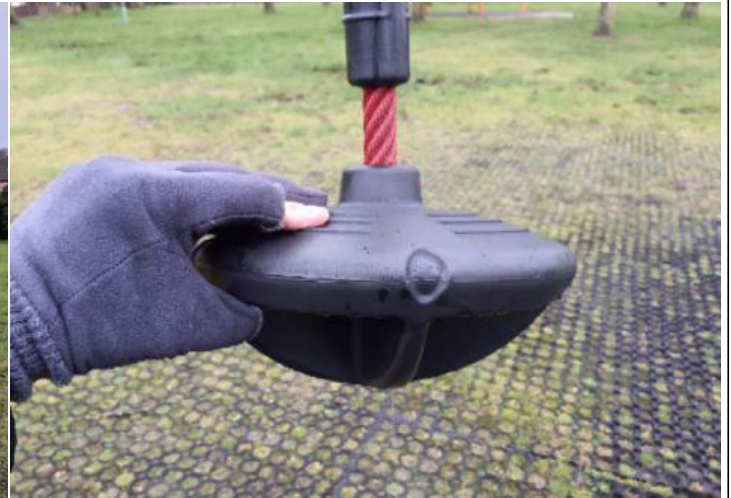
Item: Rotor Play - Overhead Rotator
Manufacturer: Kompan Ltd

Finding: The seat connection cannot be inspected without dismantling the seat

Action: Dismantle the seat to inspect the seat connection for wear

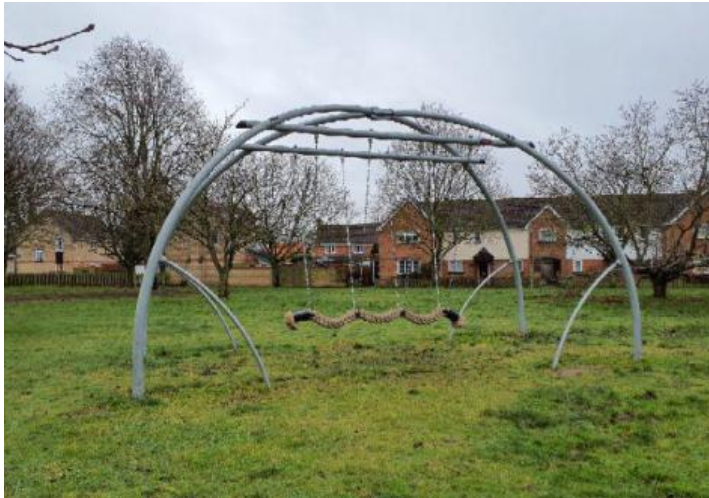
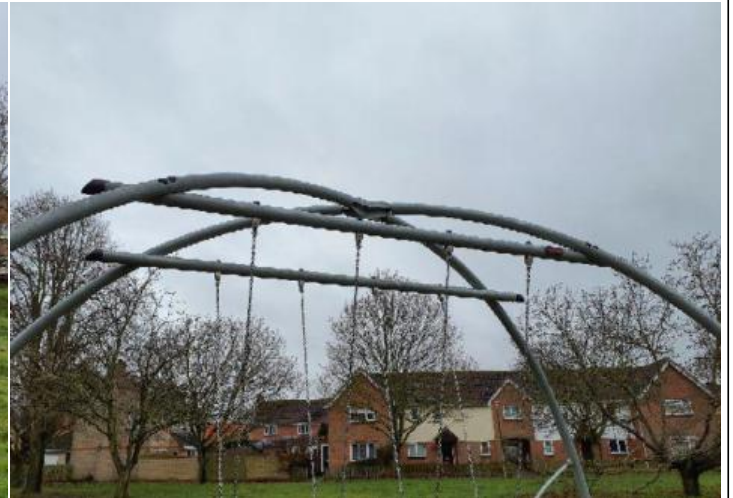
Item: Swings - Giant Rope Swing
Manufacturer: Kompan Ltd

Finding: The fixings or components for this item were in excess of 2.5m above the standing surface and could not be fully accessed by the inspector. We have completed a visual inspection of the fixings from ground level but a maintenance inspection should be undertaken to assess the condition, security and wear of the components at intervals in accordance with the manufacturers recommendations.

Action: Inspect in accordance with the manufacturers recommendations

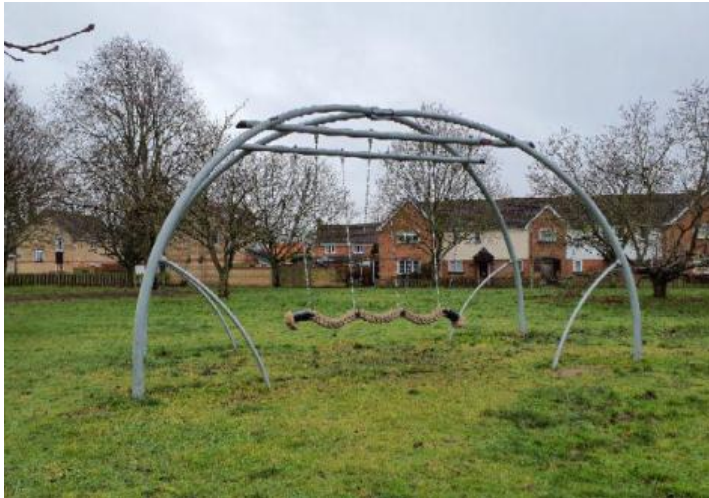
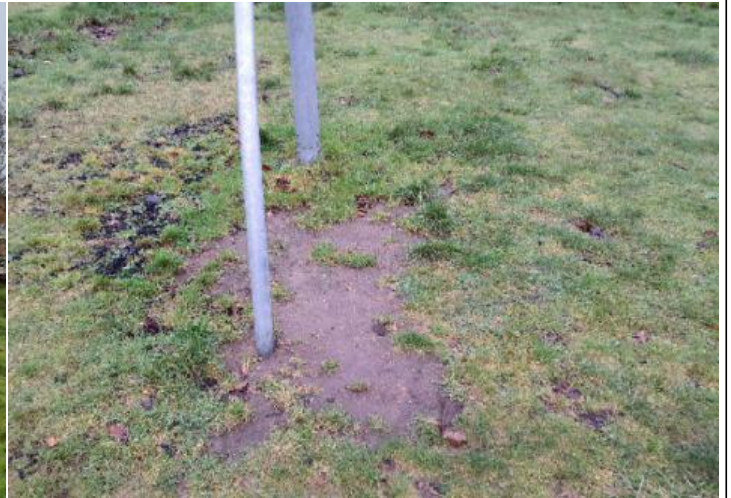
Item: Swings - Giant Rope Swing
Manufacturer: Kompan Ltd

Finding: The surface has eroded in some areas and may be slippery in wet conditions
Action: Reinstate the surface

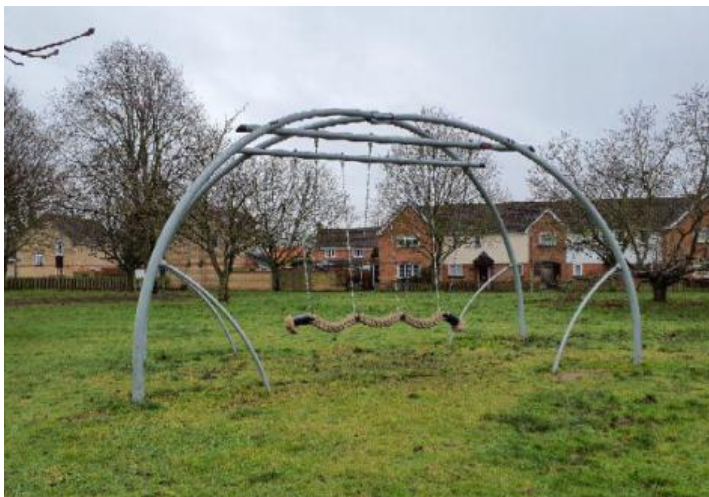
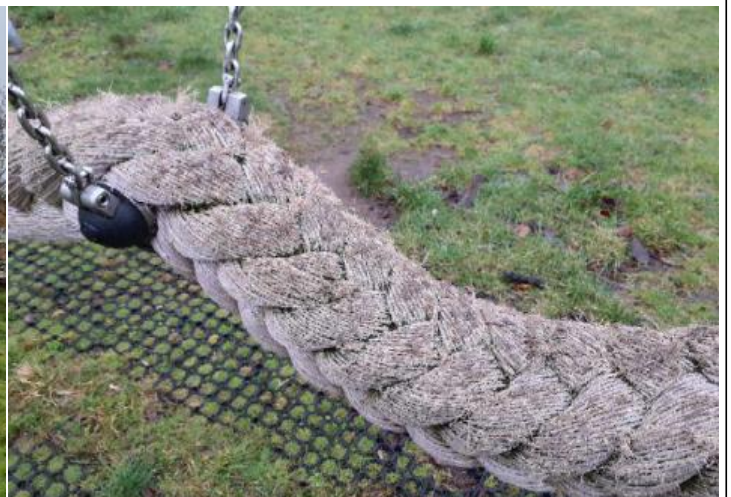
Item: Swings - Giant Rope Swing
Manufacturer: Kompan Ltd

Finding: The seat has minor damage or wear

Action: Monitor for any further deterioration and replace as required

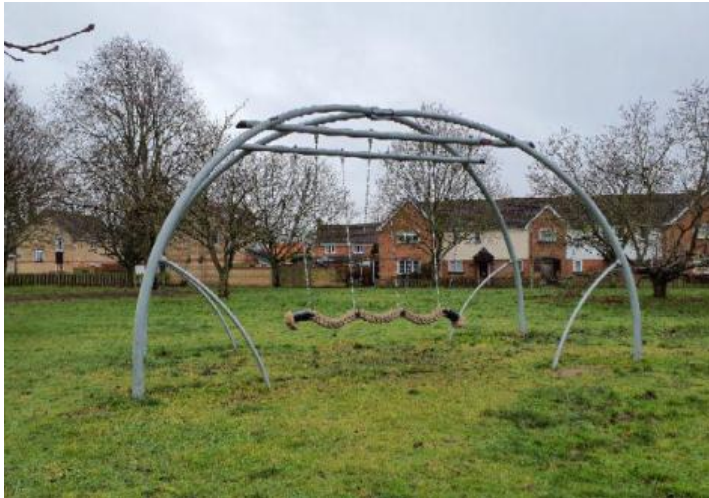
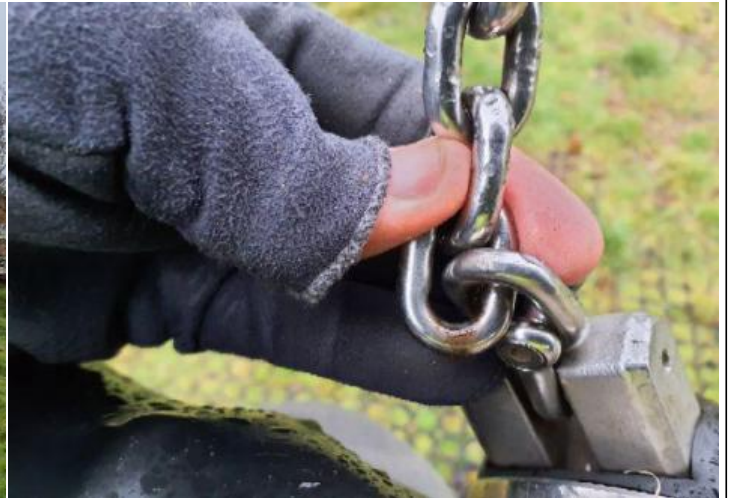
Item: Swings - Giant Rope Swing
Manufacturer: Kompan Ltd

Finding: There is some notable evidence of chain wear

Action: Monitor for any further deterioration and replace when 40% worn

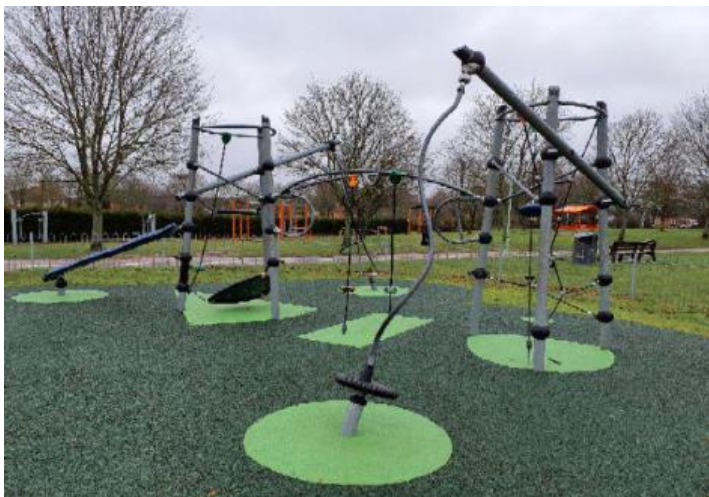
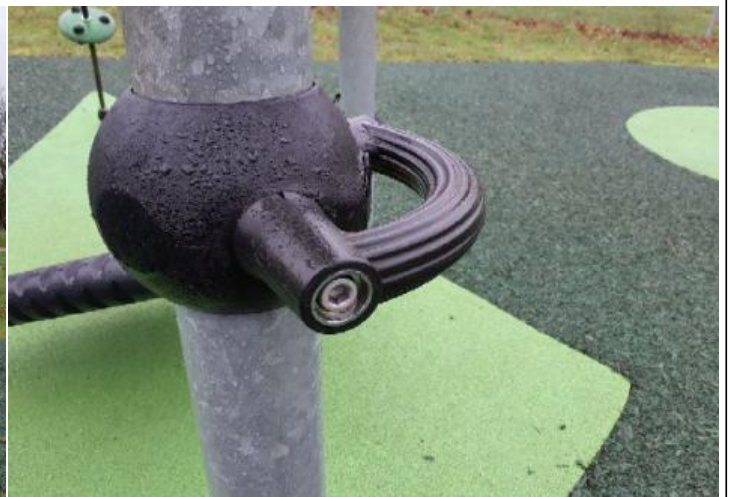
Item: Activity Equipment - Climbing Frame
Manufacturer: Kompan Ltd

Finding: There is/are bolt cap covers missing or damaged on the item

Action: Replace missing or damaged bolt cap covers

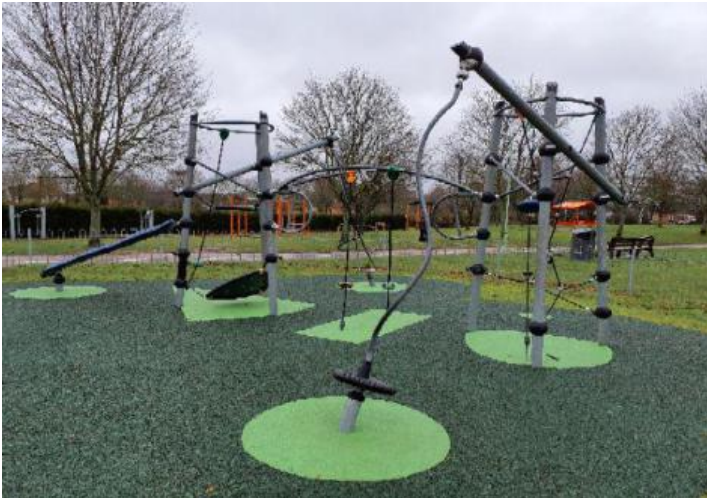
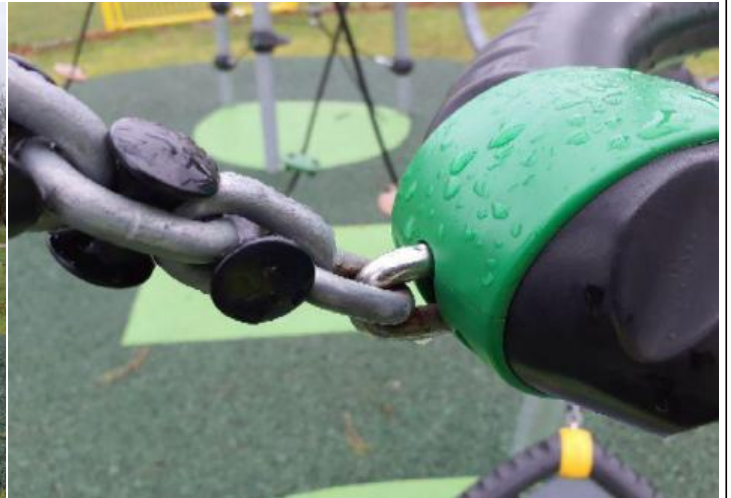
Item: Activity Equipment - Climbing Frame
Manufacturer: Kompan Ltd

Finding: There is some notable evidence of chain wear

Action: Monitor for any further deterioration and replace when 40% worn

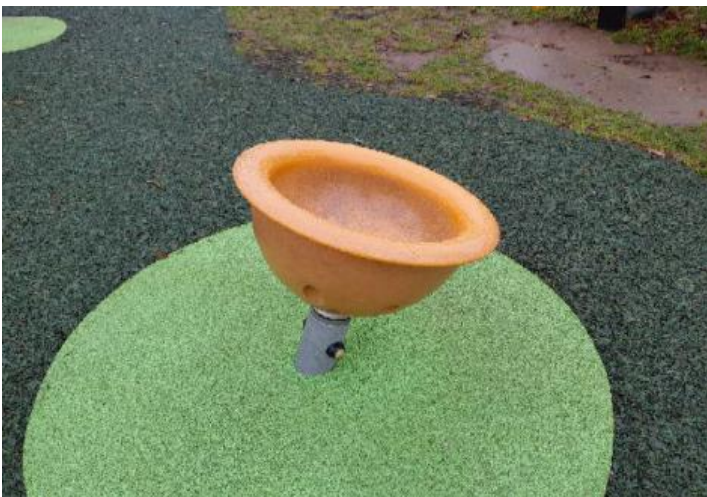
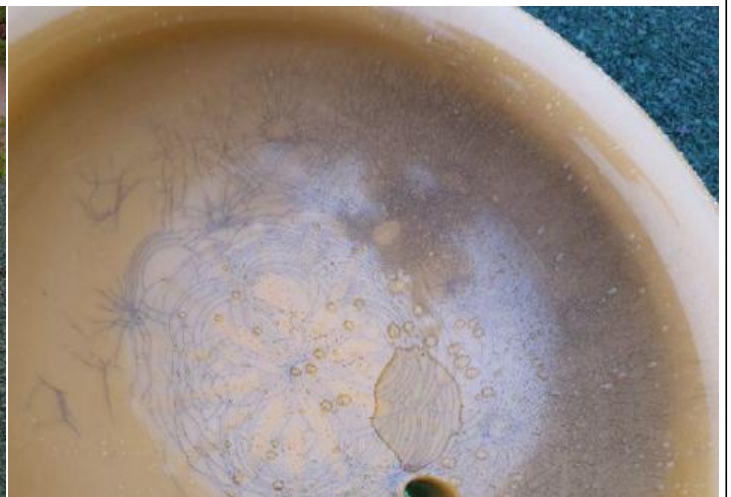
Item: Rotor Play - Spinner Bowl
Manufacturer: Kompan Ltd

Finding: There is some damage to the item

Action: Monitor for any further deterioration and repair as required

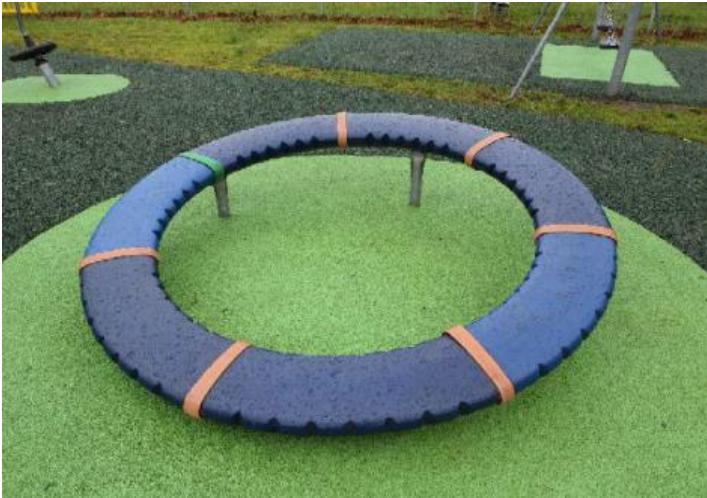
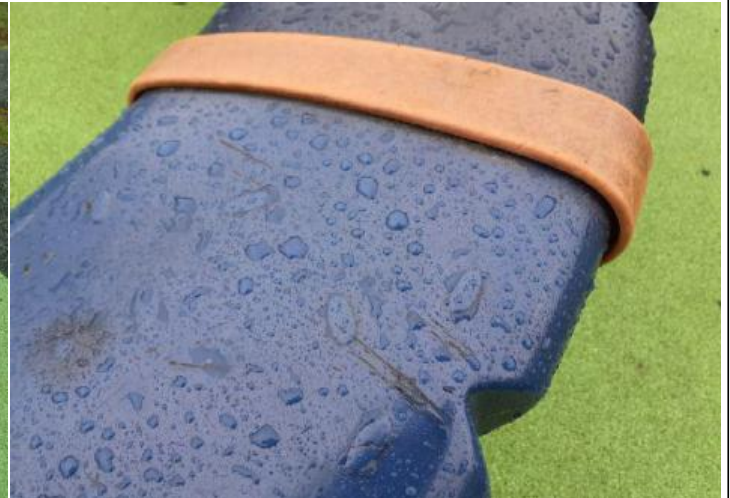
Item: Rotor Play - Supernova
Manufacturer: Kompan Ltd

Finding: There is some damage to the item

Action: Monitor for any further deterioration and repair as required

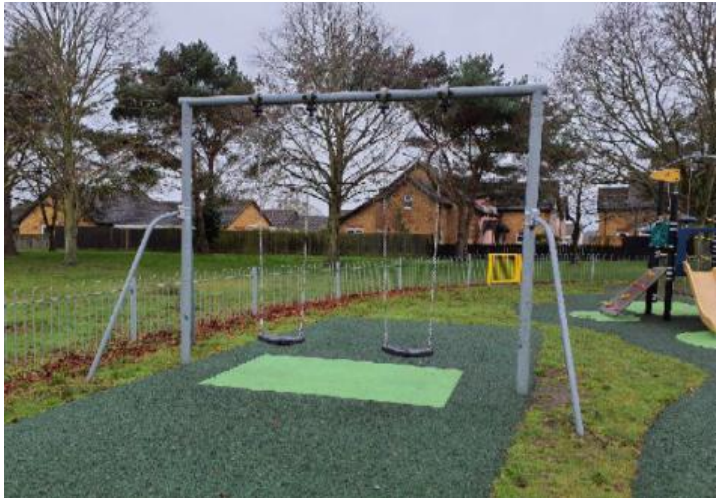
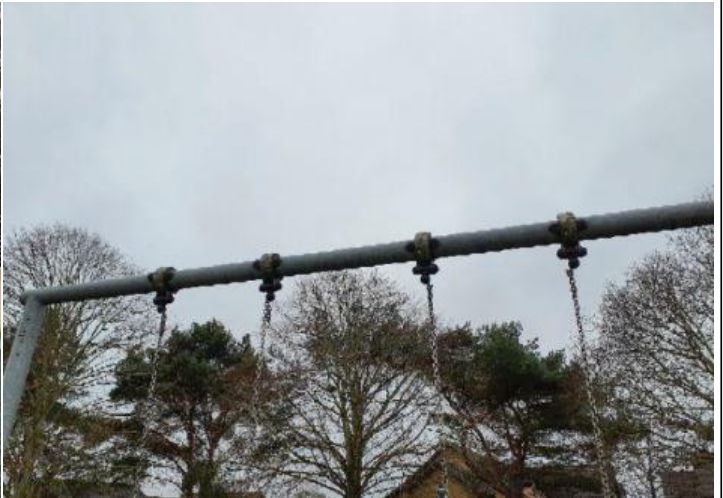
Item: Swings - 1 Bay 2 Seat (Flat)
Manufacturer: Kompan Ltd

Finding: The fixings or components for this item were in excess of 2.5m above the standing surface and could not be fully accessed by the inspector. We have completed a visual inspection of the fixings from ground level but a maintenance inspection should be undertaken to assess the condition, security and wear of the components at intervals in accordance with the manufacturers recommendations.

Action: Inspect in accordance with the manufacturers recommendations

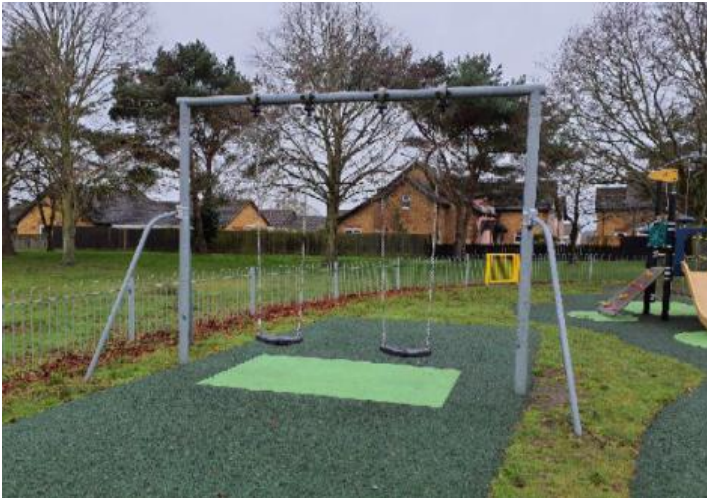
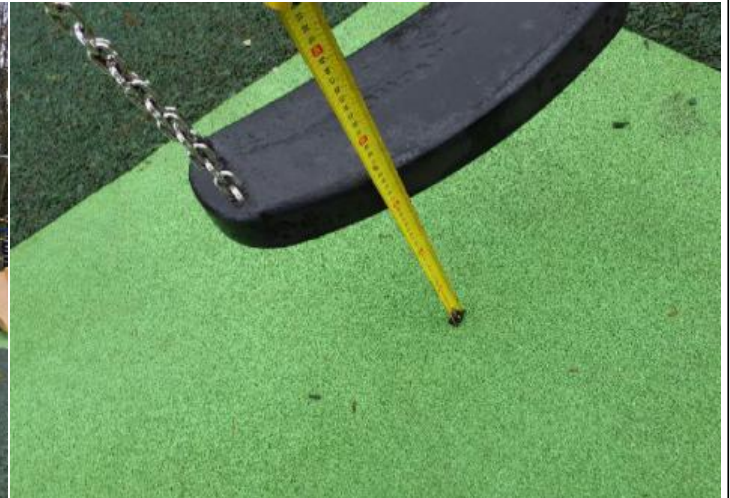
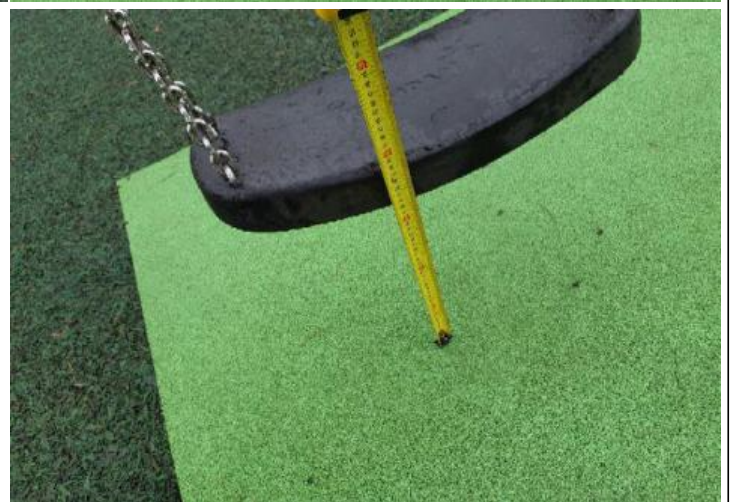
Item: Swings - 1 Bay 2 Seat (Flat)
Manufacturer: Kompan Ltd

Finding: The seat clearance from finished surface level to the underside of the seat is too low and does not meet the requirements of BS EN 1176 Part 2 (350mm minimum clearance required)

Action: Adjust seat height/s (400mm-500mm is recommended)

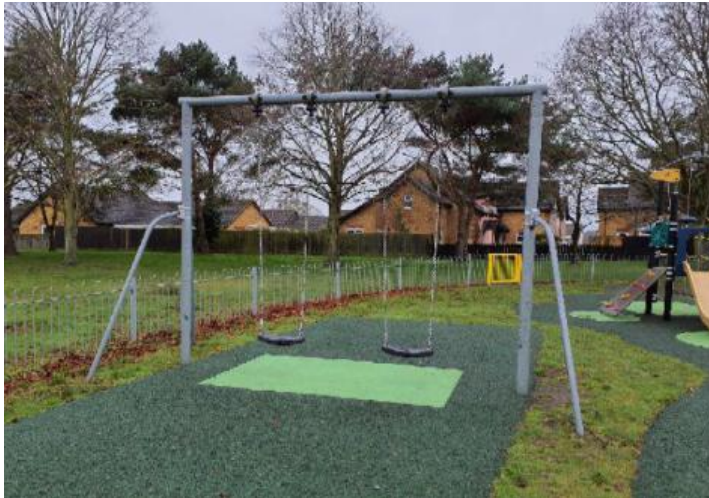
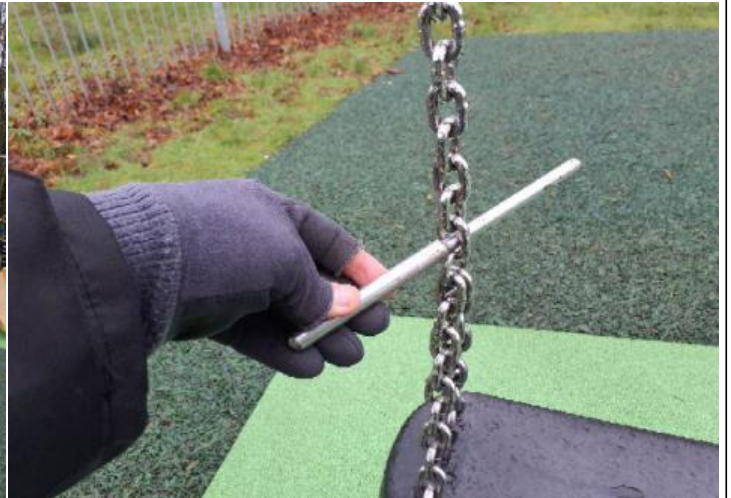
Item: Swings - 1 Bay 2 Seat (Flat)
Manufacturer: Kompan Ltd

Finding: The chain openings are in excess of 8.6mm and do not meet the recommendations of BS EN 1176 Part 1

Action: Monitor - No remedial work recommended

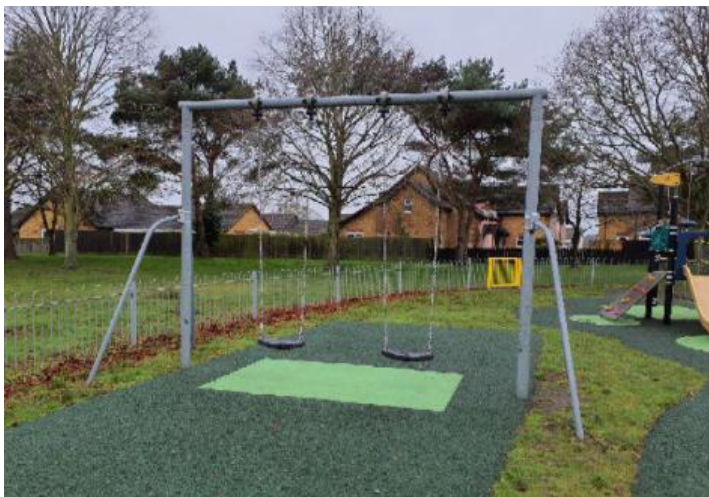
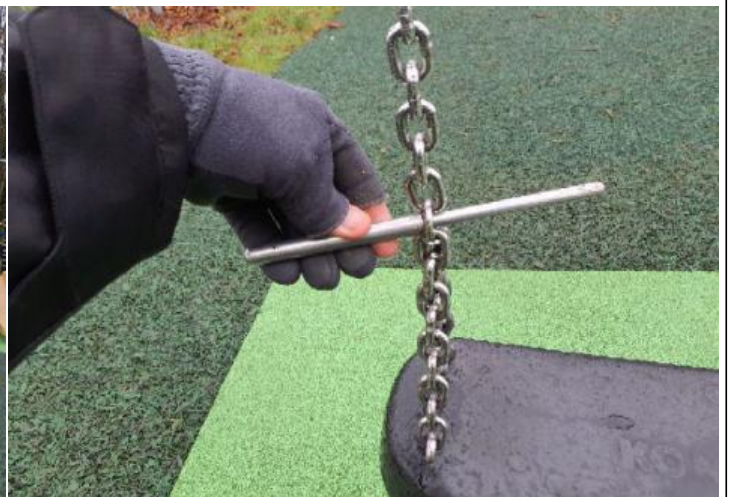
Item: Swings - 1 Bay 2 Seat (Flat)
Manufacturer: Kompan Ltd

Finding: The connecting links are in excess of 8.6mm and less than 12mm and fail the requirements of BS EN 1176 Part 1; clause 4.2.13, Chains

Action: Monitor use and replace with compliant links at the next maintenance cycle

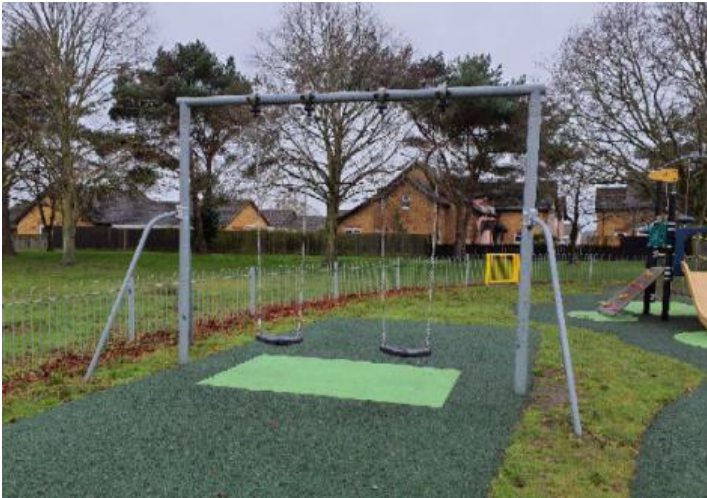
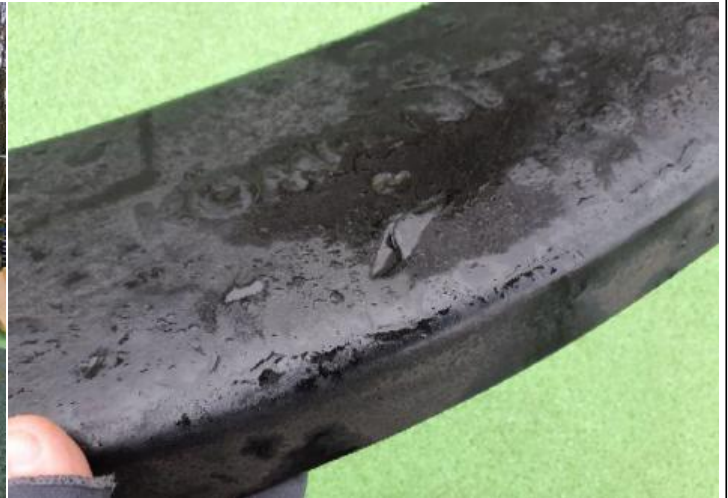
Item: Swings - 1 Bay 2 Seat (Flat)
Manufacturer: Kompan Ltd

Finding: The seat has minor damage or wear

Action: Monitor for any further deterioration and replace as required

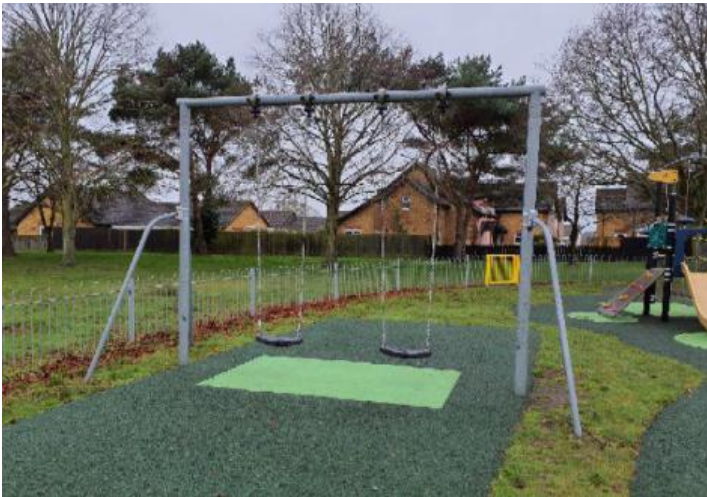
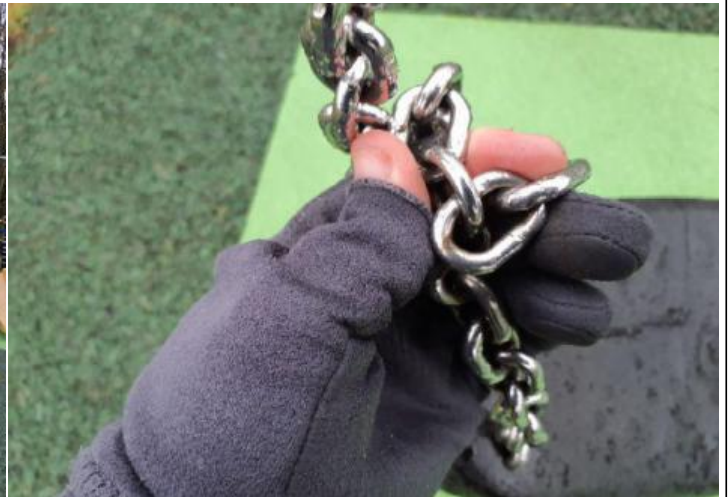
Item: Swings - 1 Bay 2 Seat (Flat)
Manufacturer: Kompan Ltd

Finding: There is some notable evidence of chain wear

Action: Monitor for any further deterioration and replace when 40% worn

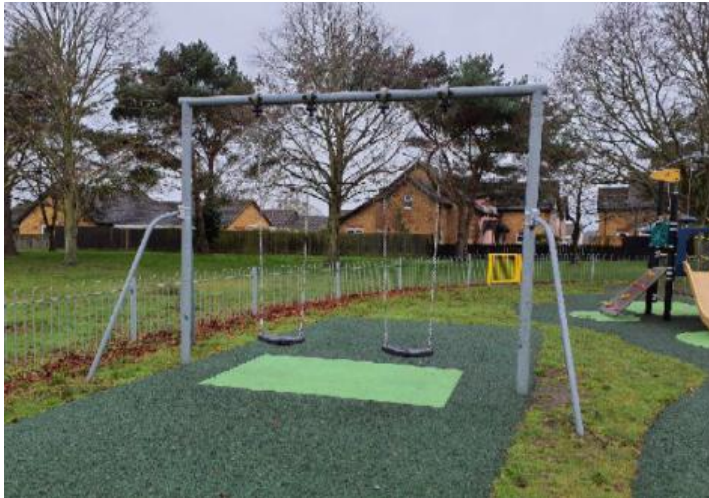
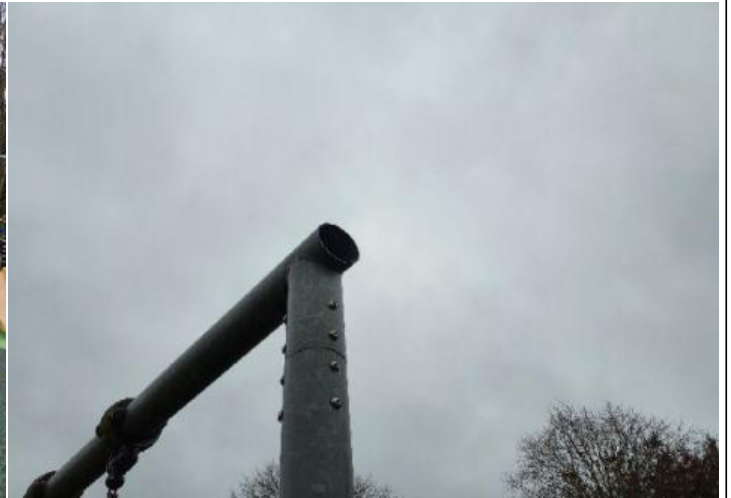
Item: Swings - 1 Bay 2 Seat (Flat)
Manufacturer: Kompan Ltd

Finding: There are post / end caps missing from the item

Action: Replace missing post caps

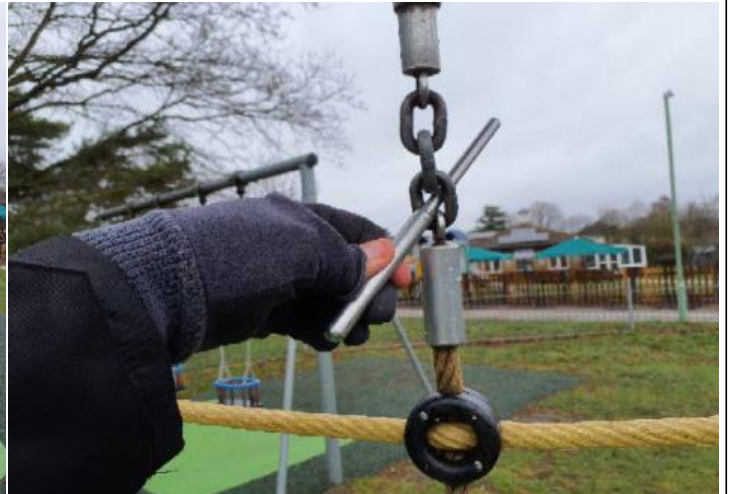
Item: Activity Equipment - Multi Play (Junior)
Manufacturer: Kompan Ltd

Finding: The chain openings are in excess of 8.6mm and do not meet the recommendations of BS EN 1176 Part 1

Action: Monitor - No remedial work recommended

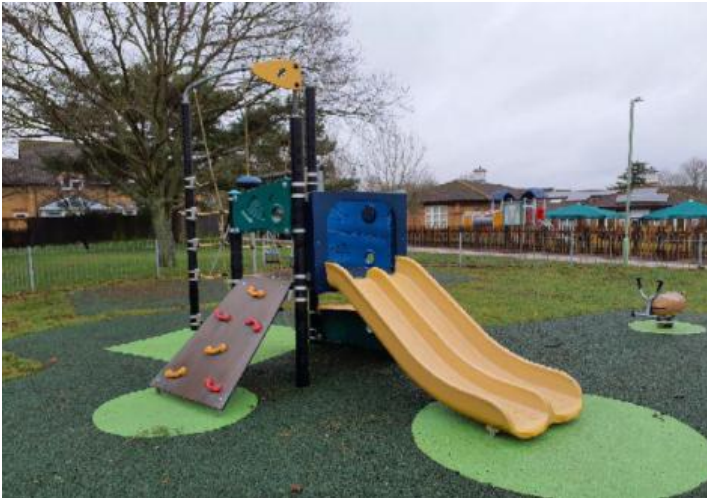
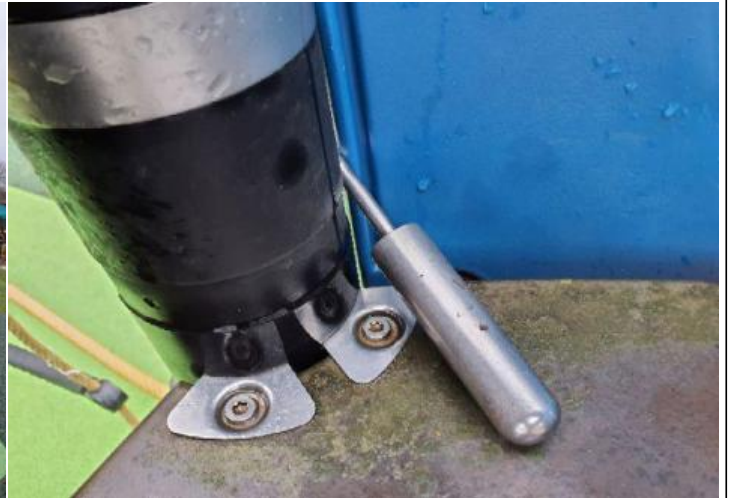
Item: Activity Equipment - Multi Play (Junior)
Manufacturer: Kompan Ltd

Finding: There is/are finger entrapment/s in the barrier and the item fails to meet the requirements of BS EN 1176 Part 1 4.2.7.6 Entrapment of fingers
Action: Monitor - No remedial work recommended

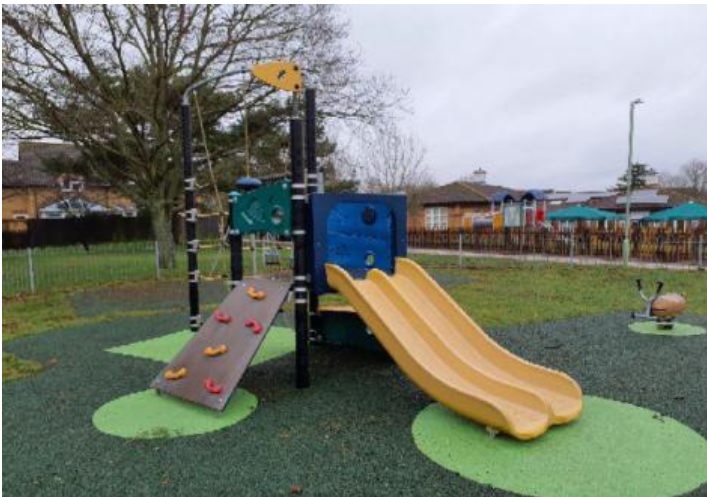
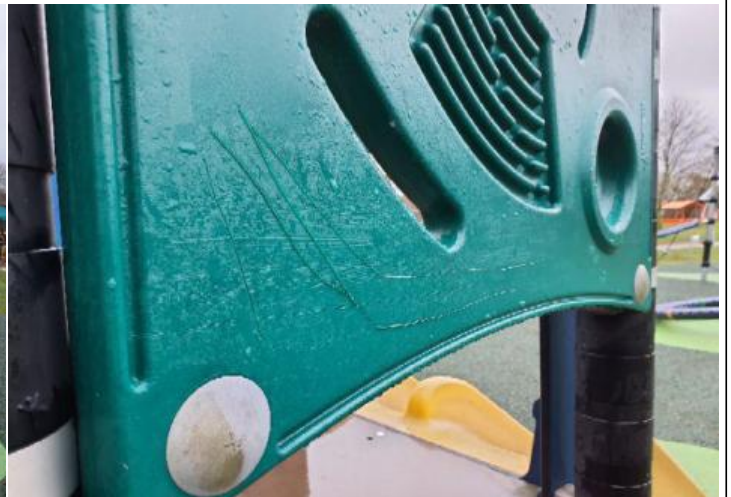
Item: Activity Equipment - Multi Play (Junior)
Manufacturer: Kompan Ltd

Finding: There is some damage to the item
Action: Monitor for any further deterioration and repair as required
