Annual Inspection

Mid Suffolk District Council

Thurston - Thedwastre Park

Inspection Ref: 2273556

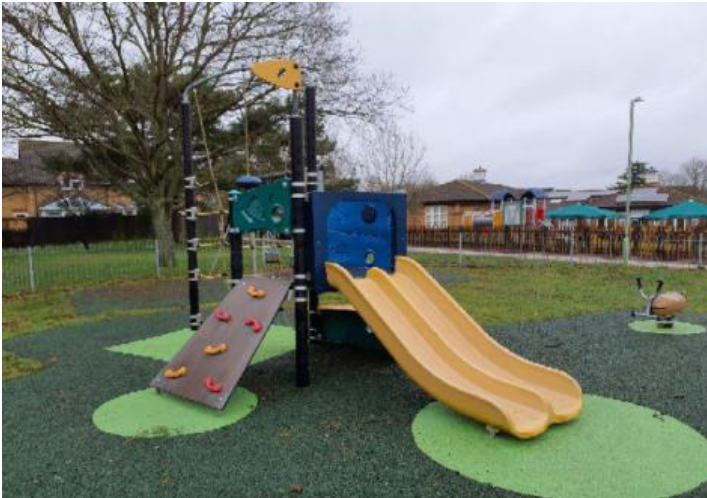
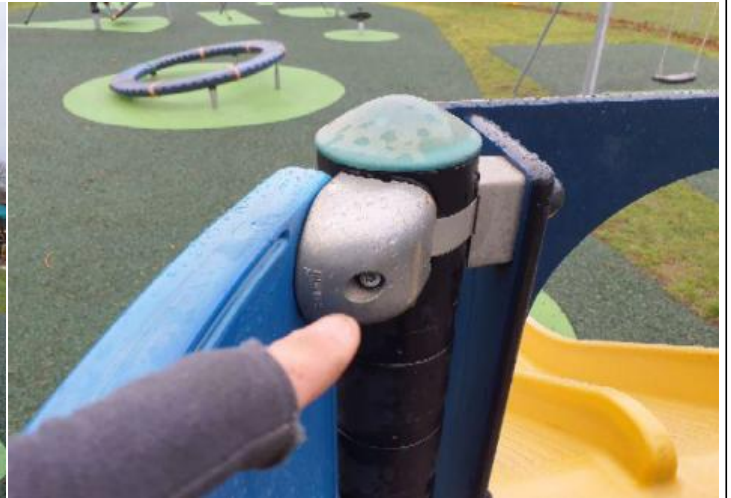
Item: Activity Equipment - Multi Play (Junior)
Manufacturer: Kompan Ltd

Finding: A number of fixing(s) have worked loose

Action: Secure all loose fixings

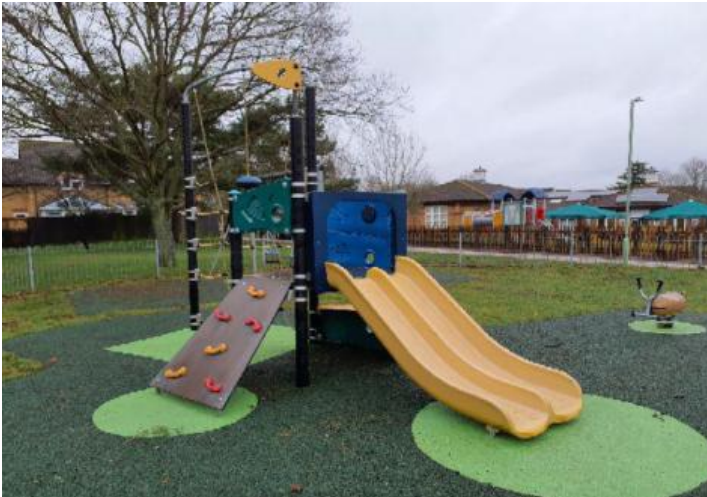
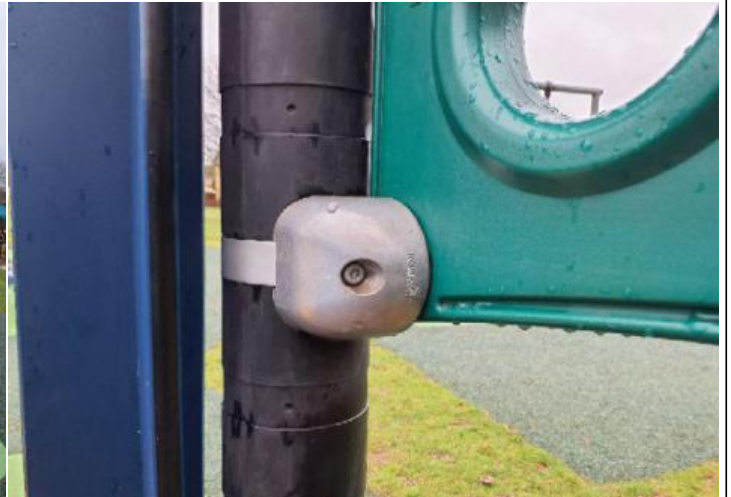
Item: Activity Equipment - Multi Play (Junior)
Manufacturer: Kompan Ltd

Finding: There is/are inserts missing

Action: Replace missing inserts

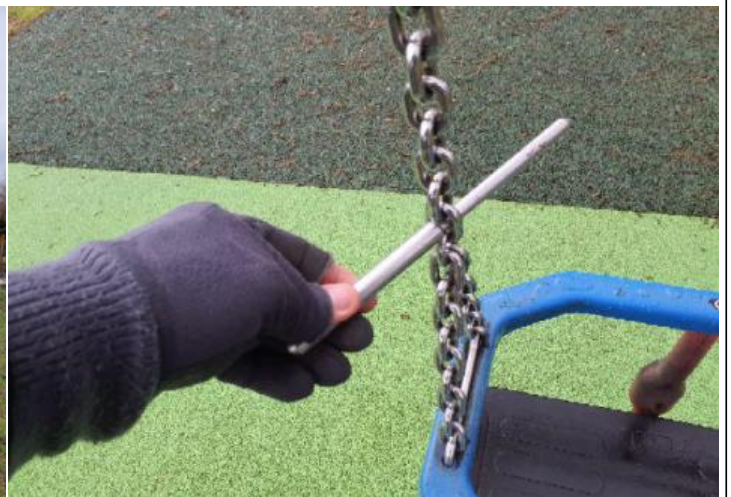
Item: Swings - 1 Bay 2 Seat (Cradle)
Manufacturer: Kompan Ltd

Finding: The chain openings are in excess of 8.6mm and do not meet the recommendations of BS EN 1176 Part 1

Action: Monitor - No remedial work recommended

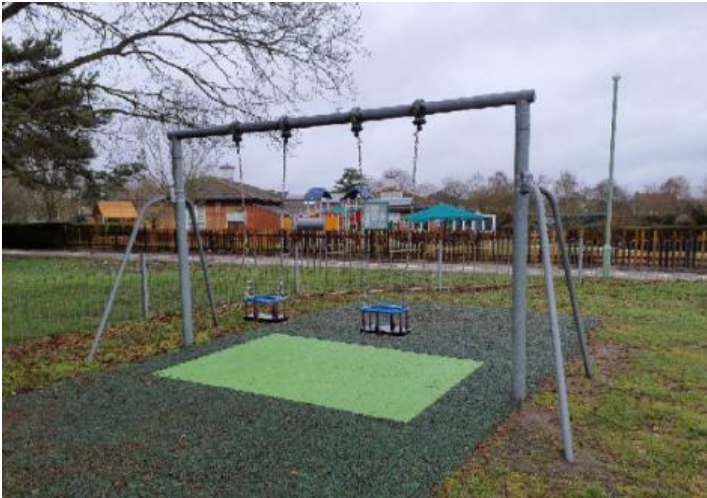
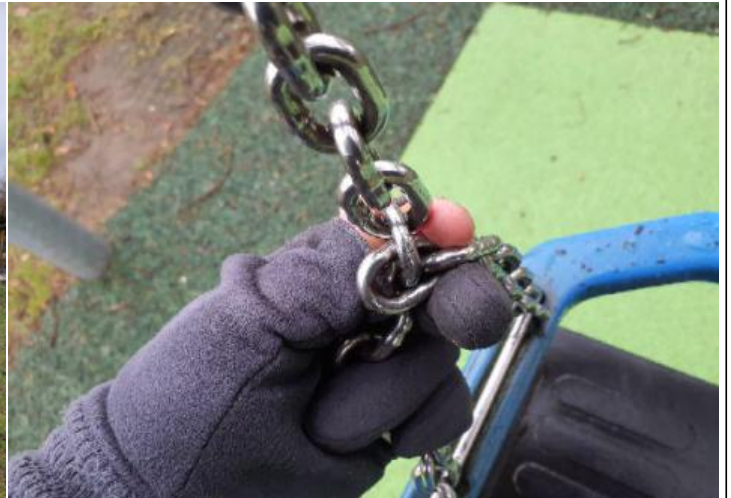
Item: Swings - 1 Bay 2 Seat (Cradle)
Manufacturer: Kompan Ltd

Finding: There is some notable evidence of chain wear

Action: Monitor for any further deterioration and replace when 40% worn

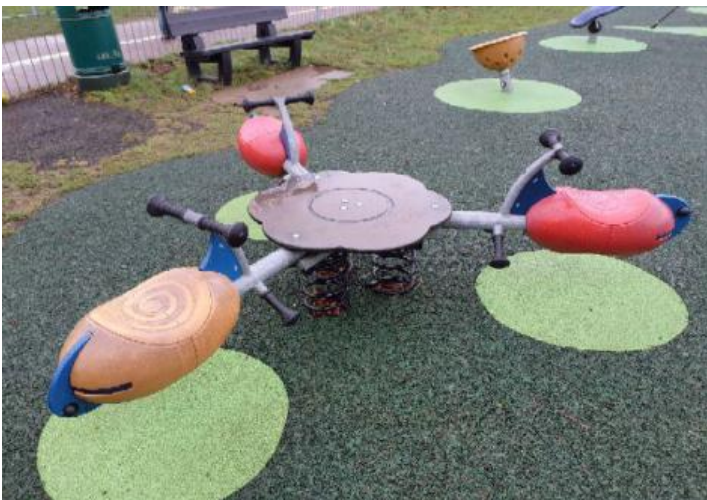
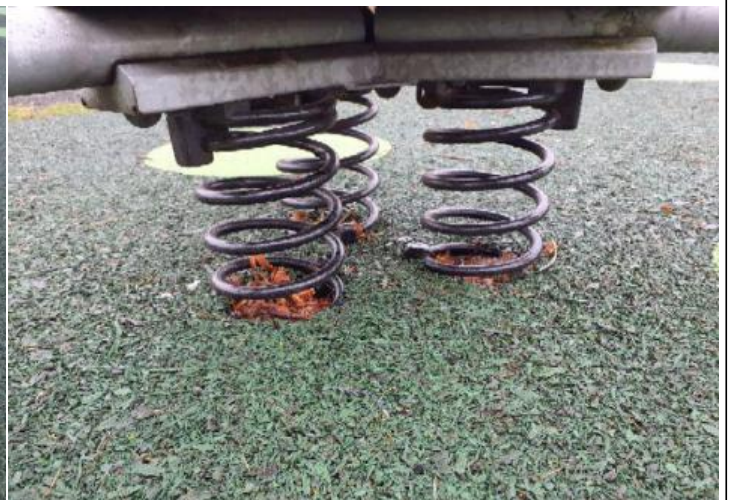
Item: Rocking Equipment - Three Way Springer
Manufacturer: Kompan Ltd

Finding: The spring clamps are loose

Action: Tighten all loose fixings

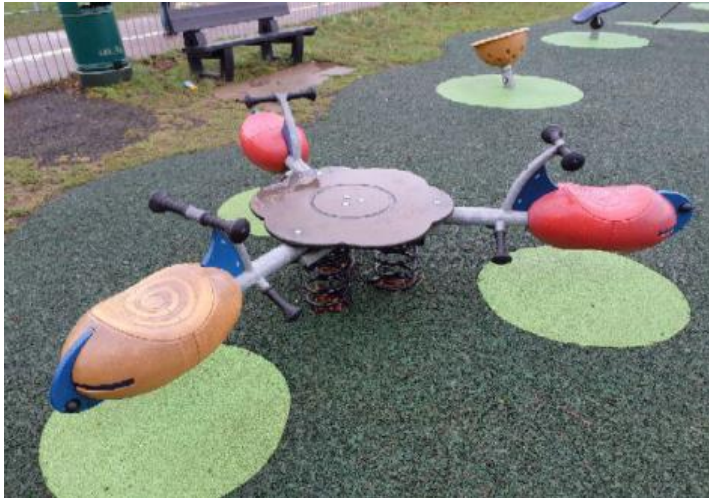
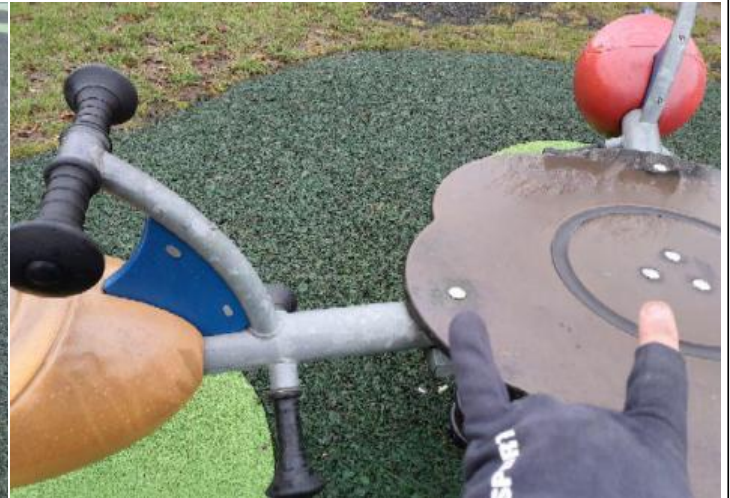
Item: Rocking Equipment - Three Way Springer
Manufacturer: Kompan Ltd

Finding: A number of fixing(s) have worked loose

Action: Secure all loose fixings
