Annual Inspection

Mid Suffolk District Council

Thurston Playing Field

Heath Road, Thurston, Suffolk, IP31 3PJ

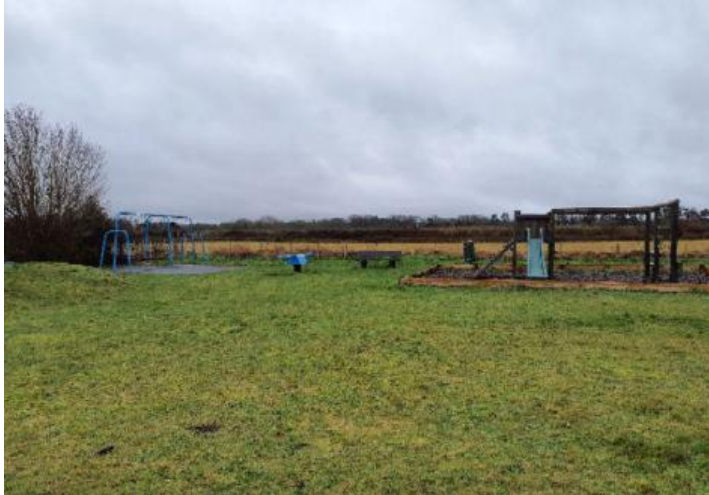
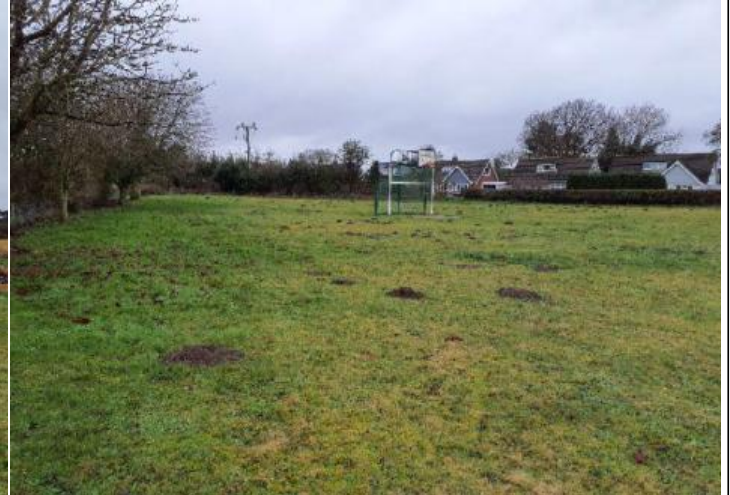
Item: Ancillary Items - Site General
Manufacturer: Owner/Operator

Finding: There are a number of molehills within the area and these may present unforeseen hazards for users

Action: Remove moles by appropriate means, reinstate surfaces to level and maintain the area

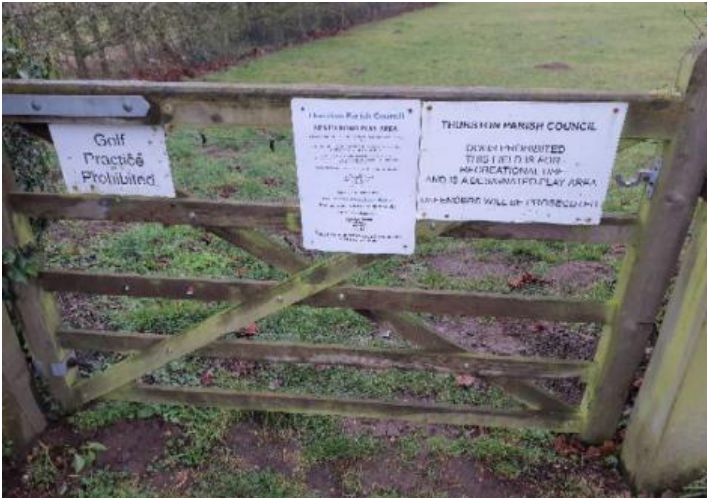
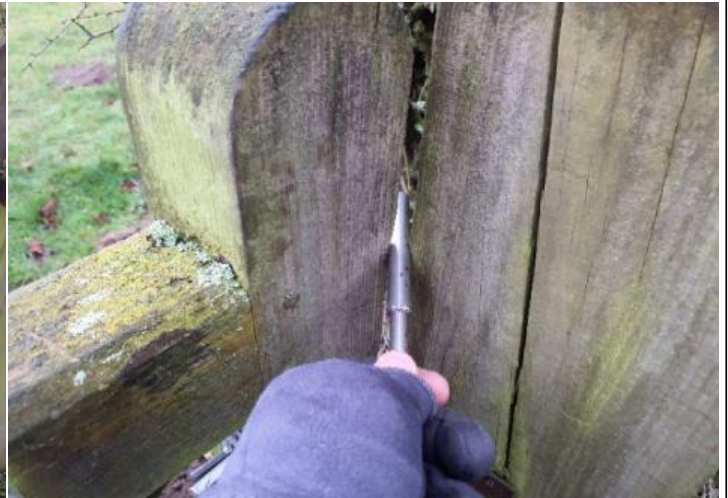
Item: Gates - Gate
Manufacturer: Not Identified

Finding: There are openings that are less than 12mm that could trap or crush fingers

Action: Provide a 12mm gap throughout full range of motion at both sides of gate

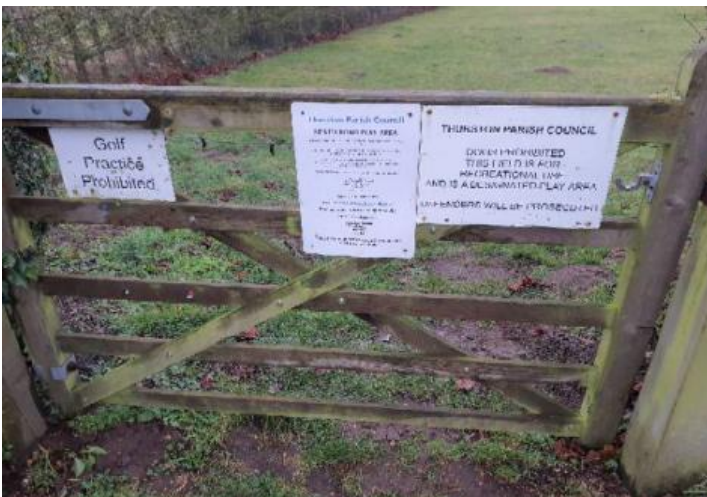
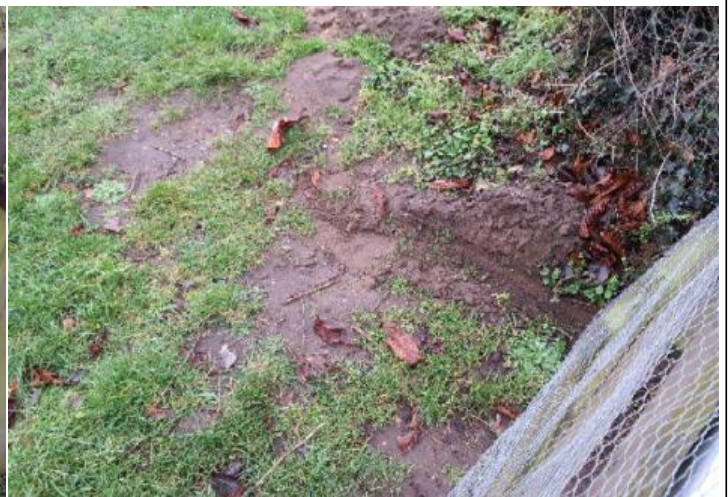
Item: Gates - Gate
Manufacturer: Not Identified

Finding: The surface has eroded in some areas and may be slippery in wet conditions

Action: Reinstate the surface

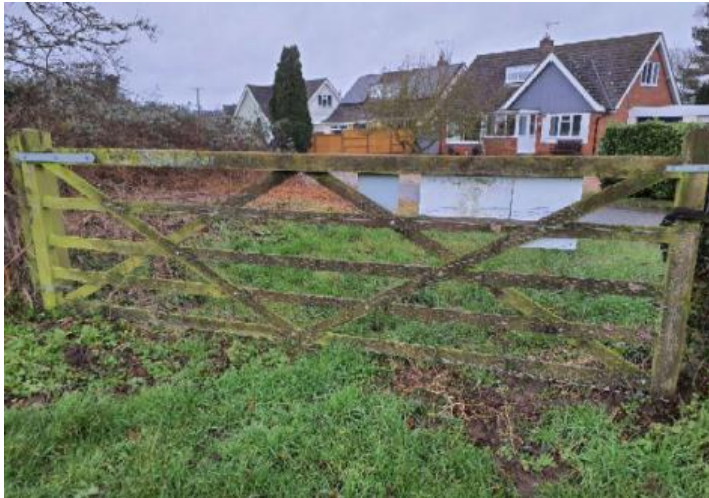
Item: Gates - Gate - Maintenance
Manufacturer: Not Identified

Finding: The maintenance gate was correctly padlocked at the time of inspection, however this means that the inspector was unable to fully assess the gate

Action: Ensure that there are 12mm gaps throughout the full range of motion on gate/s and between leaves where relevant

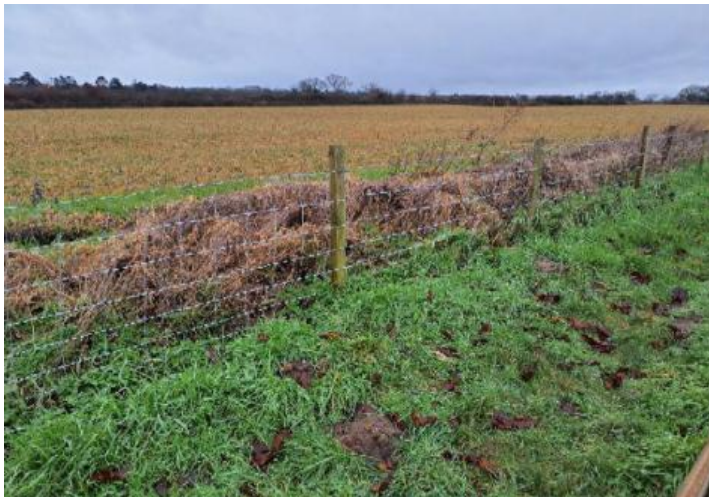
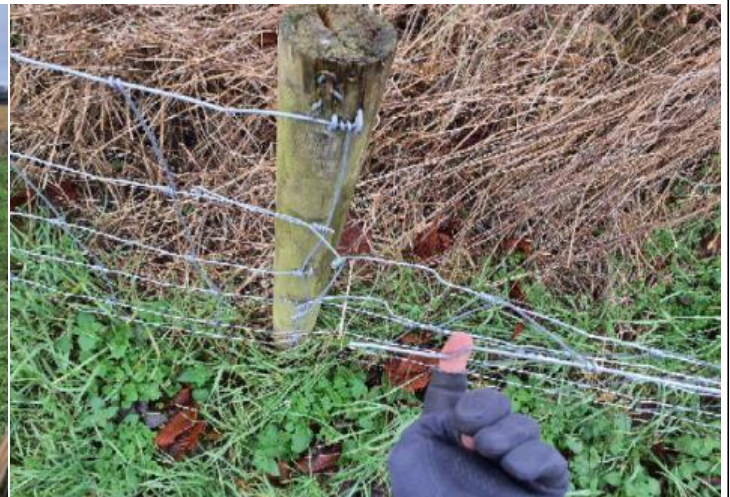
Item: Fences - Fence
Manufacturer: Not Identified

Finding: The fence is damaged in places

Action: Repair or replace all affected sections

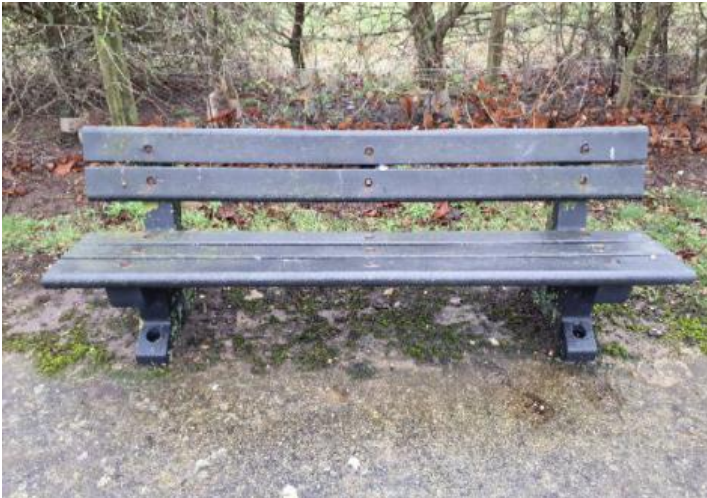
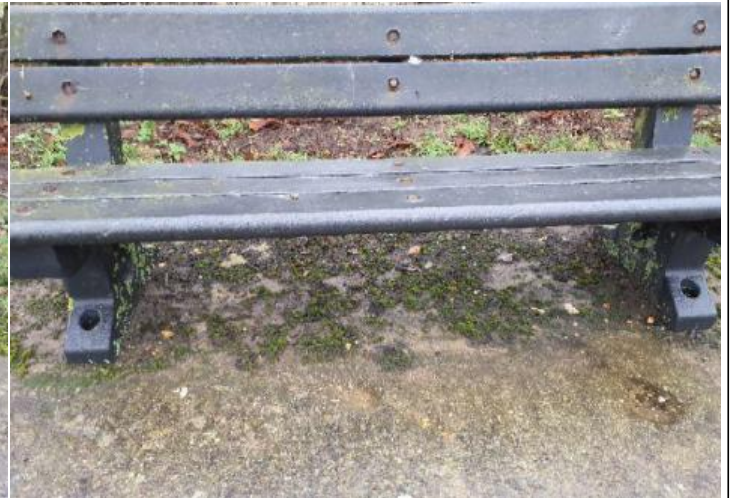
Item: Ancillary Items - Bench
Manufacturer: Not Identified

Finding: There is algae, silt or moss growth on the surface resulting in slippery conditions

Action: Clean and treat appropriately

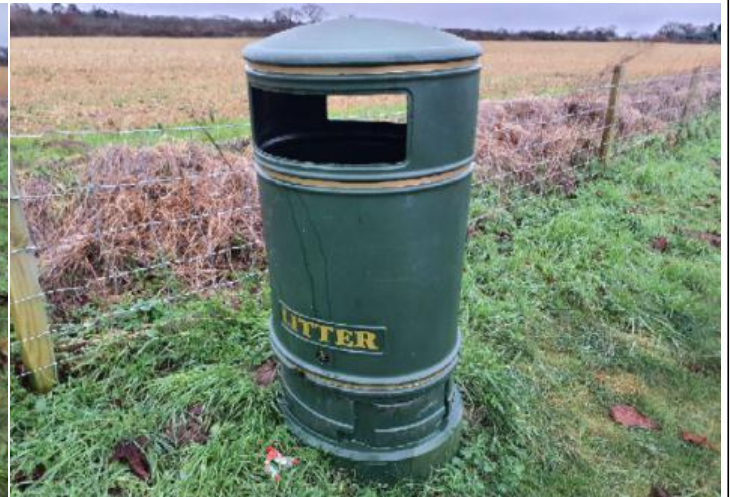
Item: Ancillary Items - Litter Bin
Manufacturer: Not Identified

Finding: The lid or door of the litter bin is not secured

Action: Ensure the lid or door is kept locked

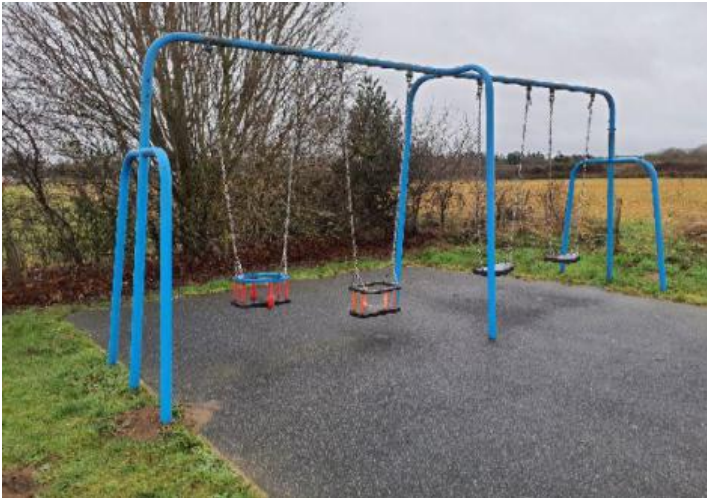
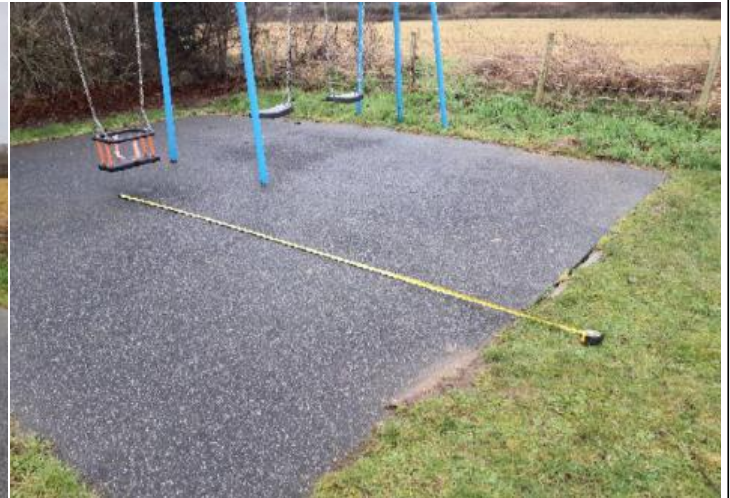
Item: Swings - 2 Bay (2 Flat, 2 Cradle)
Manufacturer: Not Identified

Finding: The surfacing dimensions are short and do not meet with the requirements of the current applicable standard

Action: Monitor - no remedial action recommended

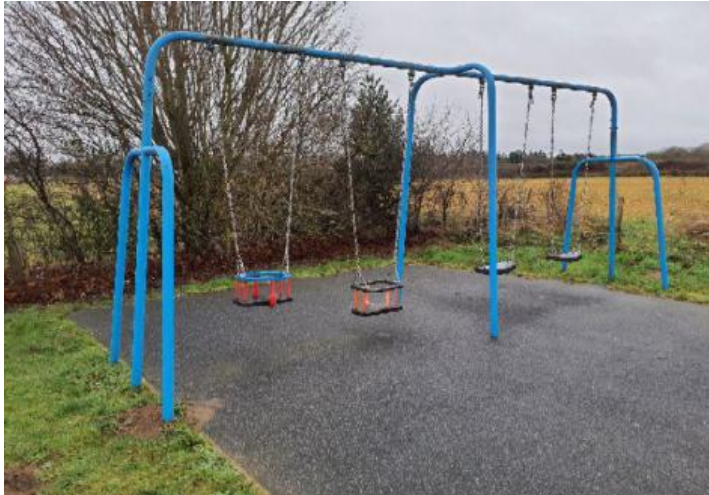
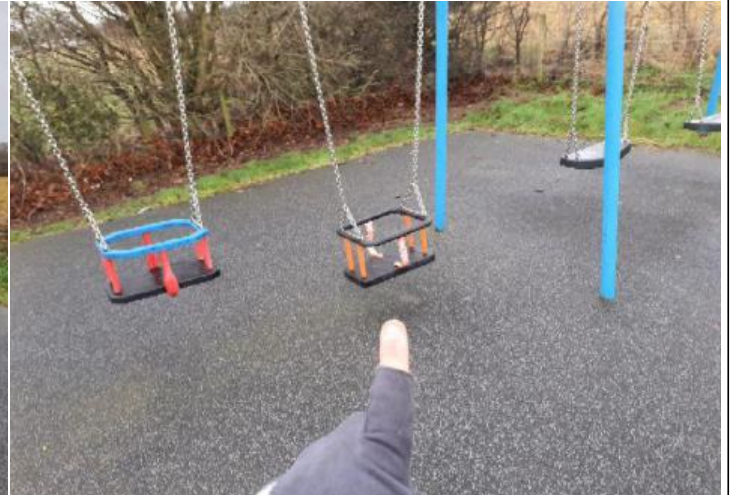
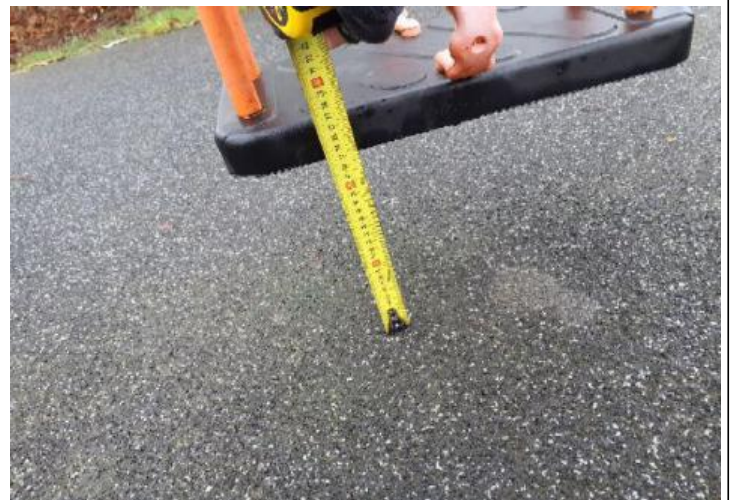
Item: Swings - 2 Bay (2 Flat, 2 Cradle)
Manufacturer: Not Identified

Finding: The seat clearance from finished surface level to the underside of the seat is too low and does not meet the requirements of BS EN 1176 Part 2 (350mm minimum clearance required / currently 220mm)

Action: Adjust seat height/s (400mm-500mm is recommended)

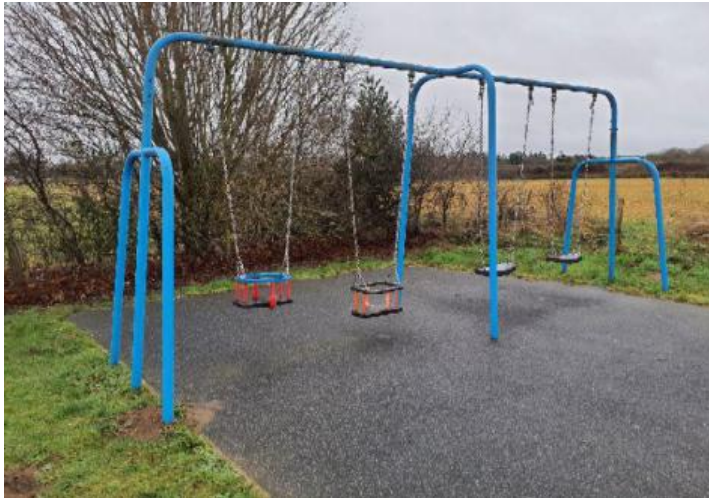
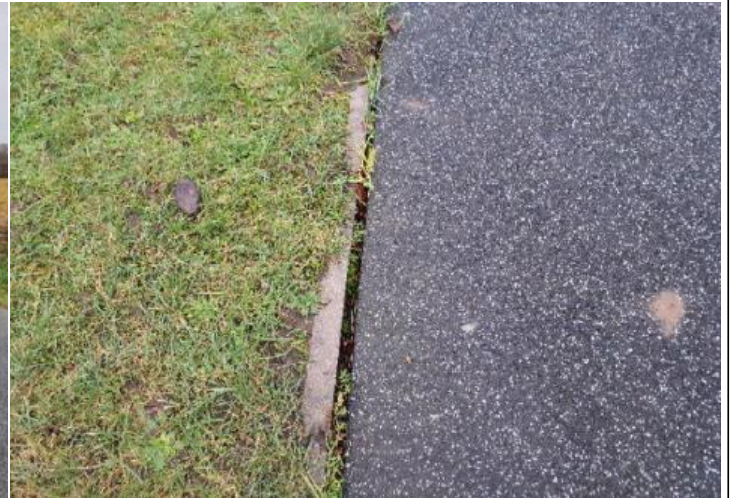
Item: Swings - 2 Bay (2 Flat, 2 Cradle)
Manufacturer: Not Identified

Finding: There are gaps opening between the surfacing and the edging surround or between the joints in the surfacing
Action: Monitor for any further deterioration and repair as required

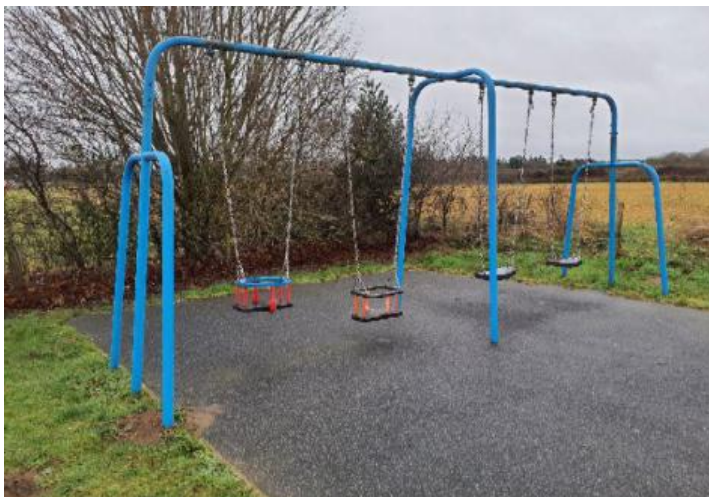
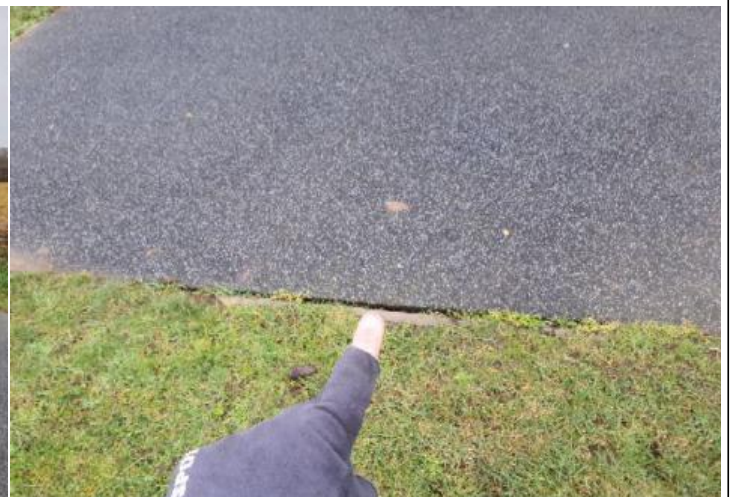
Item: Swings - 2 Bay (2 Flat, 2 Cradle)
Manufacturer: Not Identified

Finding: The surface is lifting at the edges and creating trip points
Action: Repair perimeter of surfacing to remove trip points

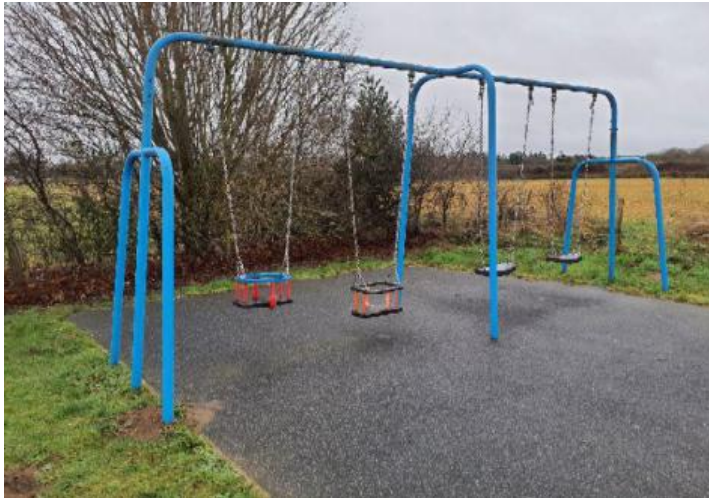
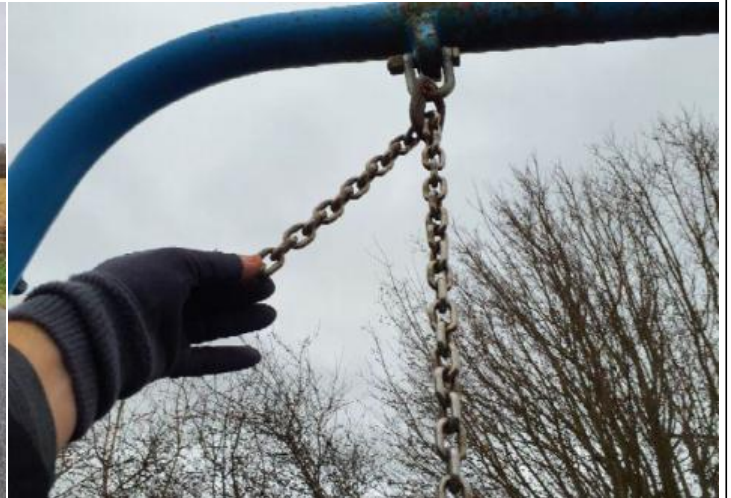
Item: Swings - 2 Bay (2 Flat, 2 Cradle)
Manufacturer: Not Identified

Finding: There are excessive chain tails

Action: Cut back excessive chain links

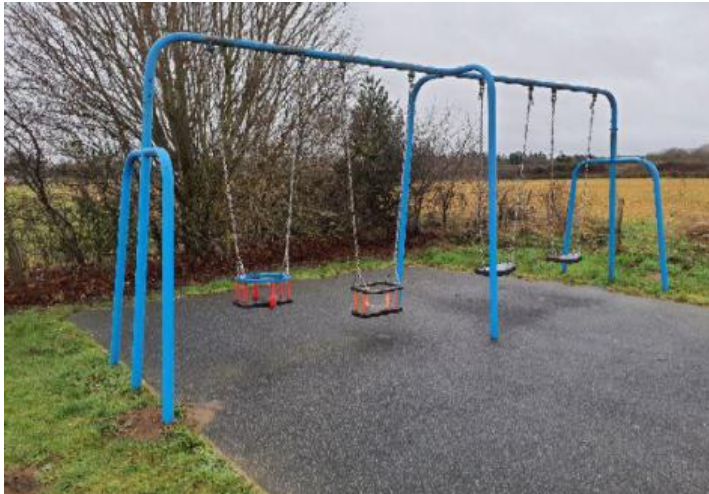
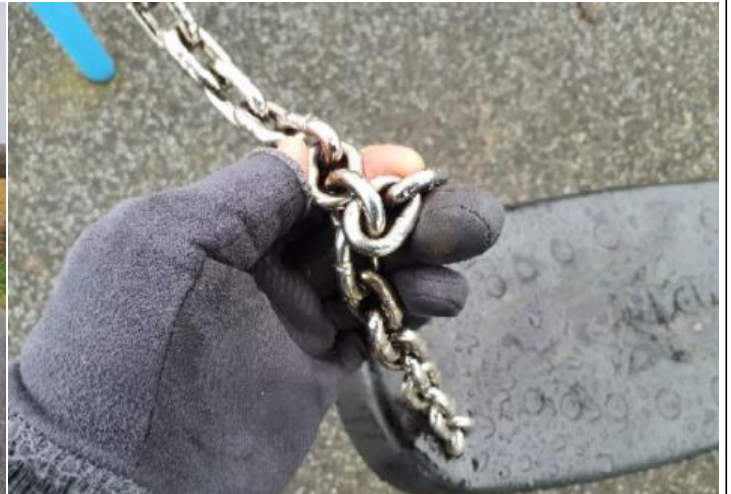
Item: Swings - 2 Bay (2 Flat, 2 Cradle)
Manufacturer: Not Identified

Finding: There is some notable evidence of chain wear

Action: Monitor for any further deterioration and replace when 40% worn

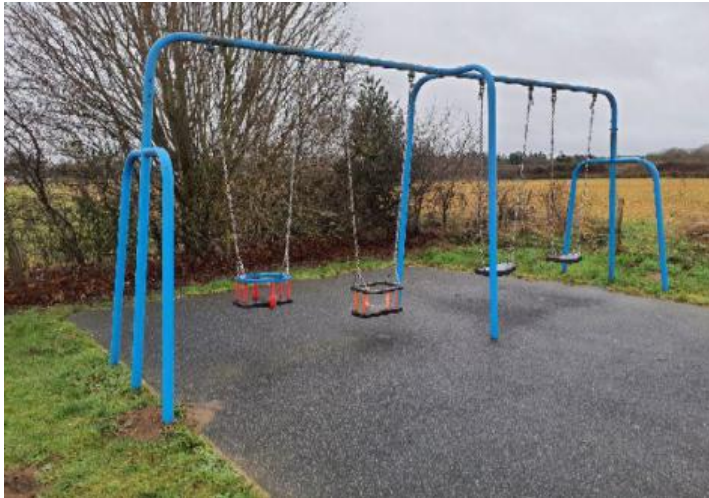
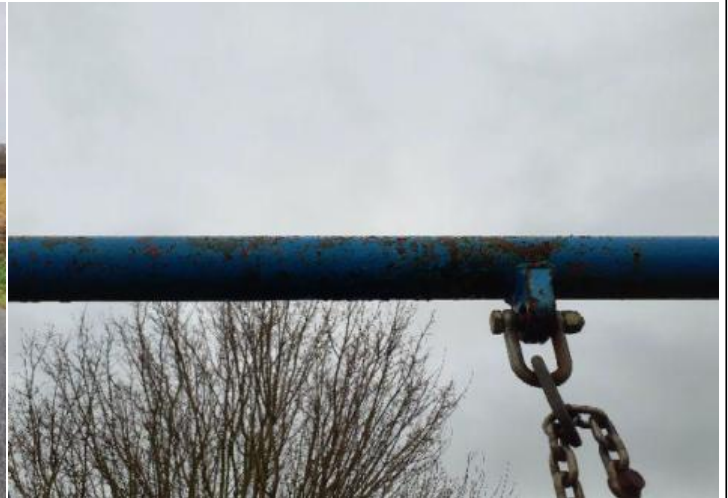
Item: Swings - 2 Bay (2 Flat, 2 Cradle)
Manufacturer: Not Identified

Finding: The paintwork on this item has been damaged or worn exposing the metal underneath which is rusting / corroding

Action: Treat affected areas and repaint

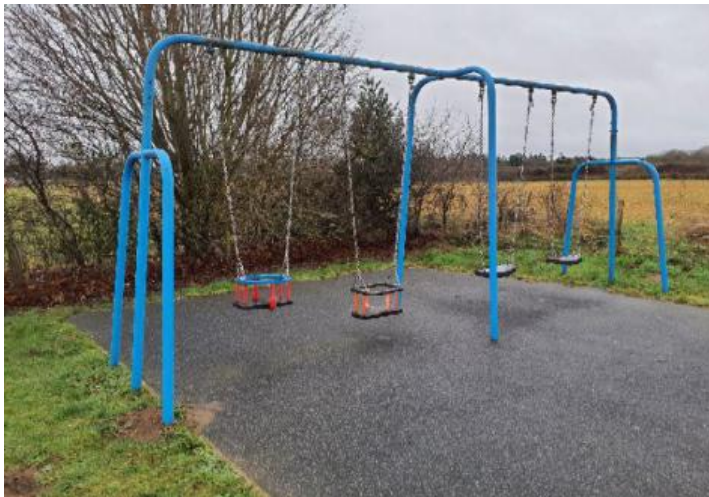
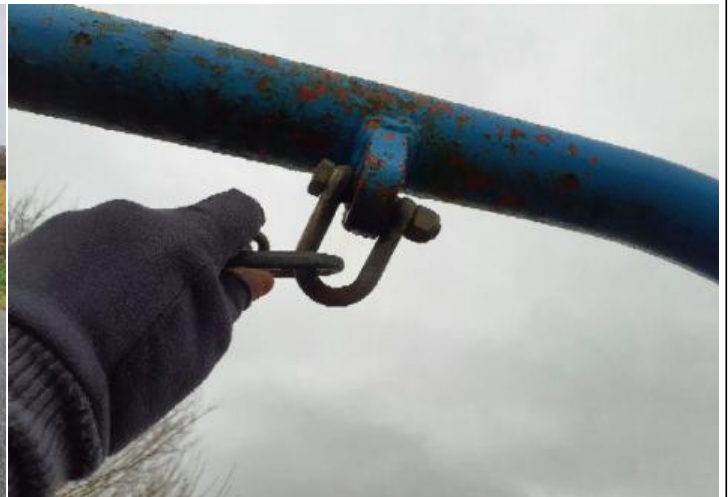
Item: Swings - 2 Bay (2 Flat, 2 Cradle)
Manufacturer: Not Identified

Finding: There is some wear to the shackles

Action: Monitor for any further deterioration and replace when 40% worn

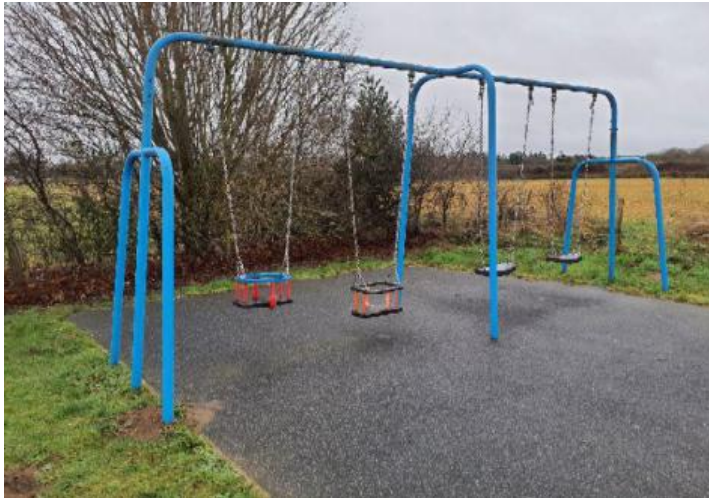
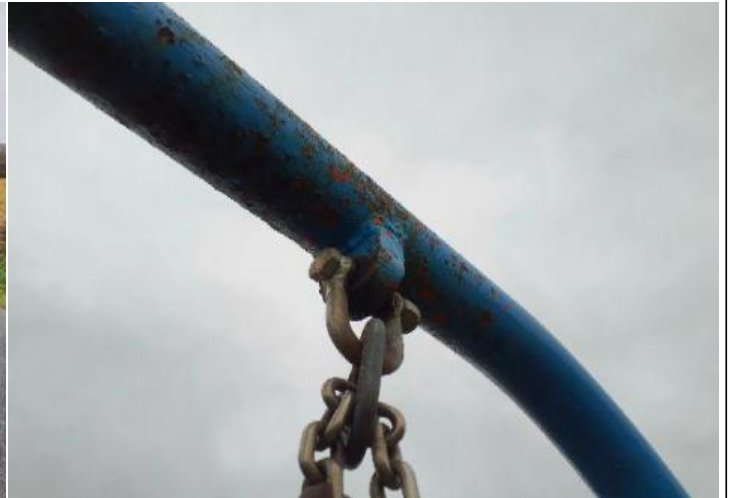
Item: Swings - 2 Bay (2 Flat, 2 Cradle)
Manufacturer: Not Identified

Finding: The bushes are worn or missing

Action: Replace worn or missing bushes

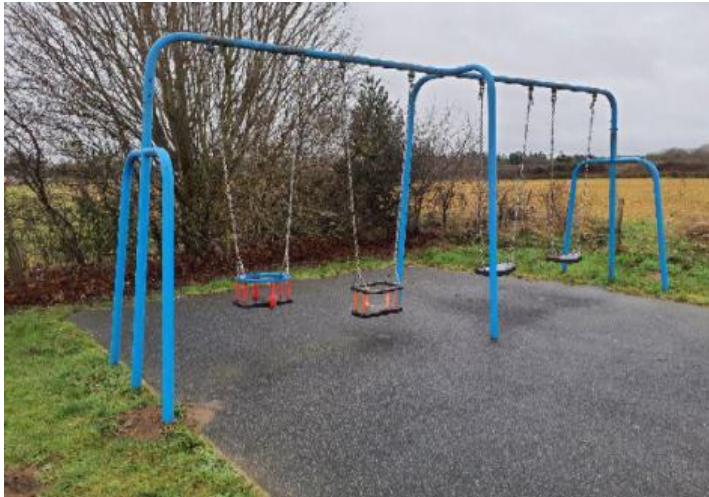
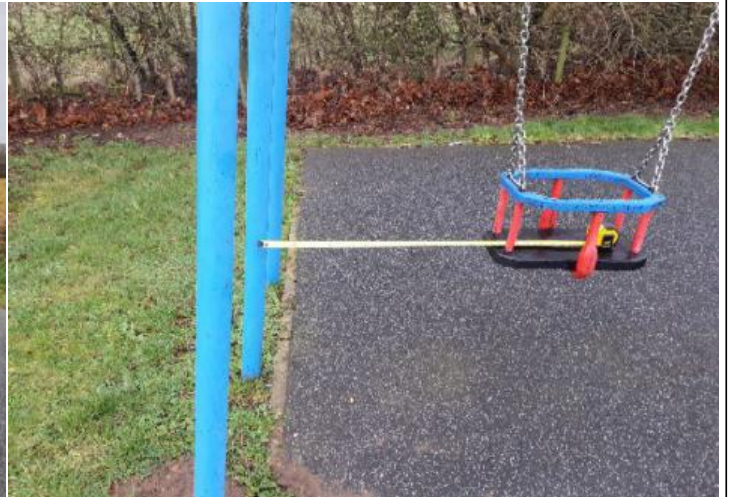
Item: Swings - 2 Bay (2 Flat, 2 Cradle)
Manufacturer: Not Identified

Finding: The surfacing width under the seat/s is / are less than 875mm when measured from the centre of the seat outwards, and fails the requirements of BS EN 1176 Part 2

Action: Monitor - No remedial work recommended

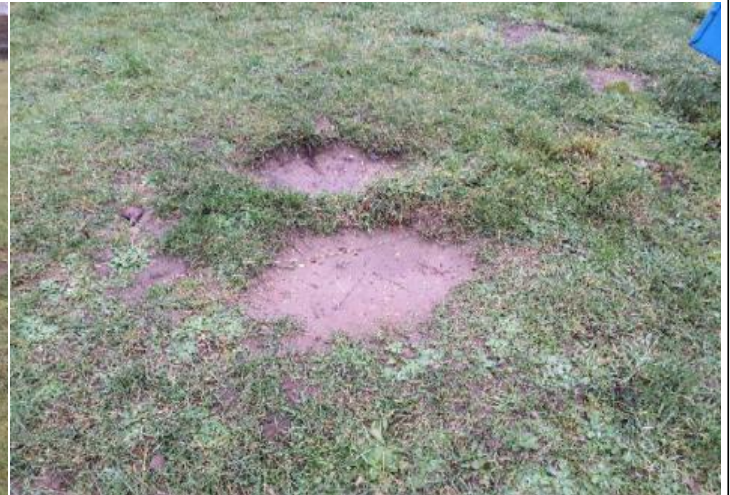
Item: Rocking Equipment - See Saw
Manufacturer: Wicksteed Playgrounds

Finding: The grass has eroded within the impact area of the equipment and may not provide the necessary impact attenuating properties for the equipment fall height; the surface may also be slippery in wet weather
Action: Reinstate the grass or provide an all weather surface

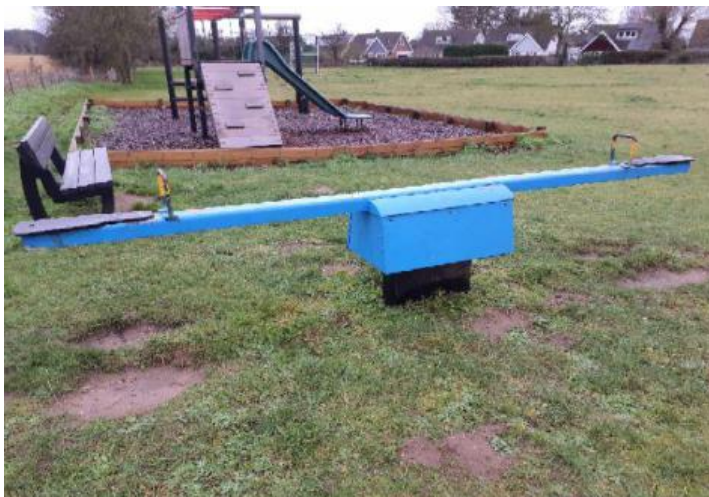
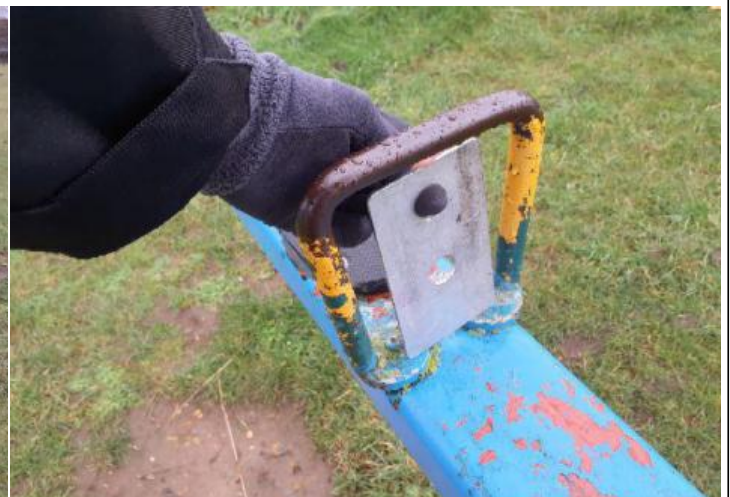
Item: Rocking Equipment - See Saw
Manufacturer: Wicksteed Playgrounds

Finding: The item fails to meet the requirements of BS EN 1176 Part 1 4.2.7.2 for head and neck entrapment in the frame
Action: Monitor - No remedial work recommended

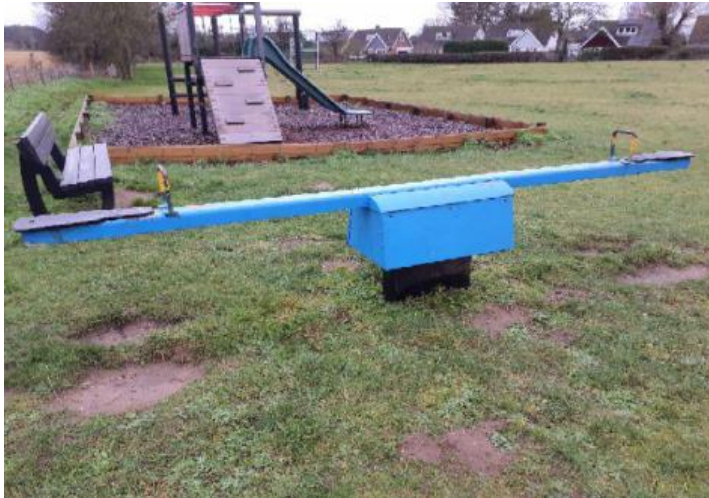
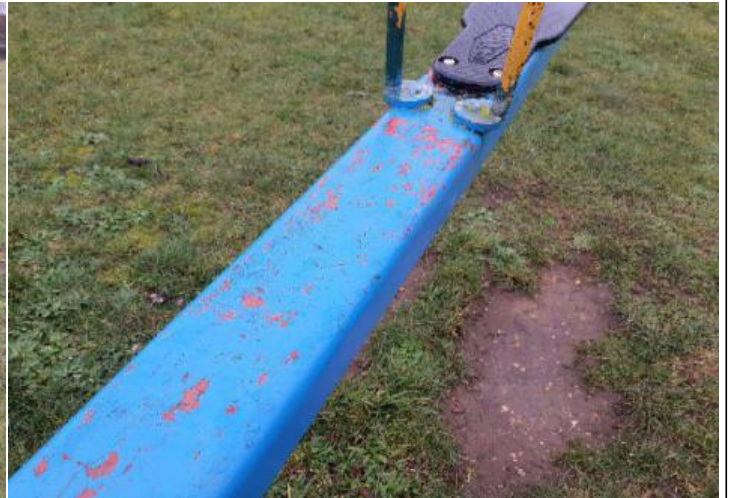
Item: Rocking Equipment - See Saw
Manufacturer: Wicksteed Playgrounds

Finding: The paint is flaking off the metalwork

Action: Rub down and re-paint

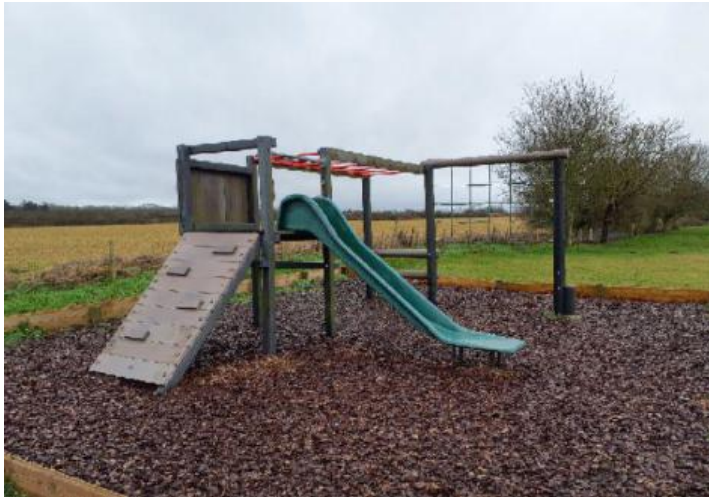
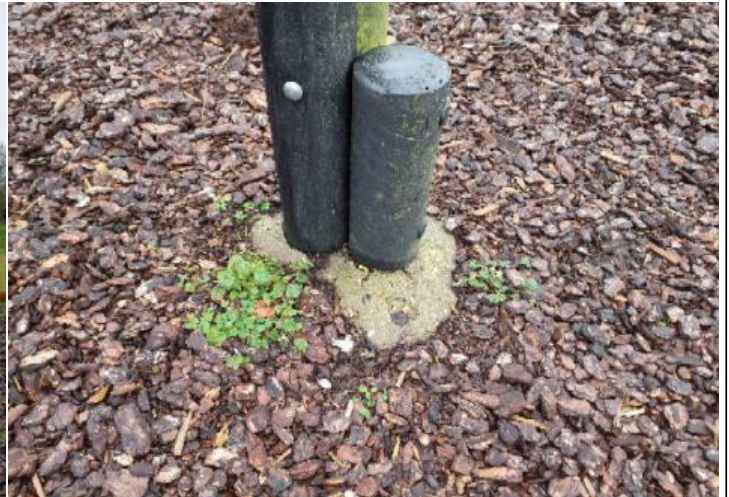
Item: Activity Equipment - Multi Play (Junior)
Manufacturer: Not Identified

Finding: The exposed foundation forms a hard object within the impact area of the equipment in contravention of the requirements of BS EN 1176 Part 1

Action: Top up loosefill levels to cover foundations

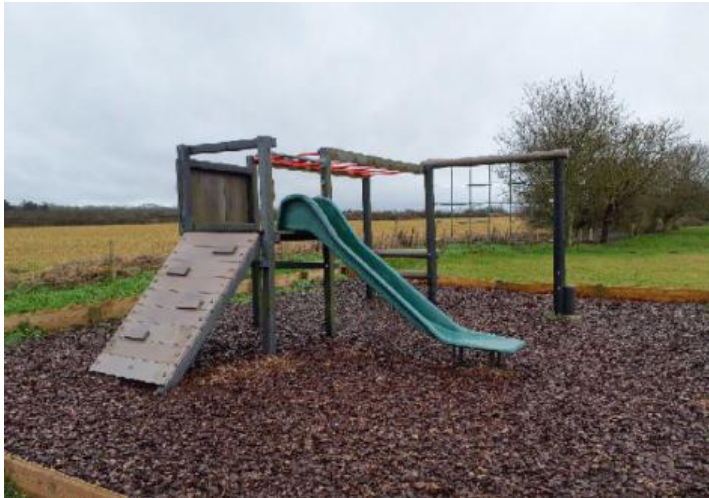
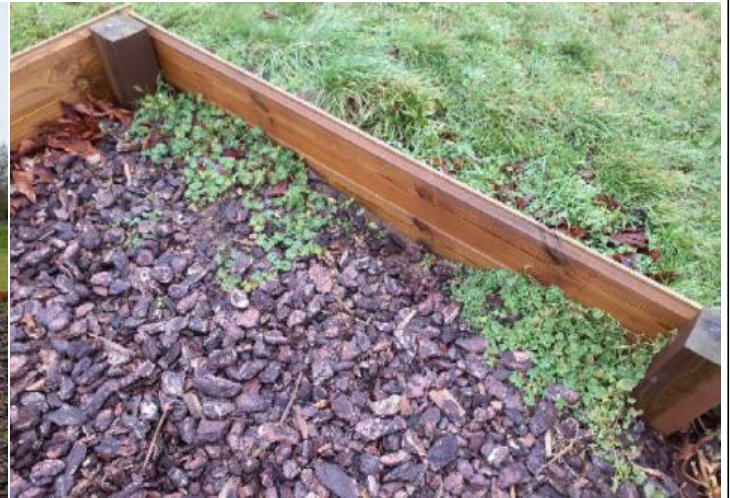
Item: Activity Equipment - Multi Play (Junior)
Manufacturer: Not Identified

Finding: There is weed / vegetation growth on, between, or around the edges of the surfacing
Action: Remove weed / vegetation growth

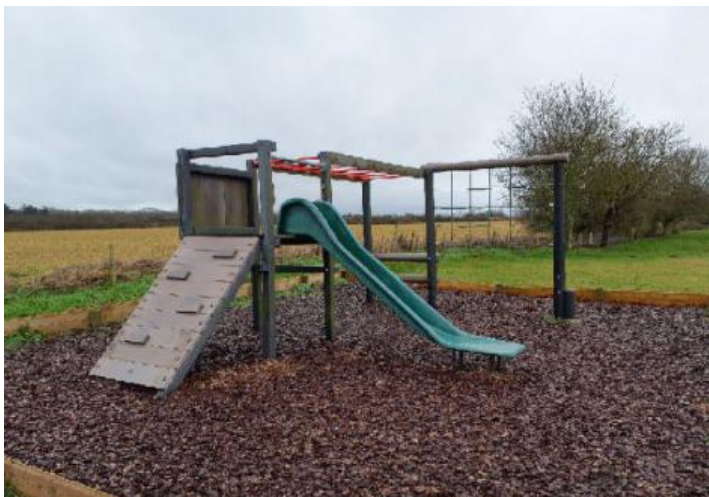
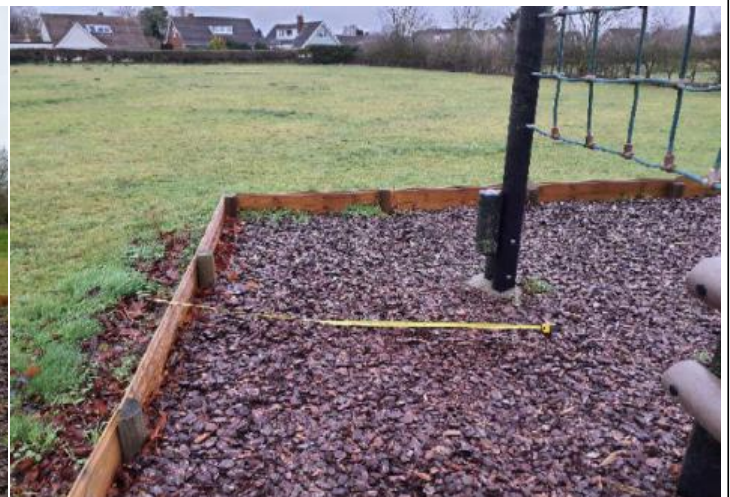
Item: Activity Equipment - Multi Play (Junior)
Manufacturer: Not Identified

Finding: The timber edge forms a hard object within the falling space of the equipment in contravention of the requirements of BS EN 1176 Part 1
Action: Monitor - No remedial work recommended

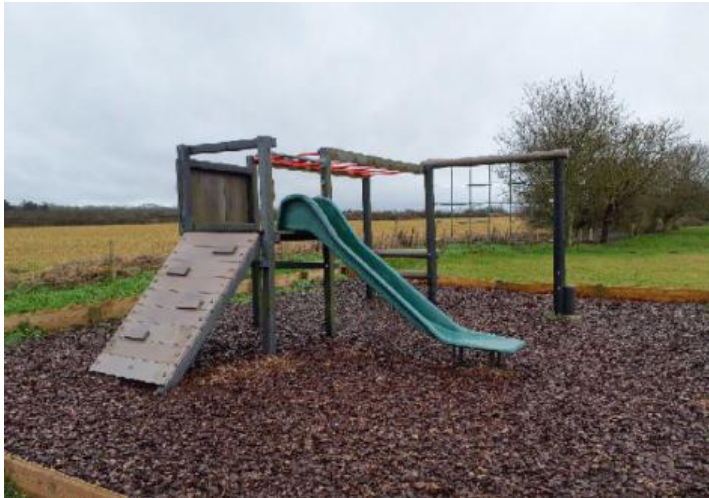
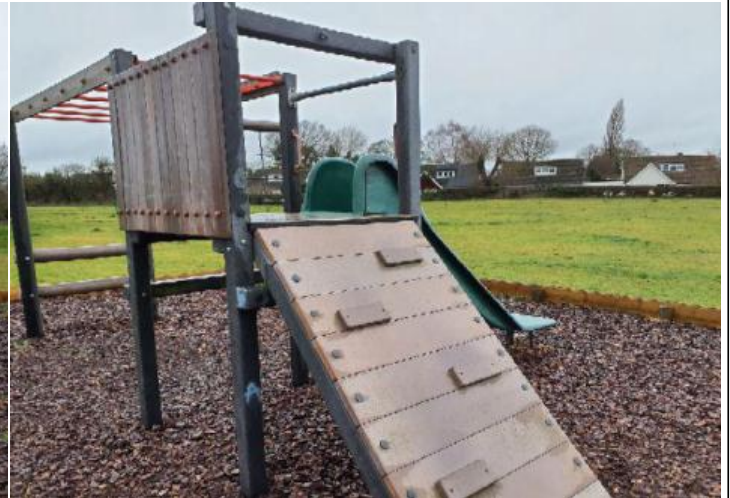
Item: Activity Equipment - Multi Play (Junior)
Manufacturer: Not Identified

Finding: The item has missing component(s)

Action: Consider replacing missing components

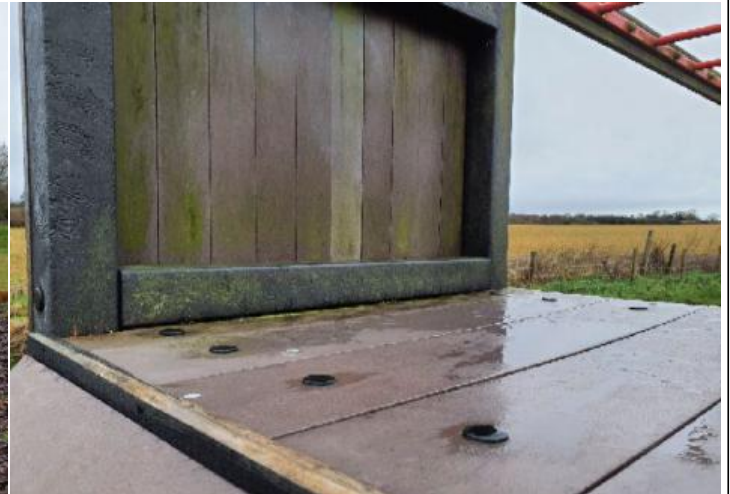
Finding: There is algae or moss on the surface of the equipment

Action: Clean and treat appropriately

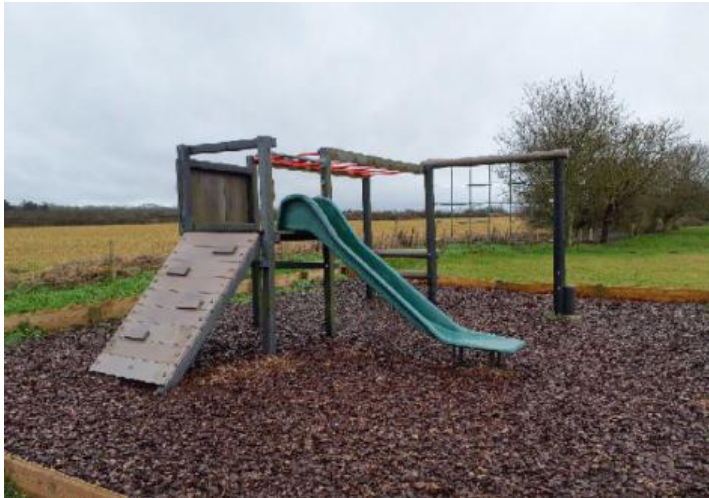
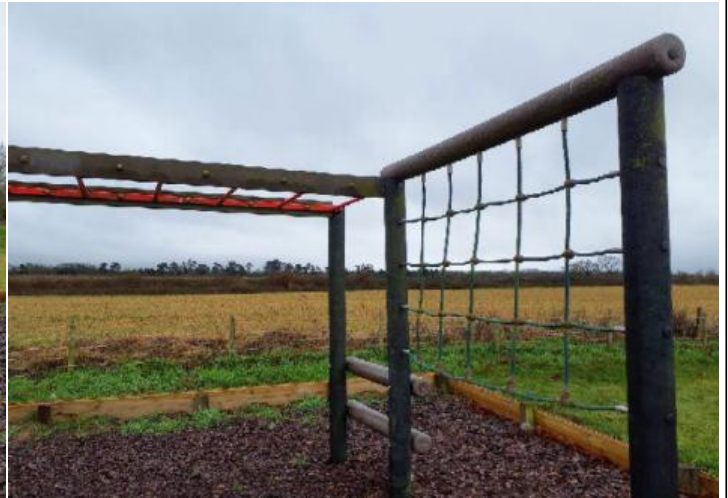
Finding: The depth of the loose fill surfacing is lower than the recommended depth specified in BS EN 1176 for a fall height over 2.0m. A minimum depth of 400mm is recommended (including an extra 100mm to allow for compaction and displacement as per BS EN 1176 Part 1 - Table 4)

Action: Top up loosefill to recommended levels

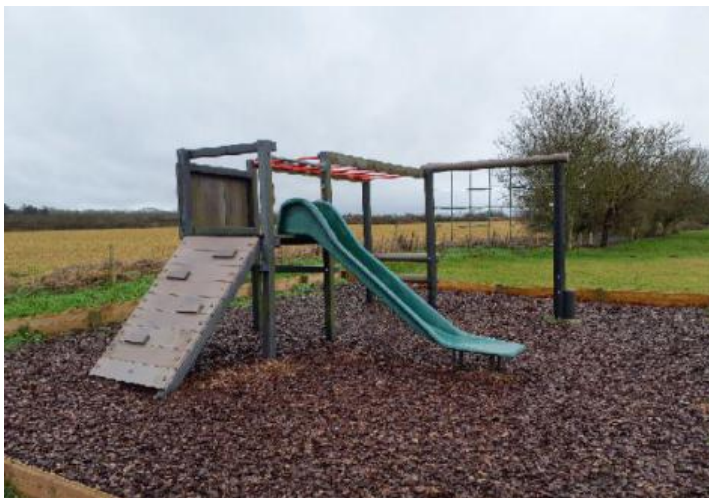
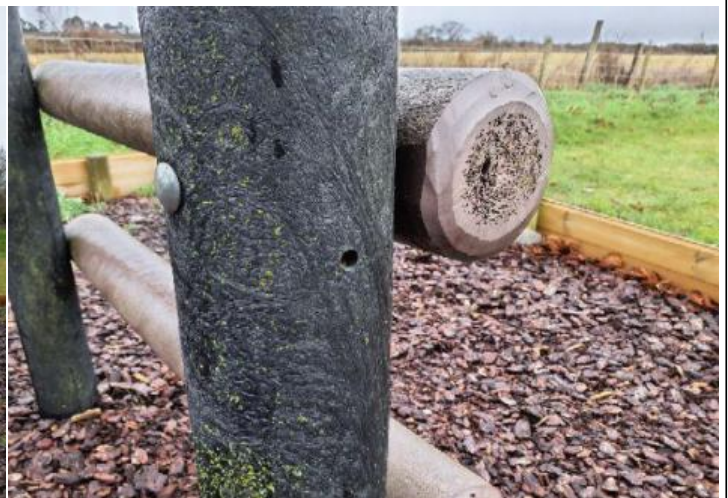
Finding: There is/are inserts missing

Action: Replace missing inserts

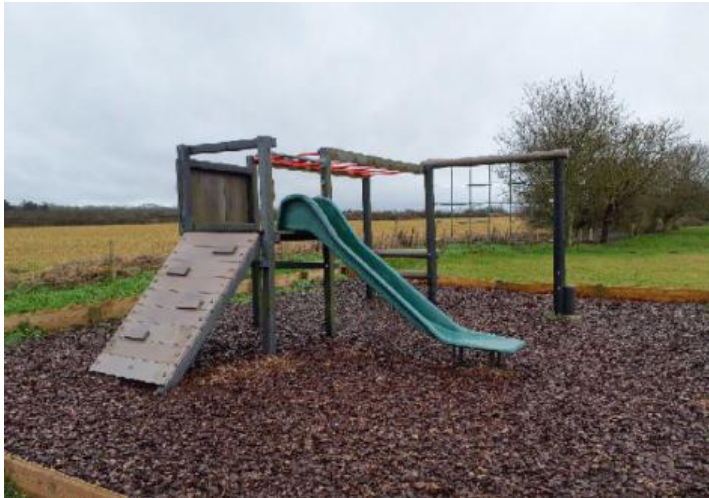
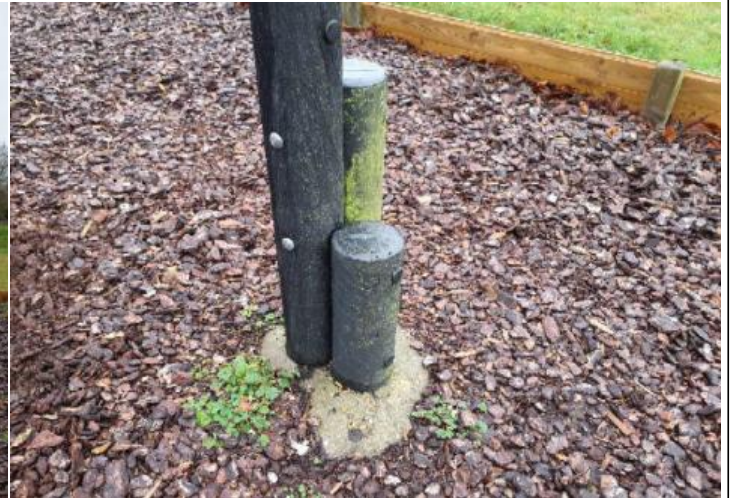
Finding: The item is slightly loose in its foundations

Action: Monitor for any further deterioration and repair as required

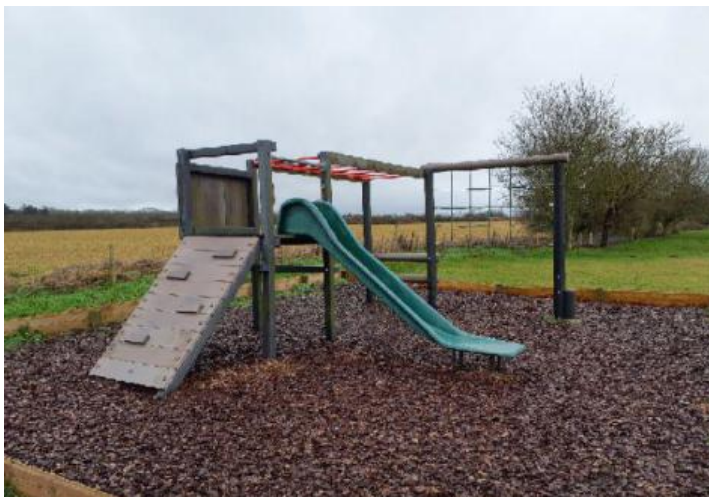
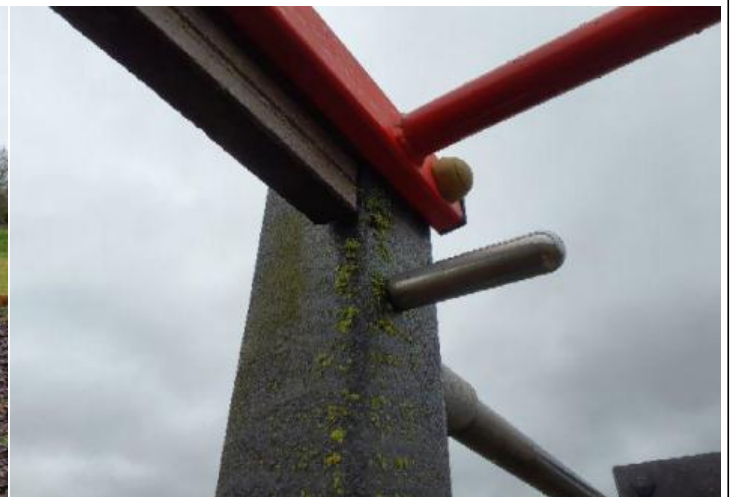
Finding: There is/are finger entrapment/s in the post due to missing inserts and the item fails to meet the requirements of BS EN 1176 Part 1 4.2.7.6 Entrapment of fingers

Action: Provide inserts to remove entrapment

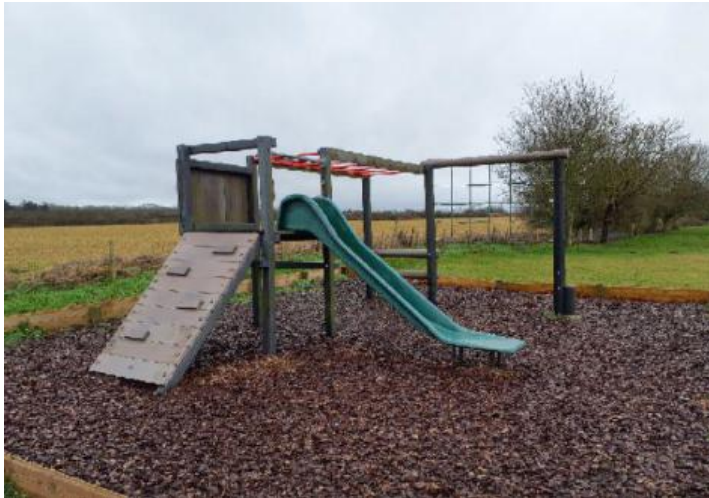
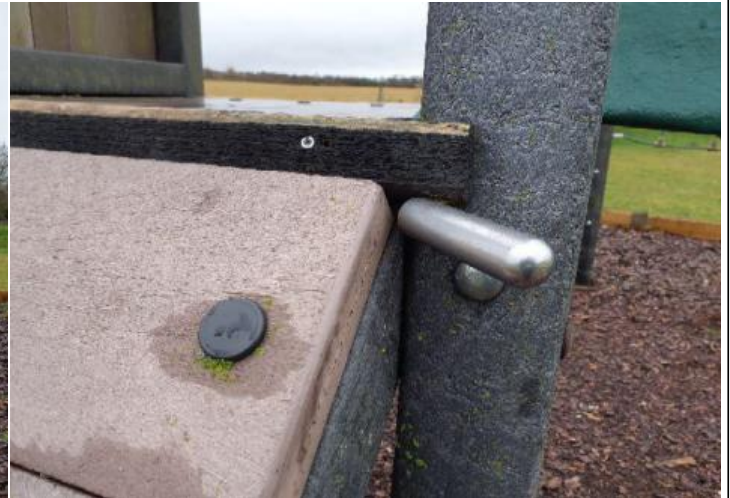
Finding: There is/are finger entrapment/s in the climbing wall and the item fails to meet the requirements of BS EN 1176 Part 1 4.2.7.6 Entrapment of fingers

Action: Monitor - No remedial work recommended

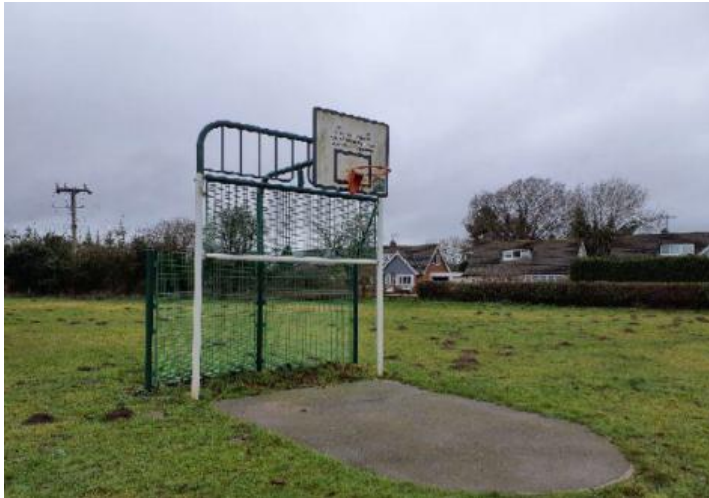
Finding: A clearly visible facility sign should be provided in a prominent position with the wording as detailed BS EN 15312- the equipment is not intended for children less than 3 years old- the warning - Do not climb on the framework or nets- the warning - Do not hang on the ring (if provided)- the warning - Do not wear rings or other jewellery- name and telephone number of the administrator- number to call in case of accident

Action: Provide signage to BS EN 15312
