Annual Inspection

Mid Suffolk District Council

Thurston Playing Field

Heath Road, Thurston, Suffolk, IP31 3PJ

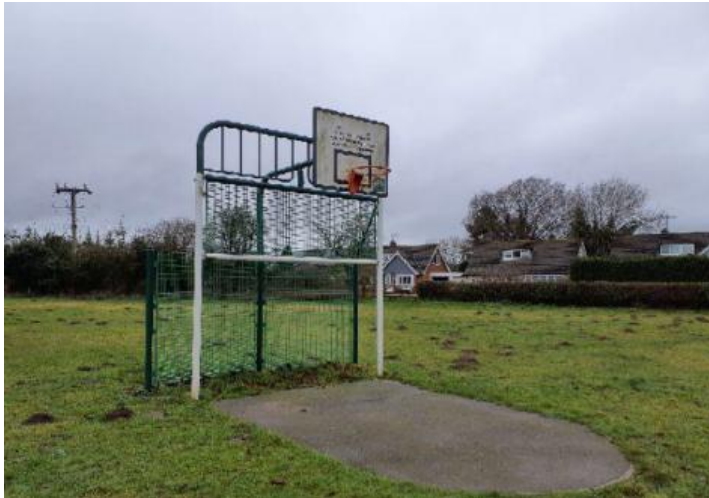
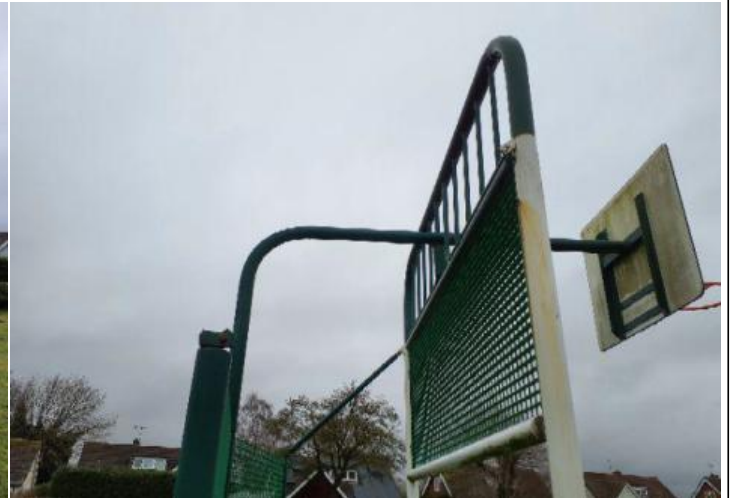
Item: Multi Use Games Area - Basket Ball Goal **Risk Level:** L - Low Risk
Manufacturer: Playquest **Surface:** Grass

Finding: A support brace has been removed/not fitted

Action: Refer to the manufacturer

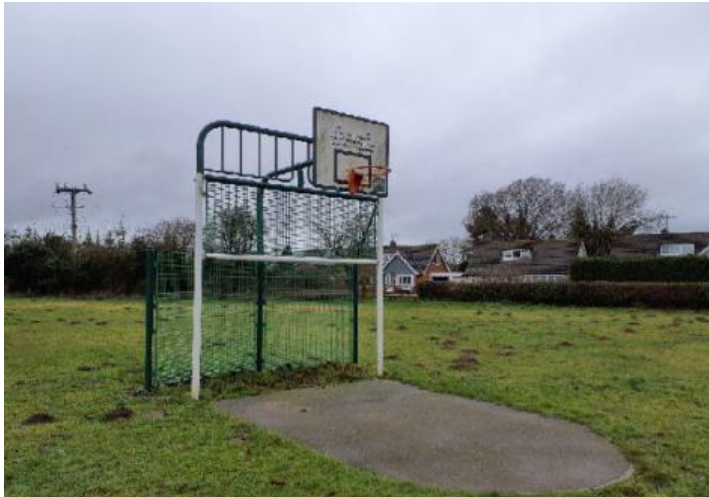
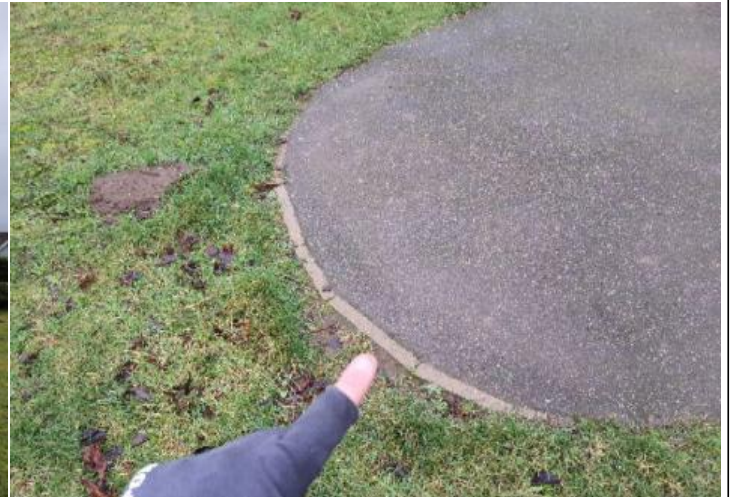
Item: Multi Use Games Area - Basket Ball Goal **Risk Level:** L - Low Risk
Manufacturer: Playquest **Surface:** Grass

Finding: There are trip hazards at the edges of the surface

Action: Reinstate surrounding surface levels to remove the trip points

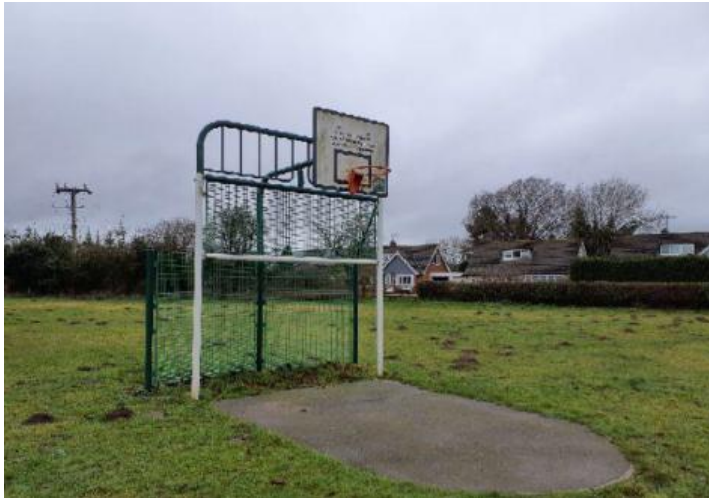
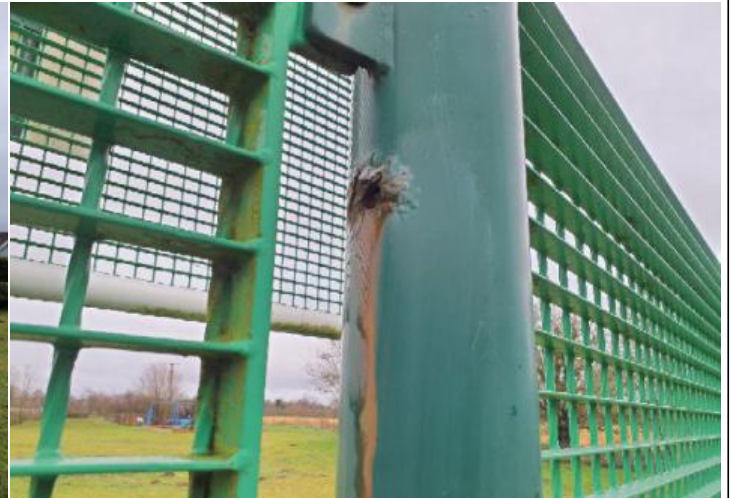
Finding: The paintwork on this item has been damaged or worn exposing the metal underneath which is rusting / corroding

Action: Treat affected areas and repaint
