Annual Inspection

Thurston Trim Trail Fitness Area

New Green Centre, Station Hill, Thurston, Suffolk, IP31
3QU

Inspection Ref: 1915609

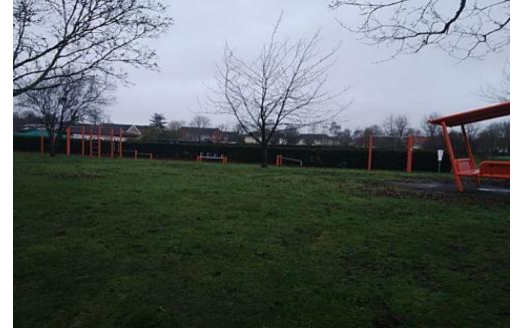
Item: Site General
Manufacturer: Owner/Operator
Surface Type: N/A
Item Quantity: 1
Equipment Compliance: N/A
Surface Area Compliance: N/A

There is a lack of growth within the grass area - Encourage growth with grass seeds

There is some tree debris on the surfacing - Remove and maintain

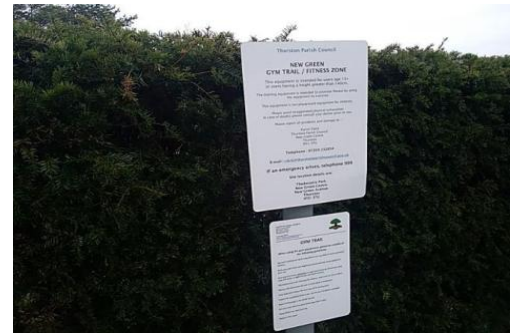
Item: Sign
Manufacturer: Owner/Operator
Surface Type: Grass
Item Quantity: 1
Equipment Compliance: N/A
Surface Area Compliance: N/A

The signage is damaged - Replace signage

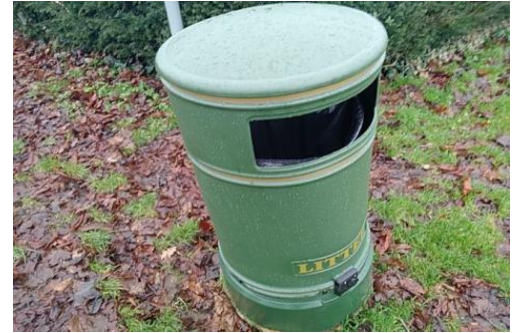
Item: Litter Bin
Manufacturer: Not Identified
Surface Type: Grass
Item Quantity: 1
Equipment Compliance: N/A
Surface Area Compliance: N/A

The item is loose in its foundations - Reinstall item to secure

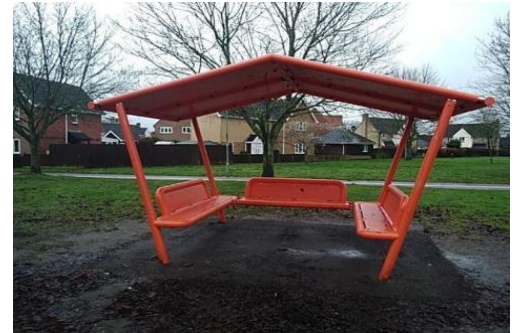
Item: Shelter
Manufacturer: Caloo
Surface Type: Grass
Item Quantity: 1
Equipment Compliance: N/A
Surface Area Compliance: N/A

There is some graffiti present - Remove the graffiti

There is/are bolt cap covers missing or damaged on the item - Replace missing or damaged bolt cap covers

The area around the item has eroded and may become slippery - Reinststate eroded area

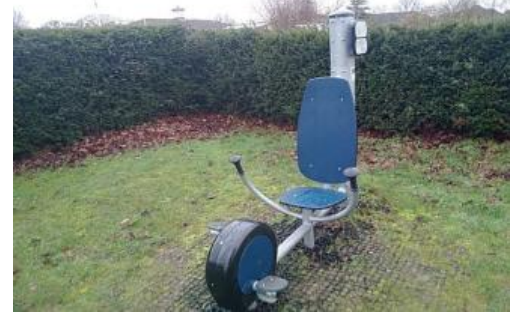
Item: Cycle
Manufacturer: Kompan Ltd
Surface Type: Grass Matrix Tiles
Item Quantity: 1
Equipment Compliance: Yes
Surface Area Compliance: N/A

This item is satisfactory - no work required -

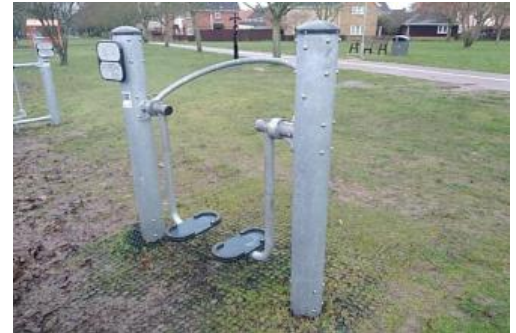
Item: Air Walker
Manufacturer: Kompan Ltd
Surface Type: Grass Matrix Tiles
Item Quantity: 1
Equipment Compliance: Yes
Surface Area Compliance: Yes

This item is satisfactory - no work required -

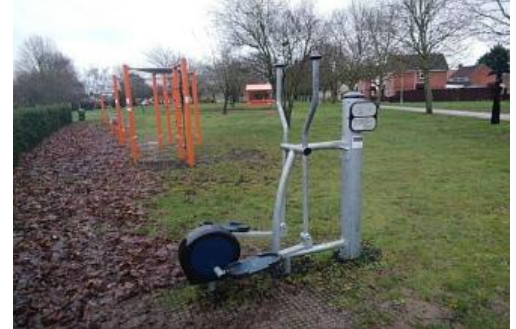
Item: Cross Trainer
Manufacturer: Kompan Ltd
Surface Type: Grass Matrix Tiles
Item Quantity: 1
Equipment Compliance: Yes
Surface Area Compliance: Yes

This item is satisfactory - no work required -

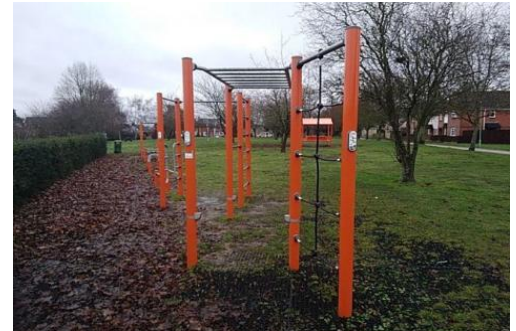
Item: Activity Station
Manufacturer: Kompan Ltd
Surface Type: Grass Matrix Tiles
Item Quantity: 1
Equipment Compliance: Yes
Surface Area Compliance: Yes

There is offensive graffiti present - Remove as soon as practicable

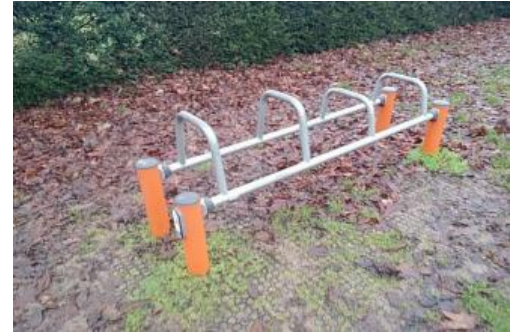
Item: Dip Station
Manufacturer: Kompan Ltd
Surface Type: Grass Matrix Tiles
Item Quantity: 1
Equipment Compliance: Yes
Surface Area Compliance: Yes

This item is satisfactory - no work required -

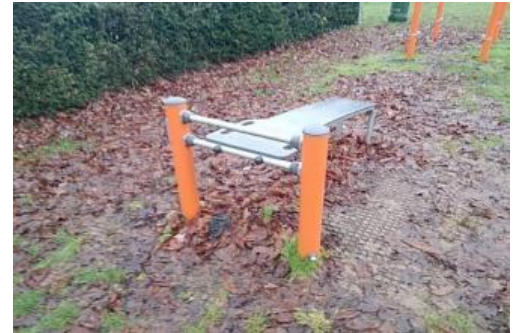
Item: Sit Up Station
Manufacturer: Kompan Ltd
Surface Type: Grass Matrix Tiles
Item Quantity: 1
Equipment Compliance: Yes
Surface Area Compliance: Yes

This item is satisfactory - no work required -

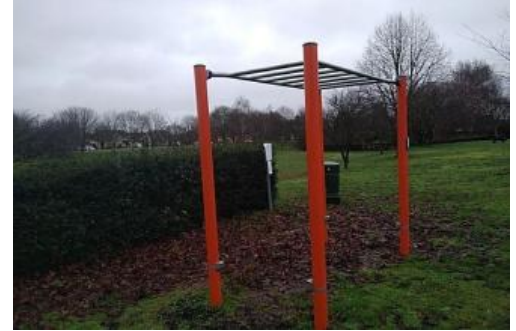
Item: Overhead Bars
Manufacturer: Kompan Ltd
Surface Type: Grass Matrix Tiles
Item Quantity: 1
Equipment Compliance: Yes
Surface Area Compliance: Yes

This item is satisfactory - no work required -

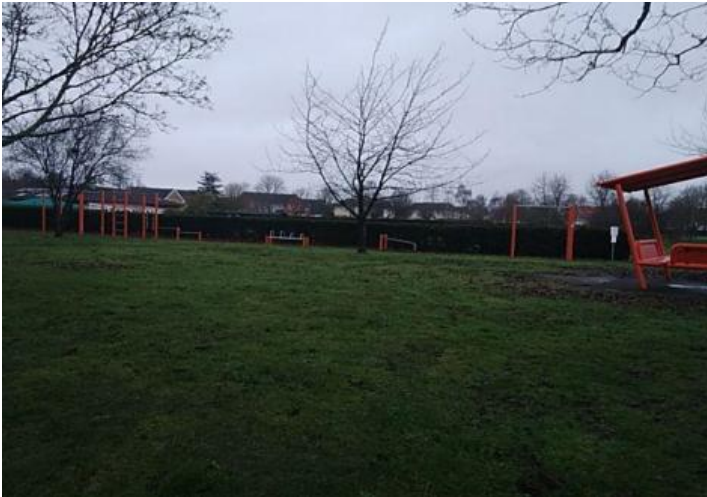
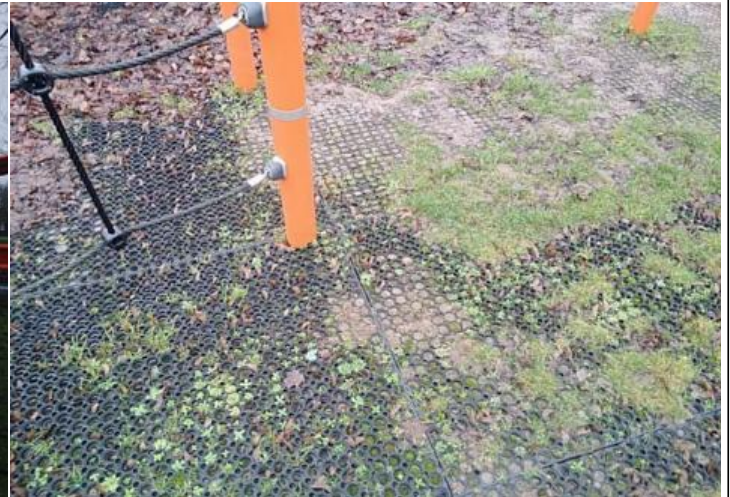
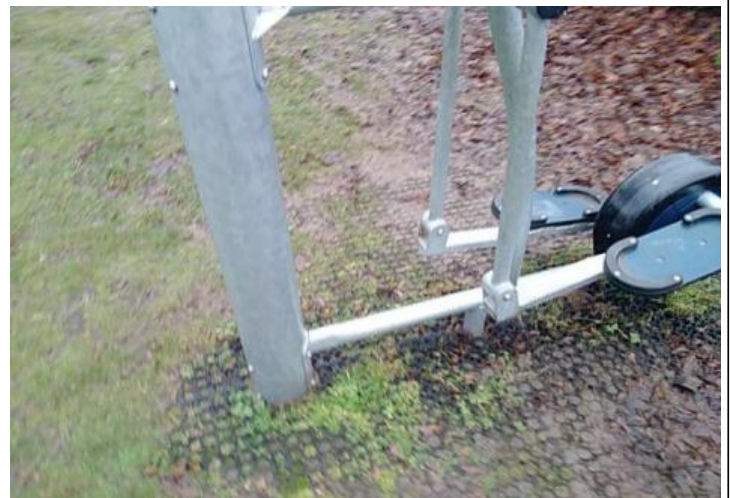
Item: Ancillary Items - Site General
Manufacturer: Owner/Operator

Finding: There is a lack of growth within the grass area

Action: Encourage growth with grass seeds

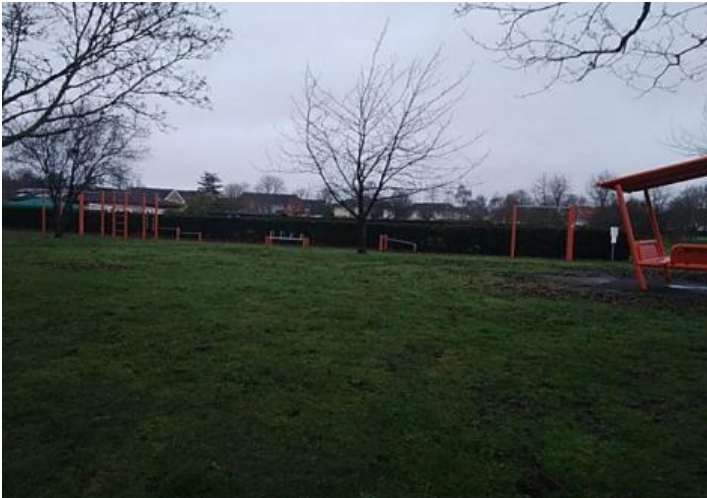
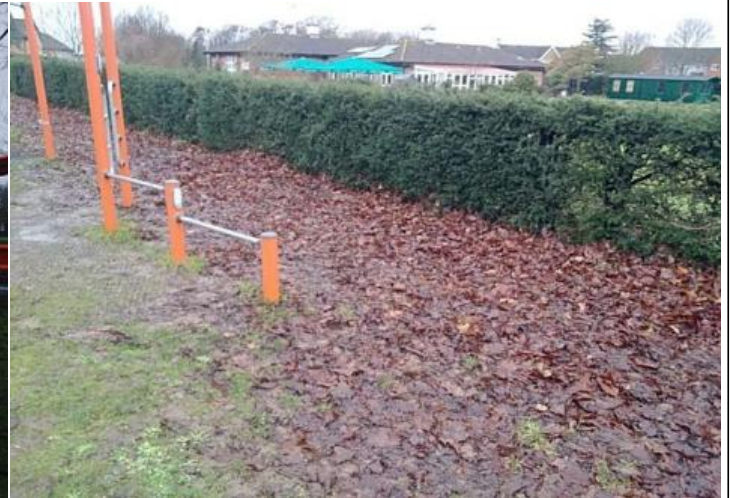
Item: Ancillary Items - Site General
Manufacturer: Owner/Operator

Finding: There is some tree debris on the surfacing

Action: Remove and maintain

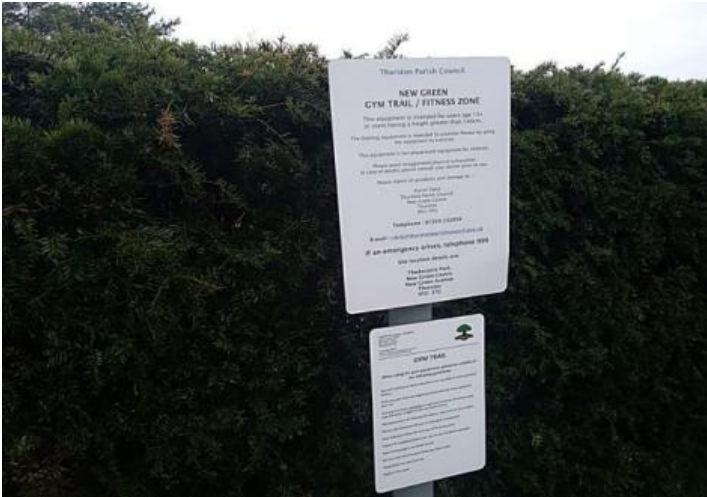
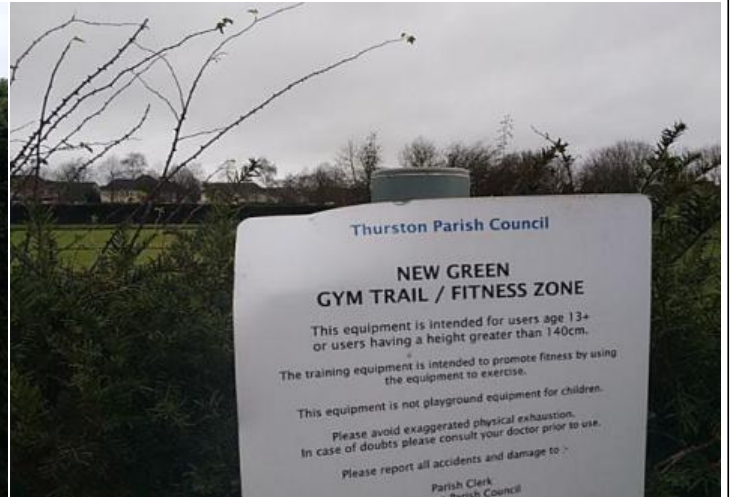
Item: Ancillary Items - Sign
Manufacturer: Owner/Operator

Finding: The signage is damaged

Action: Replace signage

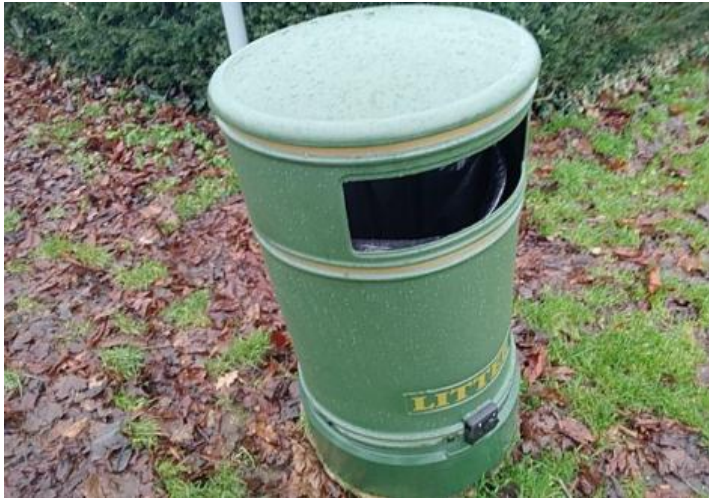
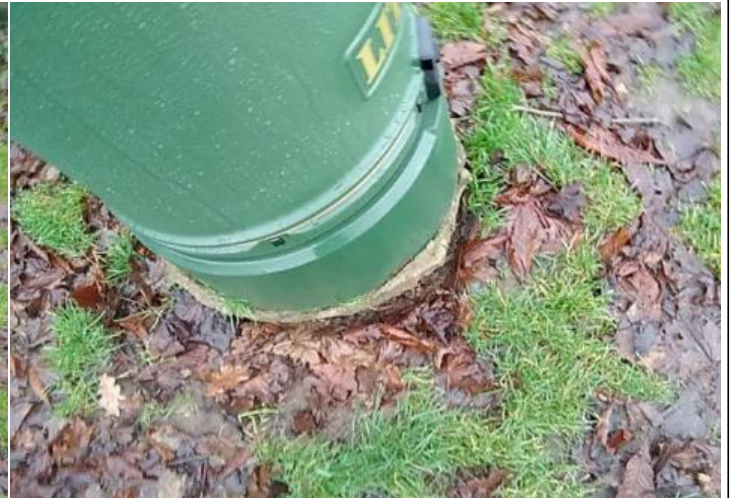
Item: Ancillary Items - Litter Bin
Manufacturer: Not Identified

Finding: The item is loose in its foundations

Action: Reinstall item to secure

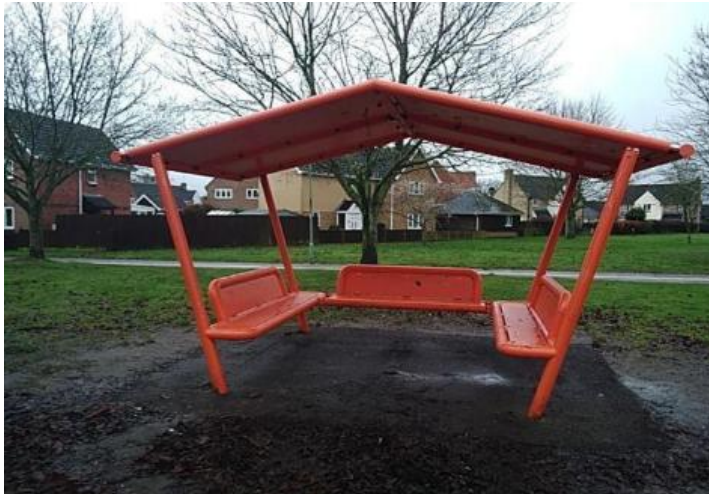
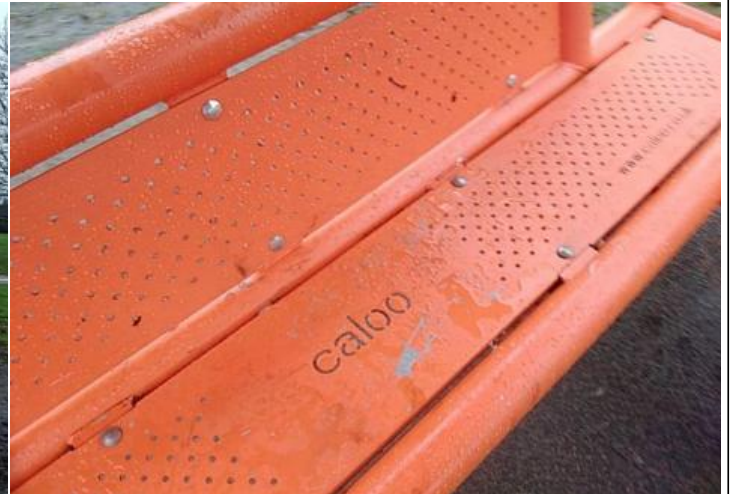
Item: Ancillary Items - Shelter
Manufacturer: Caloo

Finding: There is some graffiti present

Action: Remove the graffiti

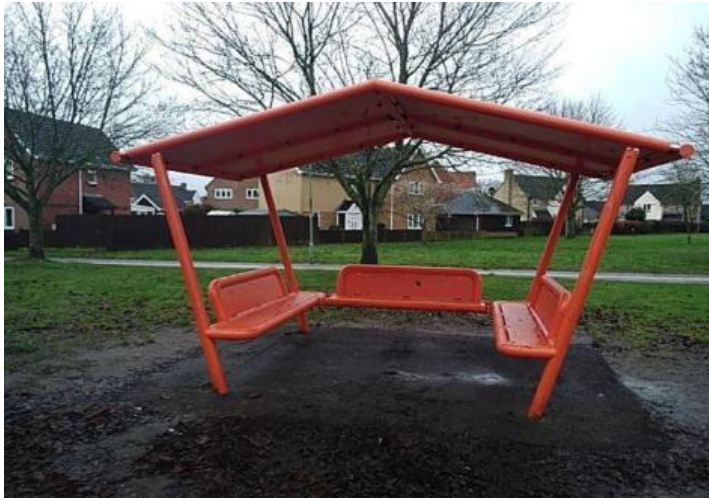
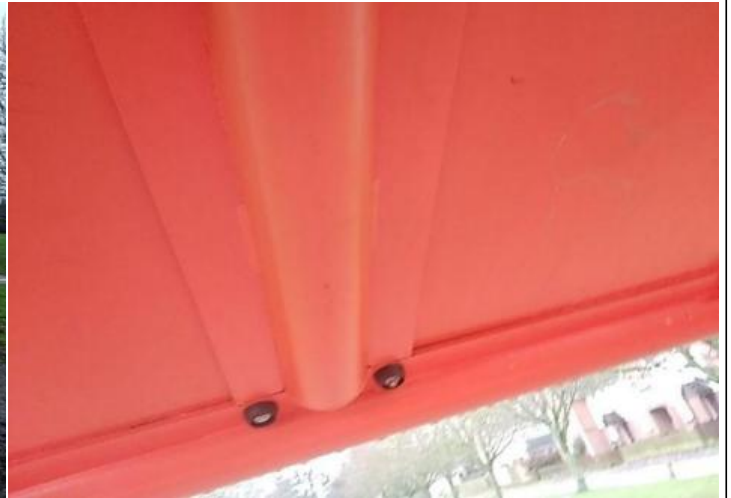
Item: Ancillary Items - Shelter
Manufacturer: Caloo

Finding: There is/are bolt cap covers missing or damaged on the item

Action: Replace missing or damaged bolt cap covers

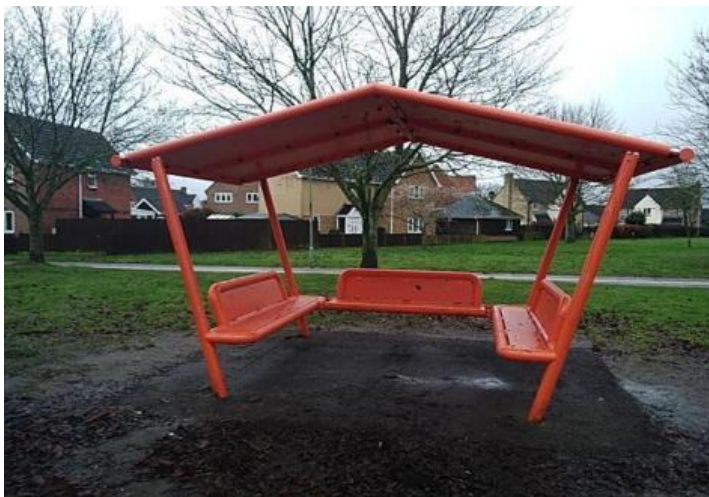
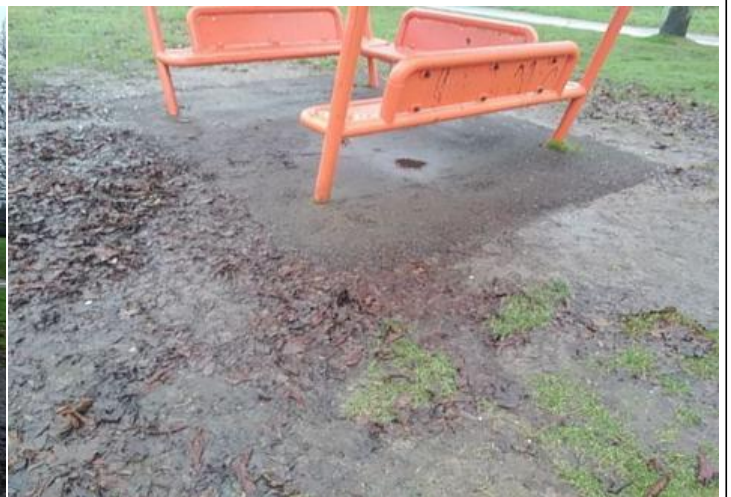
Item: Ancillary Items - Shelter
Manufacturer: Caloo

Finding: The area around the item has eroded and may become slippery

Action: Reinstate eroded area

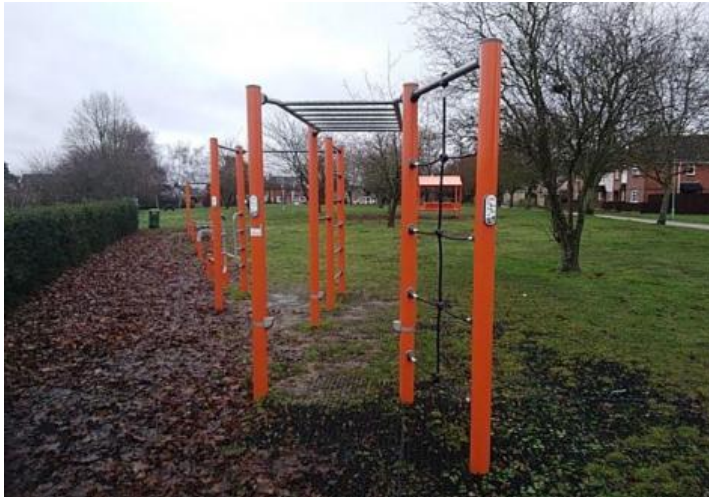
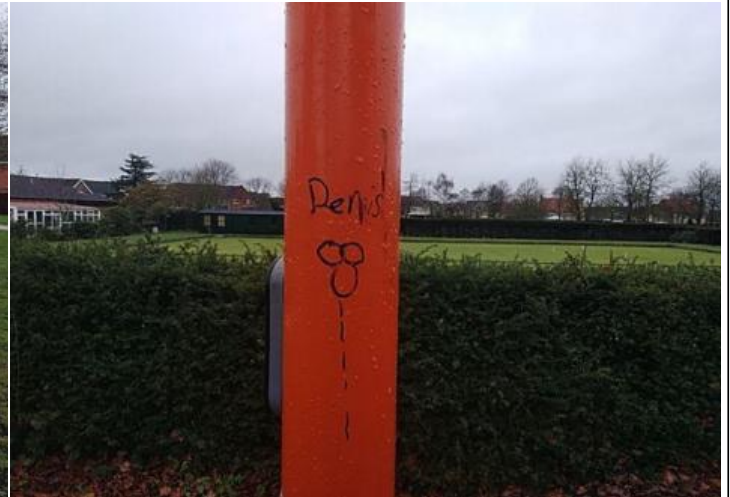
Item: Outdoor Fitness Equipment - Activity Station
Manufacturer: Kompan Ltd

Finding: There is offensive graffiti present

Action: Remove as soon as practicable
