## Annual Inspection

Mid Suffolk District Council

Thurston Playing Field

Inspection Ref: 1915608

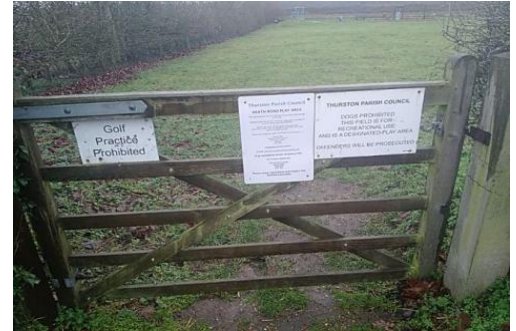
**Item:** Gate  
**Manufacturer:** Not Identified  
**Surface Type:** Grass  
**Item Quantity:** 1  
**Equipment Compliance:** N/A  
**Surface Area Compliance:** N/A

**Total Findings:** 2

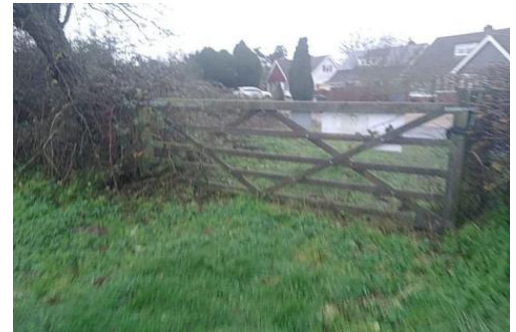
**Item:** Gate - Maintenance  
**Manufacturer:** Not Identified  
**Surface Type:** Grass  
**Item Quantity:** 1  
**Equipment Compliance:** N/A  
**Surface Area Compliance:** N/A

**Total Findings:** 1

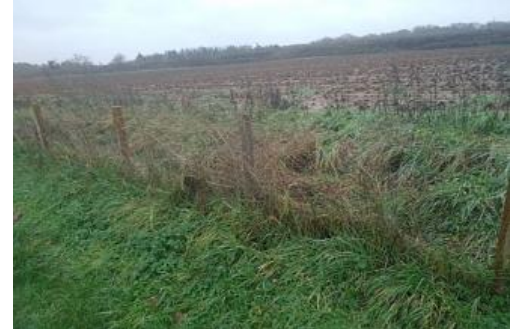
**Item:** Fence  
**Manufacturer:** Not Identified  
**Surface Type:** Grass  
**Item Quantity:** 1  
**Equipment Compliance:** N/A  
**Surface Area Compliance:** N/A

**Total Findings:** 1

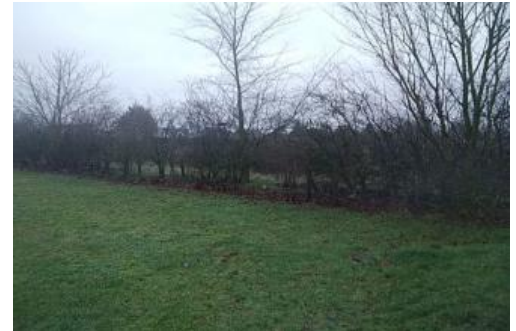
**Item:** Hedge  
**Manufacturer:** Natural Feature  
**Surface Type:** Grass  
**Item Quantity:** 1  
**Equipment Compliance:** N/A  
**Surface Area Compliance:** N/A

**Total Findings:** 1

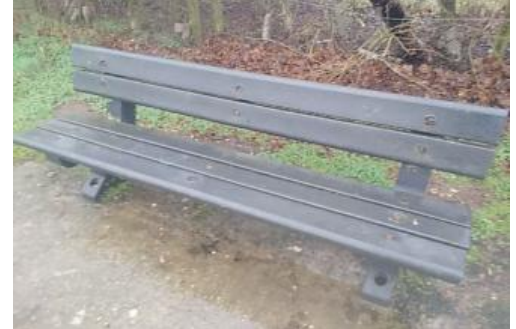
**Item:** Bench  
**Manufacturer:** Not Identified  
**Surface Type:** N/A  
**Item Quantity:** 1  
**Equipment Compliance:** N/A  
**Surface Area Compliance:** N/A

**Total Findings:** 1

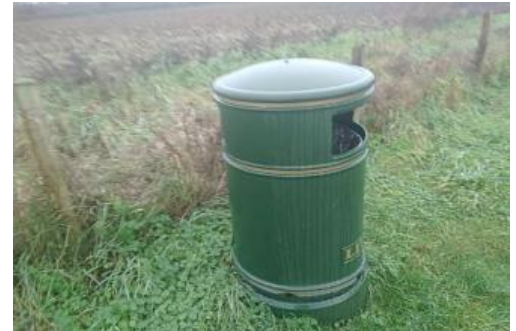
**Item:** Litter Bin  
**Manufacturer:** Not Identified  
**Surface Type:** Grass  
**Item Quantity:** 1  
**Equipment Compliance:** N/A  
**Surface Area Compliance:** N/A

**Total Findings:** 1

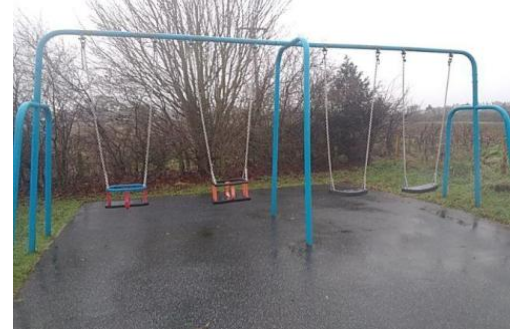
**Item:** 2 Bay (2 Flat, 2 Cradle)  
**Manufacturer:** Not Identified  
**Surface Type:** Wet Pour  
**Item Quantity:** 1  
**Equipment Compliance:** Yes  
**Surface Area Compliance:** No  
**Life Expectancy:** 5 -10 Years  
**Total Findings:** 5

**Finding 1**  
 The surfacing dimensions are short and do not meet with the requirements of the current applicable standard - Monitor - no remedial action recommended

**Finding 2**  
 There are gaps opening between the surfacing and the edging surround or between the joints in the surfacing - Monitor for any further deterioration and repair as required

**Finding 3**  
 The bushes are showing signs of wear - Monitor for any further deterioration and replace as required

**Finding 5**  
 The paintwork on this item has been damaged or worn exposing the metal underneath which is rusting - Treat any rusting components and repaint

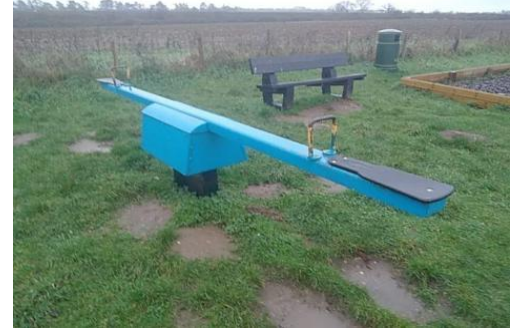
**Item:** See Saw  
**Manufacturer:** Wicksteed Playgrounds  
**Surface Type:** Grass  
**Item Quantity:** 1  
**Equipment Compliance:** No  
**Surface Area Compliance:** Yes  
**Life Expectancy:** 5 -10 Years  
**Total Findings:** 3

The area around the item has eroded and may become slippery - Reinstate eroded area

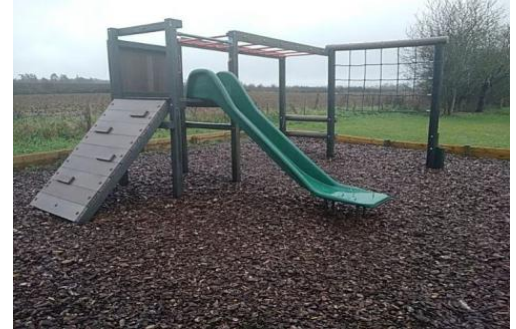
**Item:** Multi Play (Junior)  
**Manufacturer:** Not Identified  
**Surface Type:** Bark Mulch  
**Item Quantity:** 1  
**Equipment Compliance:** No  
**Surface Area Compliance:** No  
**Life Expectancy:** 5 -10 Years  
**Total Findings:** 9

There is weed / vegetation growth on, between, or around the edges of the surfacing - Remove weed / vegetation growth

The item is slightly loose in its foundations - Monitor for any further deterioration and repair as required

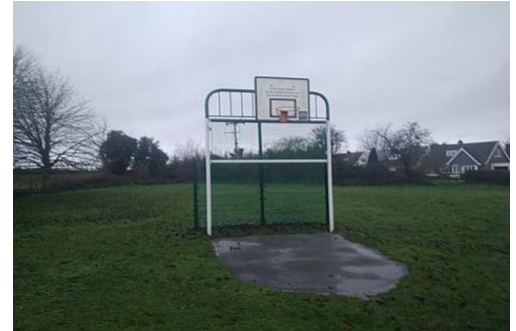
**Item:** Basket Ball Goal  
**Manufacturer:** Playquest  
**Surface Type:** Grass  
**Item Quantity:** 1  
**Equipment Compliance:** Yes  
**Surface Area Compliance:** N/A  
**Life Expectancy:** 5 -10 Years  
**Total Findings:** 4

A support brace has been removed/not fitted - The frame is stable. Monitor and replace the brace if required
