Annual Inspection

Mid Suffolk District Council

Thurston Recreation Ground

Church Road, Thurston, Suffolk, IP31 3RP

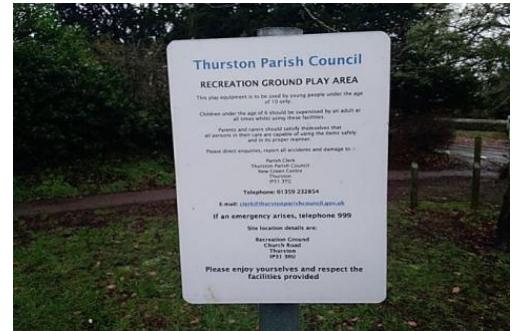
Item: Sign
Manufacturer: Owner/Operator
Surface Type: N/A
Item Quantity: 1
Equipment Compliance: N/A
Surface Area Compliance: N/A

There are post / end caps missing from the item - Replace missing post caps

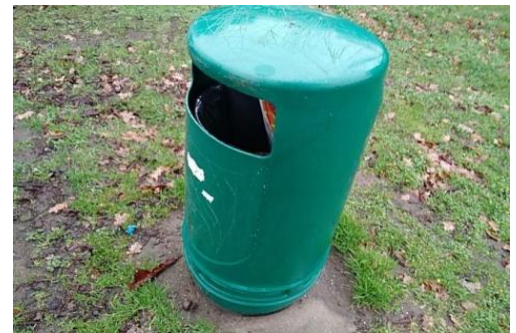
Item: Litter Bin
Manufacturer: Not Identified
Surface Type: Grass
Item Quantity: 1
Equipment Compliance: N/A
Surface Area Compliance: N/A

There is some damage/ vandalism to the bin - Monitor for any further deterioration and repair as required

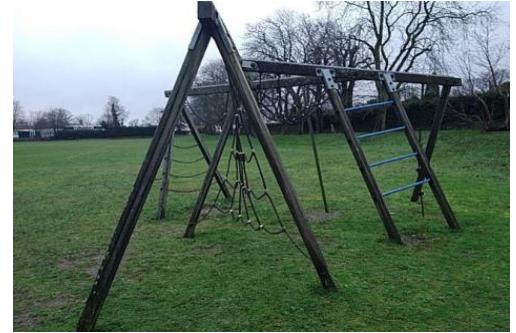
Item: Climbing Frame
Manufacturer: Kompan Ltd
Surface Type: Grass Matrix Tiles
Item Quantity: 1
Equipment Compliance: Yes
Surface Area Compliance: Yes
Life Expectancy: 5 -10 Years
Total Findings: 1

There is some strimmer / machinery damage apparent on the posts, this can penetrate the preservative applied to the timber and accelerate the rotting process - Monitor for any deterioration (rot) and replace as required

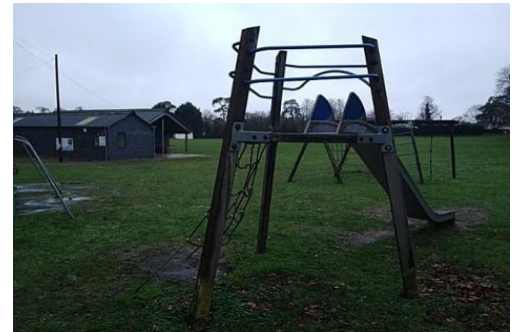
Item: Multi Play (Junior)
Manufacturer: Kompan Ltd
Surface Type: Grass Matrix Tiles
Item Quantity: 1
Equipment Compliance: No
Surface Area Compliance: Yes
Life Expectancy: 5 -10 Years
Total Findings: 4

There are a number of dents in the slide surface - Monitor for any further deterioration and repair as required

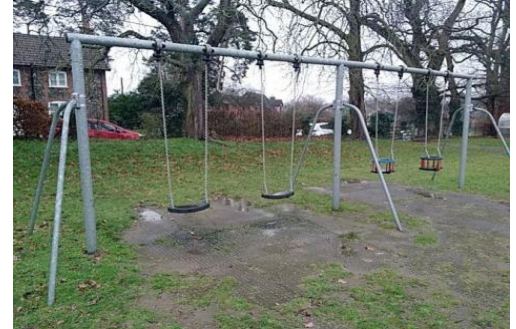
Item: 2 Bay (2 Flat, 2 Cradle)
Manufacturer: Kompan Ltd
Surface Type: Grass Matrix Tiles
Item Quantity: 1
Equipment Compliance: No
Surface Area Compliance: Yes
Life Expectancy: 5 -10 Years
Total Findings: 5

There is moderate damage to the surface - Repair the damaged areas of surfacing
