Operational Inspection

Thurston Parish Council

New Green Centre
New Green Ave, Thurston, IP31 3TG

Inspection Ref: 2245029

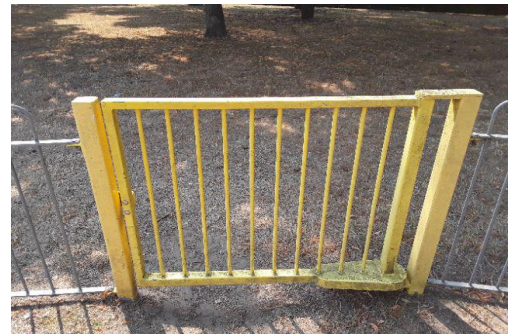
Item: Gate - Self Closing
Manufacturer: I.A.E. Fencing
Surface Type: Grass
Item Quantity: 1
Equipment Compliance: N/A
Surface Area Compliance: N/A

The area around the item has eroded and may become slippery - Reinstate eroded area

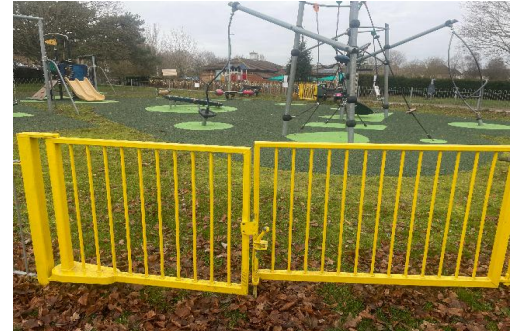
Item: Gate - Combination
Manufacturer: I.A.E. Fencing
Surface Type: Grass
Item Quantity: 1
Equipment Compliance: N/A
Surface Area Compliance: N/A

There is no padlock on the maintenance gate - Provide a padlock to secure the gate

The paintwork on this item has been damaged or worn exposing the metal underneath which is rusting - Treat any rusting components and repaint

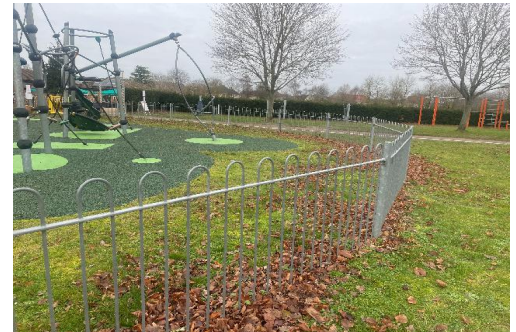
Item: Fence - Bow Top
Manufacturer: I.A.E. Fencing
Surface Type: Grass
Item Quantity: 1
Equipment Compliance: N/A
Surface Area Compliance: N/A

The paintwork on this item has been damaged or worn exposing the metal underneath which is rusting - Treat any rusting components and repaint

There is or are fixings missing on the item - Replace 2 missing fixings

There are 4 loose posts around the fence - Monitor for any further deterioration and reset as required

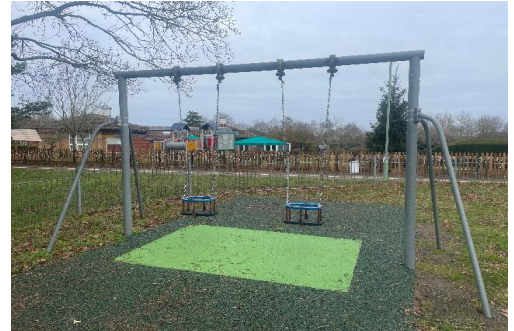
Item: 1 Bay 2 Seat (Cradle)
Manufacturer: Kompan Ltd
Surface Type: Grass Matrix Tiles
Item Quantity: 1
Equipment Compliance: N/A
Surface Area Compliance: N/A

There is algae or moss on the surface of the equipment - Clean and treat appropriately

There is some tree debris on the surfacing - Remove and maintain

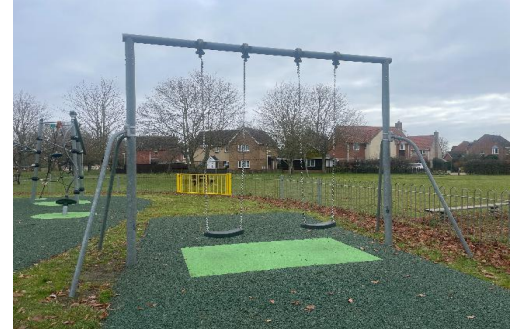
Item: 1 Bay 2 Seat (Flat)
Manufacturer: Kompan Ltd
Surface Type: Grass Matrix Tiles
Item Quantity: 1
Equipment Compliance: N/A
Surface Area Compliance: N/A

There is some notable evidence of chain wear - Monitor for any further deterioration and replace when 40% worn

The seat has minor damage or wear - Monitor for any further deterioration and replace as required

There is algae or moss on the surface of the equipment - Clean and treat appropriately

There is/are bolt cap covers missing or damaged on the item - Replace missing or damaged bolt cap covers

Seat is low - Adjust

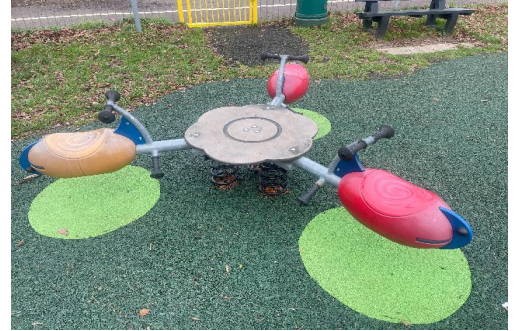
Item: Three Way Springer
Manufacturer: Kompan Ltd
Surface Type: Grass Matrix Tiles
Item Quantity: 1
Equipment Compliance: N/A
Surface Area Compliance: N/A

There is or are fixings missing on the item - Replace all missing fixings

The paintwork on the spring has been damaged or worn exposing the metal underneath which is rusting - Treat any rusting components and repaint

There is some evidence of fire damage to the item - Monitor for any further deterioration and repair as required

A number of Inaccessible fixing(s) have worked loose - Secure all loose fixings

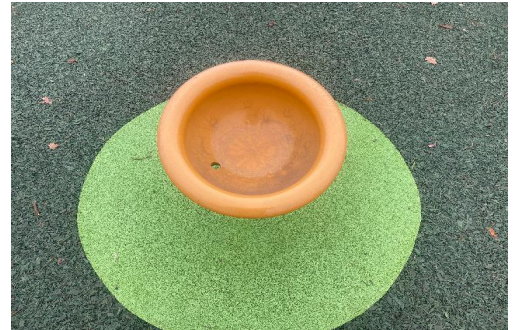
Item: Spinner Bowl
Manufacturer: Kompan Ltd
Surface Type: Grass Matrix Tiles
Item Quantity: 1
Equipment Compliance: N/A
Surface Area Compliance: N/A

There is some graffiti present - Remove the graffiti

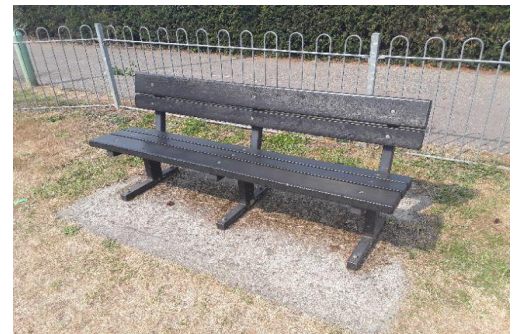
Item: Bench
Manufacturer: Unknown
Surface Type: Concrete
Item Quantity: 2
Equipment Compliance: N/A
Surface Area Compliance: N/A

The paintwork on this item has been damaged or worn exposing the metal underneath which is rusting - Treat any rusting components and repaint

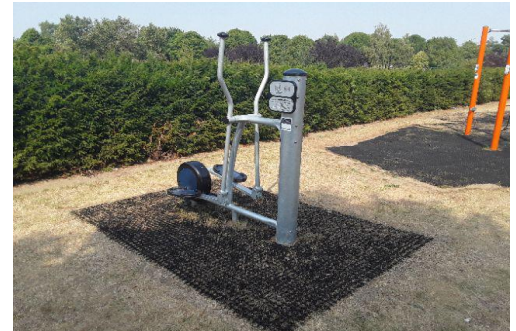
Item: Cross Trainer
Manufacturer: Kompan Ltd
Surface Type: Grass Matrix Tiles
Item Quantity: 1
Equipment Compliance: N/A
Surface Area Compliance: N/A

Slight rubbing on plastic cover - Monitor

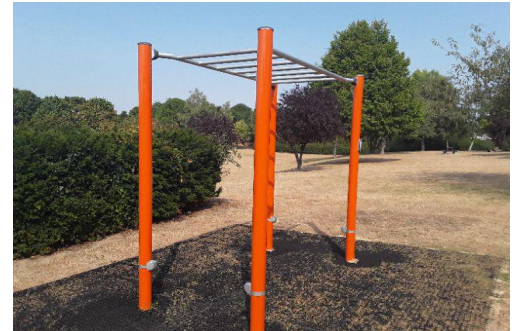
Item: Overhead Bars
Manufacturer: Kompan Ltd
Surface Type: Grass Matrix Tiles
Item Quantity: 1
Equipment Compliance: N/A
Surface Area Compliance: N/A

The surfacing around the item is damaged - Repair the damaged areas of surfacing

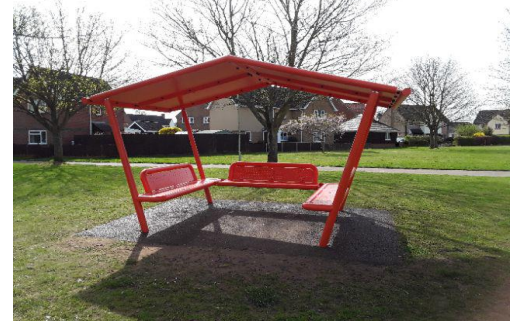
Item: Shelter
Manufacturer: Caloo
Surface Type: Wet Pour
Item Quantity: 1
Equipment Compliance: N/A
Surface Area Compliance: N/A

There is/are bolt cap covers missing or damaged on the item - Replace 9 missing or damaged bolt cap covers

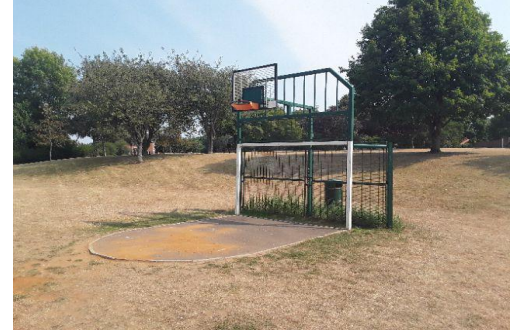
Item: Goal End
Manufacturer: Unknown
Surface Type: Tarmac
Item Quantity: 1
Equipment Compliance: N/A
Surface Area Compliance: N/A

There are trip hazards at the edges of the surface - Reinstate surrounding surface levels to remove the trip points

There is surface corrosion present on the item - Consider treating and repainting the item

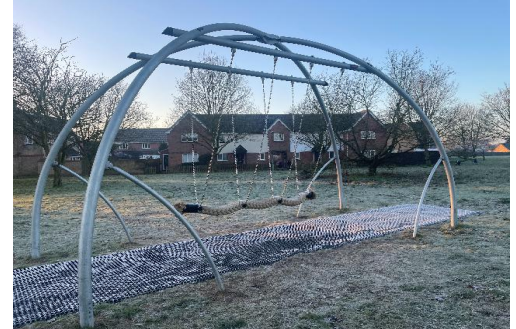
Item: Giant Rope Swing
Manufacturer: Kompan Ltd
Surface Type: Grass Matrix Tiles
Item Quantity: 1
Equipment Compliance: N/A
Surface Area Compliance: N/A

The surfacing around the item is damaged - Repair the damaged areas of surfacing

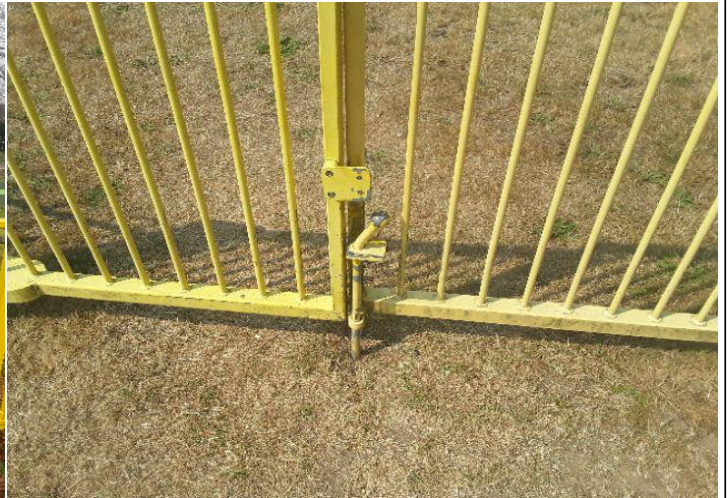
Item: Gates - Gate - Combination
Manufacturer: I.A.E. Fencing

Finding: There is no padlock on the maintenance gate

Action: Provide a padlock to secure the gate

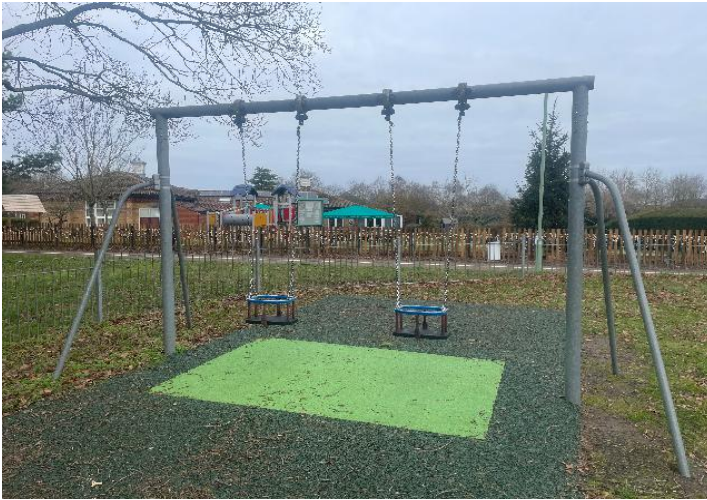
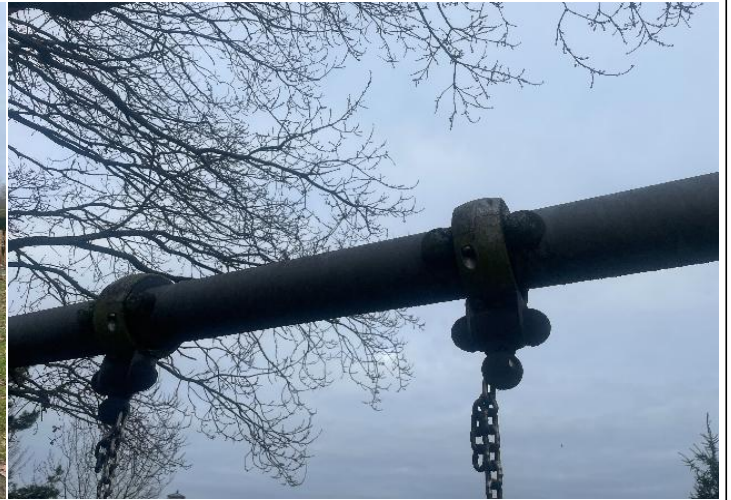
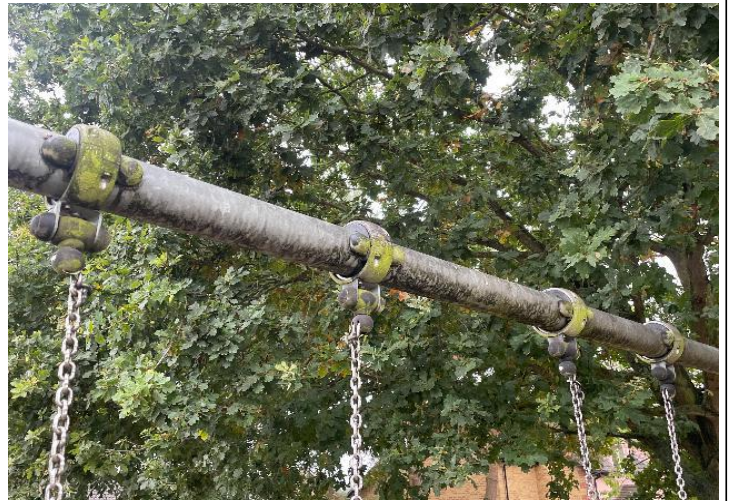
Item: Swings - 1 Bay 2 Seat (Cradle)
Manufacturer: Kompan Ltd

Finding: There is algae or moss on the surface of the equipment

Action: Clean and treat appropriately

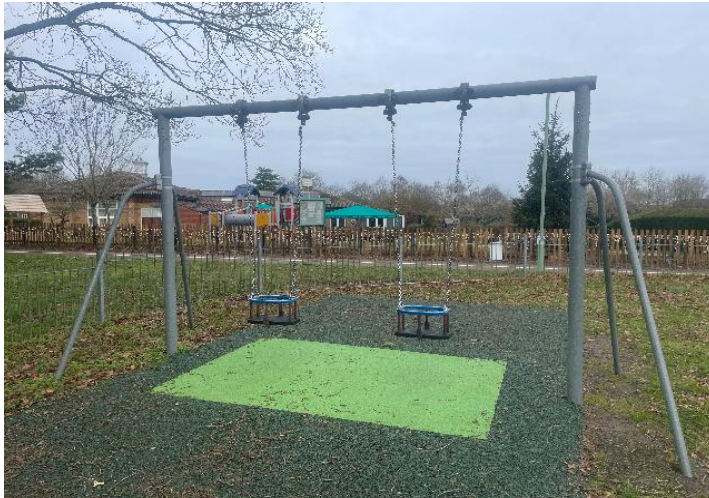
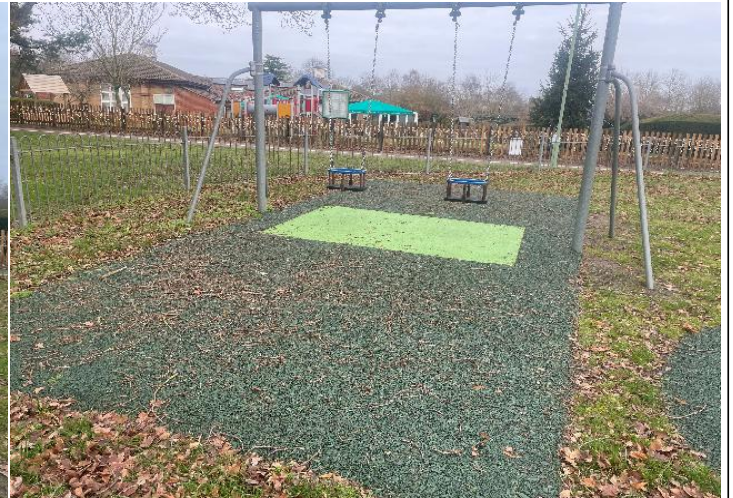
Finding: There is some tree debris on the surfacing

Action: Remove and maintain

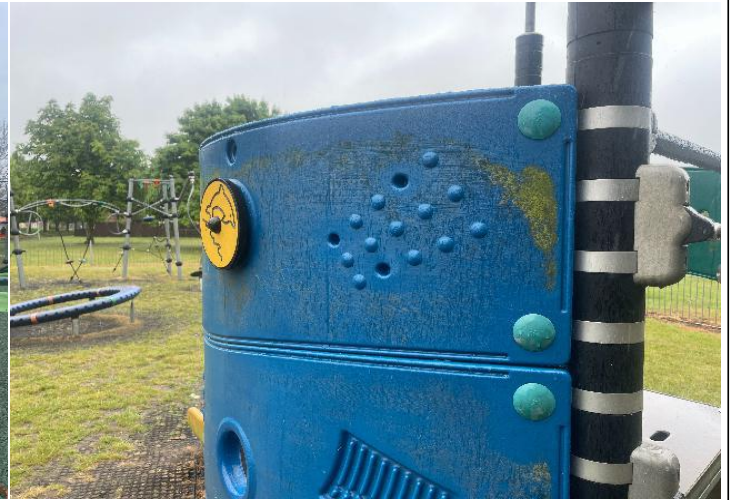
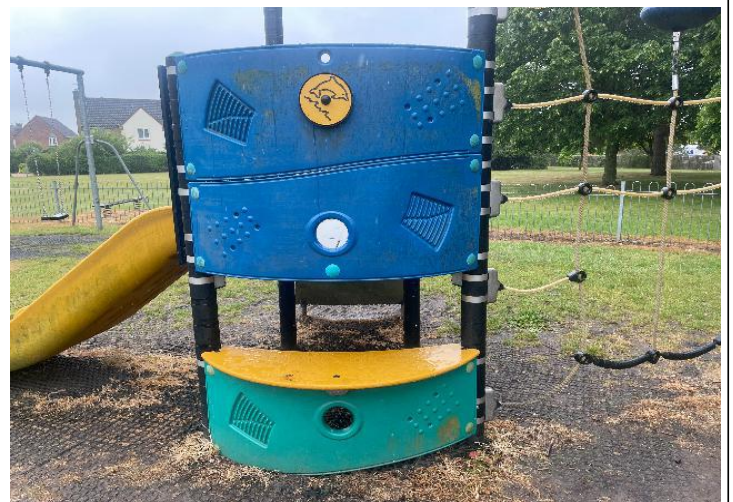
Finding: There is algae or moss on the surface of the equipment

Action: Clean and treat appropriately

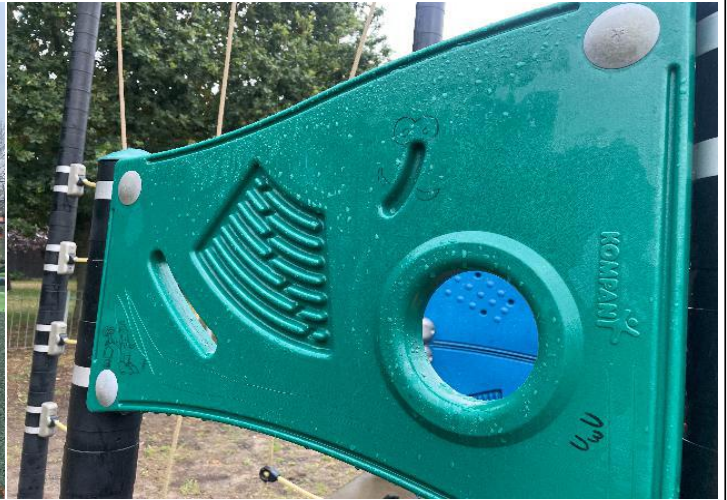
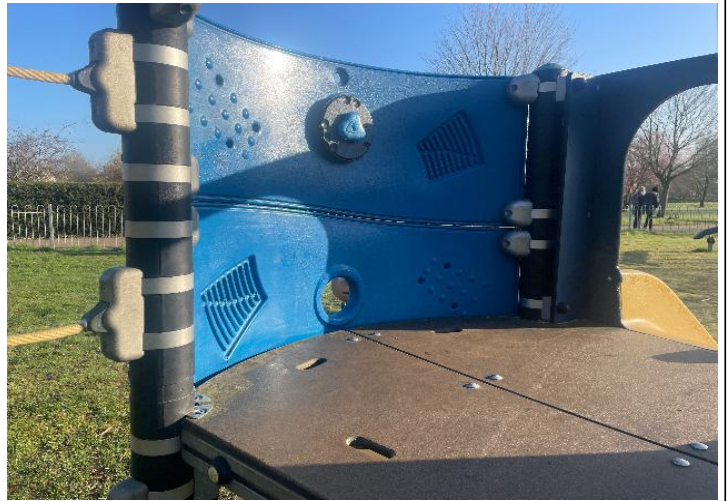
Finding: There is some graffiti present

Action: Remove the graffiti

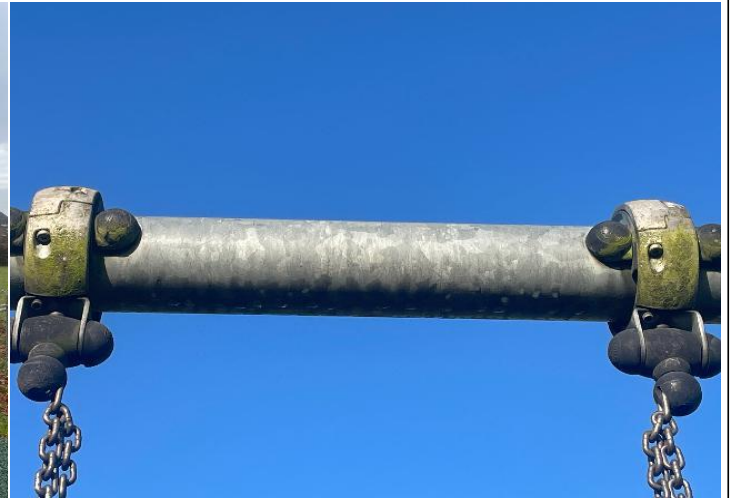
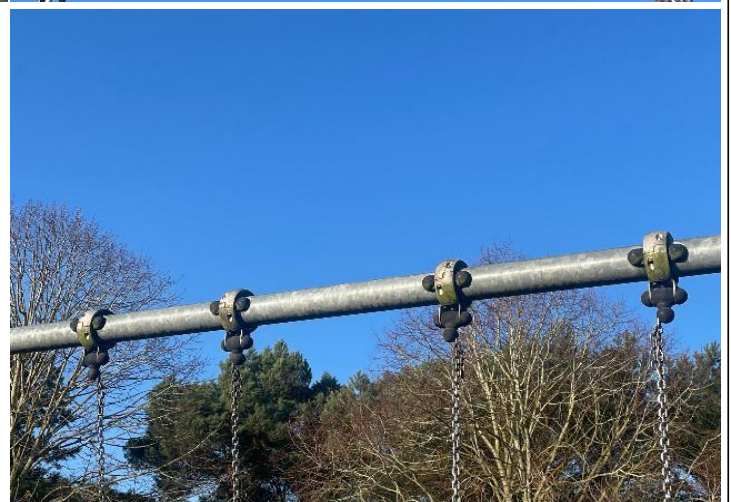
Finding: There is algae or moss on the surface of the equipment

Action: Clean and treat appropriately

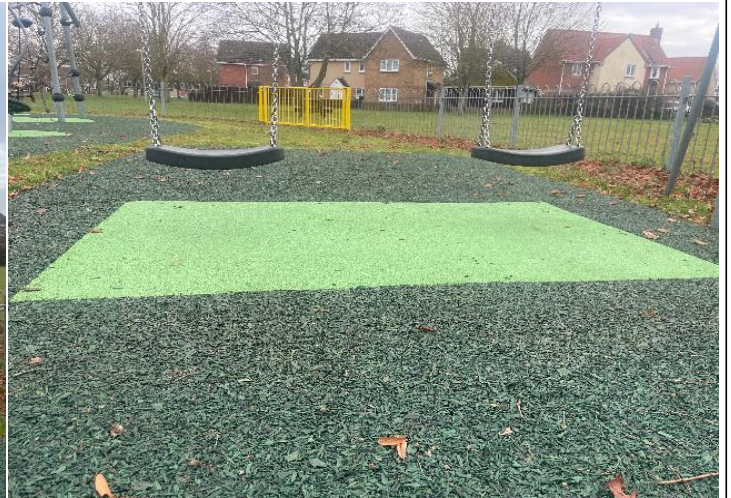
Finding: Seat is low

Action: Adjust

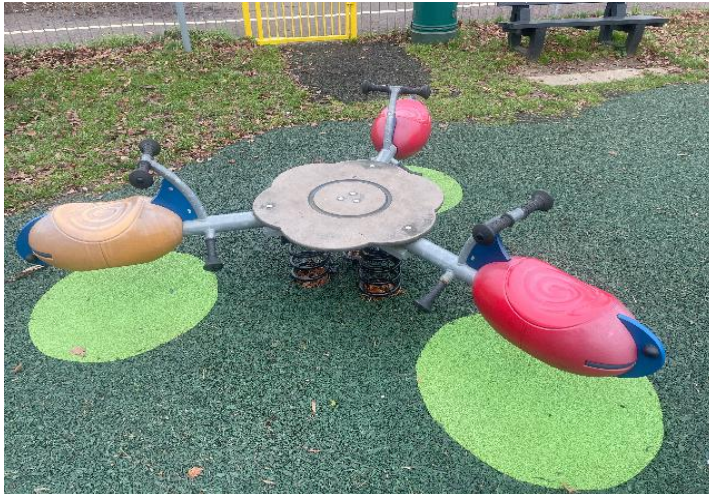
Finding: The paintwork on the spring has been damaged or worn exposing the metal underneath which is rusting

Action: Treat any rusting components and repaint

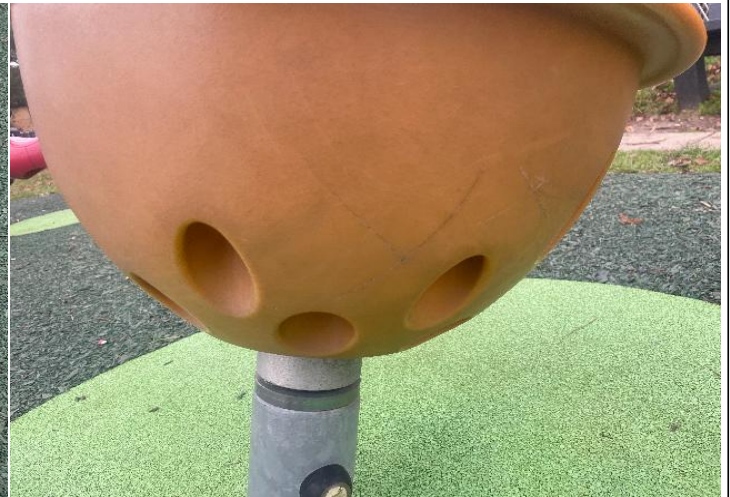
Finding: There is some graffiti present

Action: Remove the graffiti

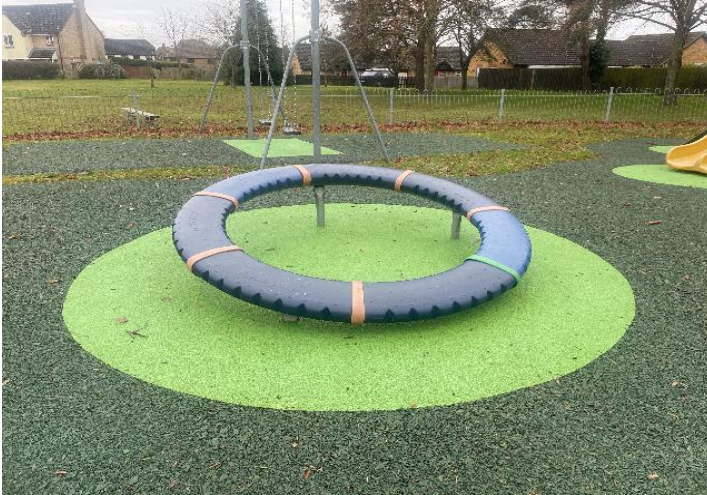
Finding: Some segments have minor damage

Action: Monitor

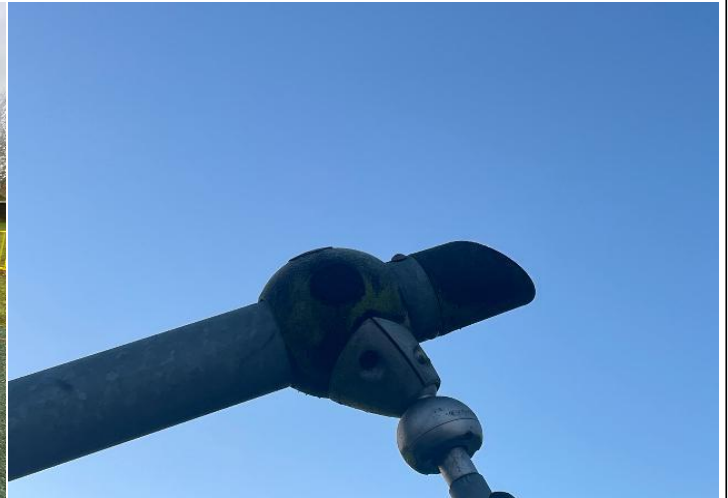
Finding: There is algae or moss on the surface of the equipment

Action: Clean and treat appropriately

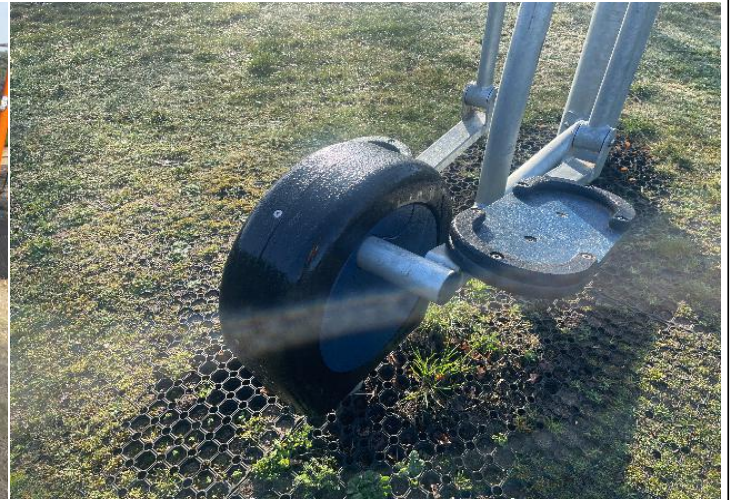
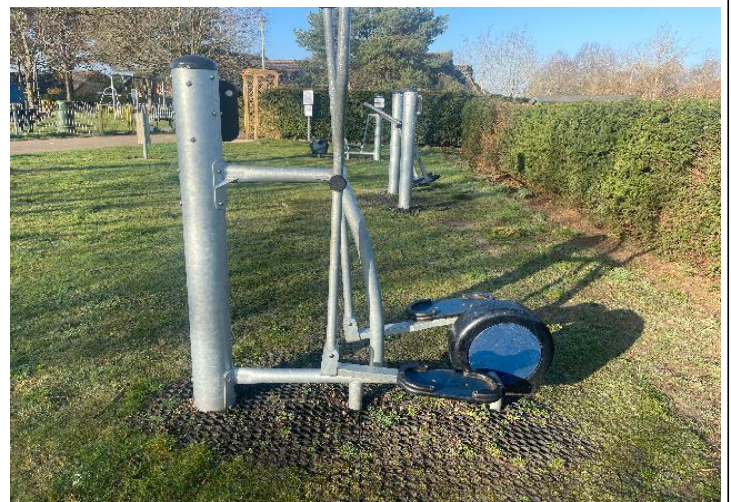
Finding: Slight rubbing on plastic cover

Action: Monitor

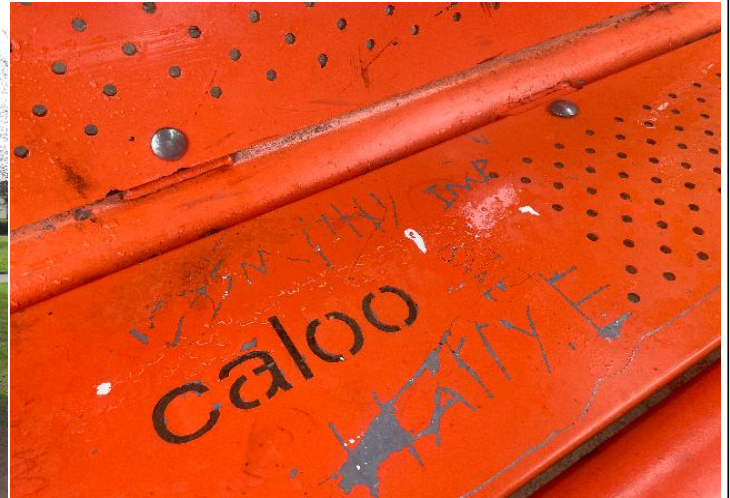
Finding: There is some graffiti present

Action: Remove the graffiti

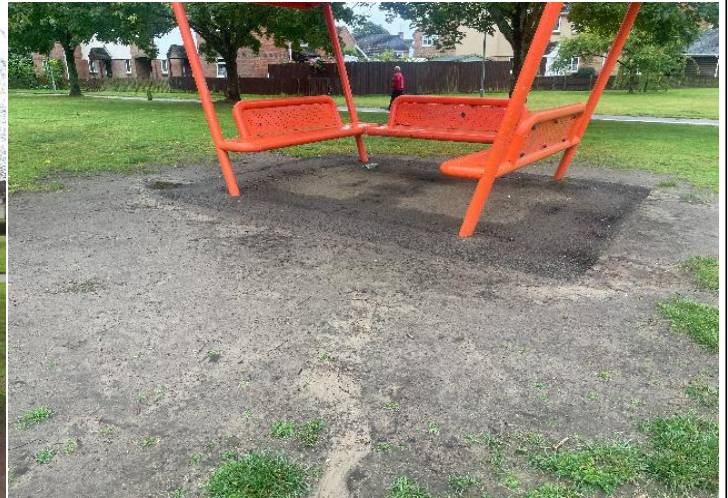
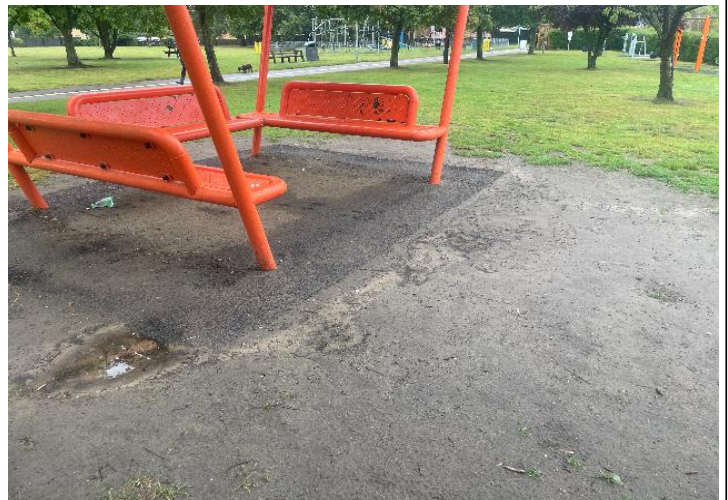
Finding: The surface has eroded in some areas

Action: Reinststate the surface

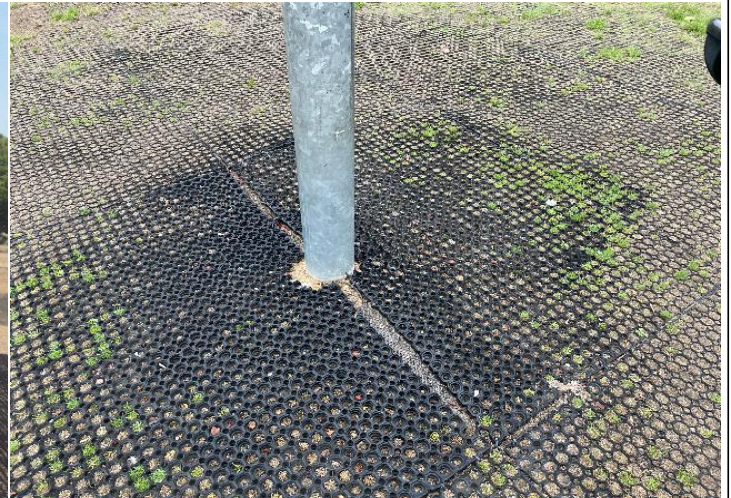
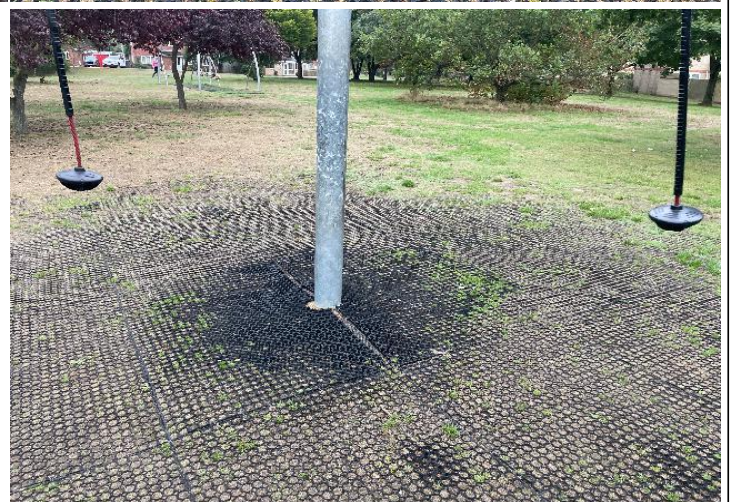
Finding: There are gaps opening between the grass mat tiles

Action: Reinstate surface

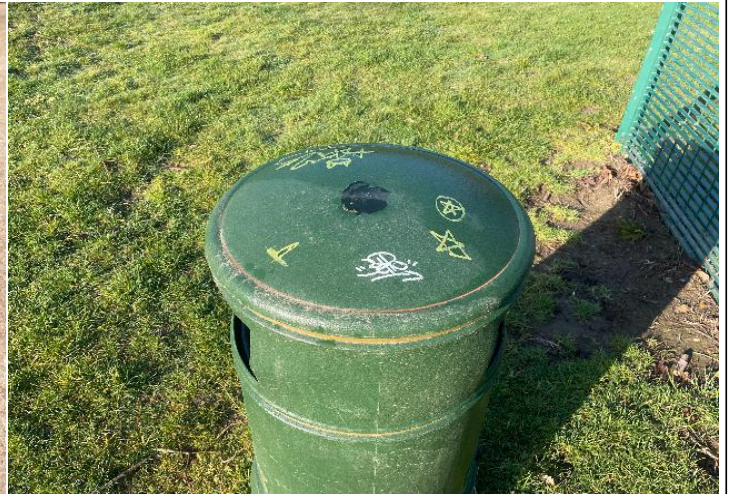
Finding: There is some graffiti present

Action: Remove the graffiti

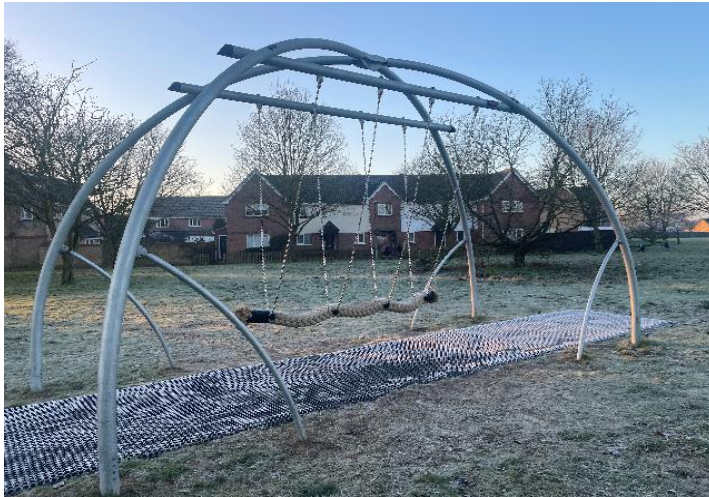
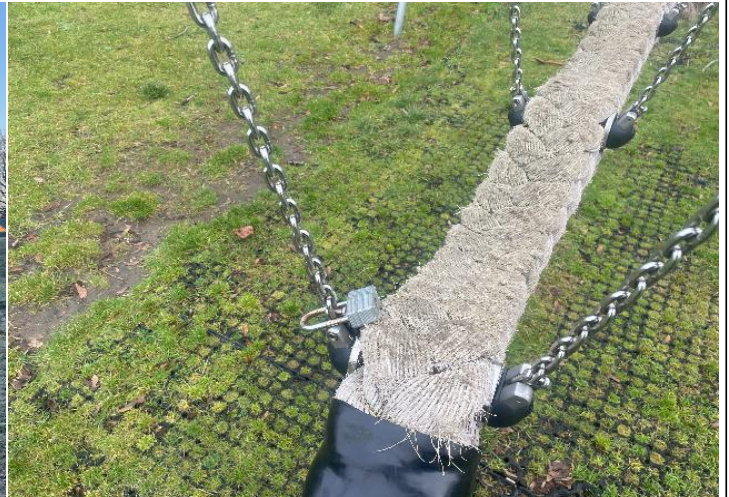
Finding: Padlock attached to chains

Action: Remove

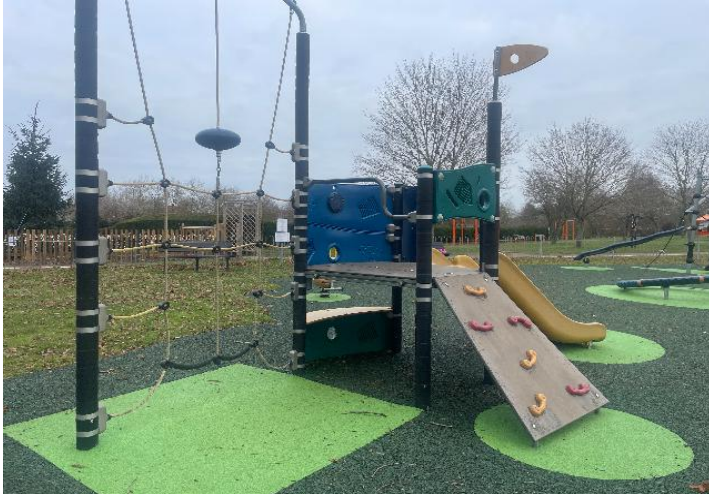
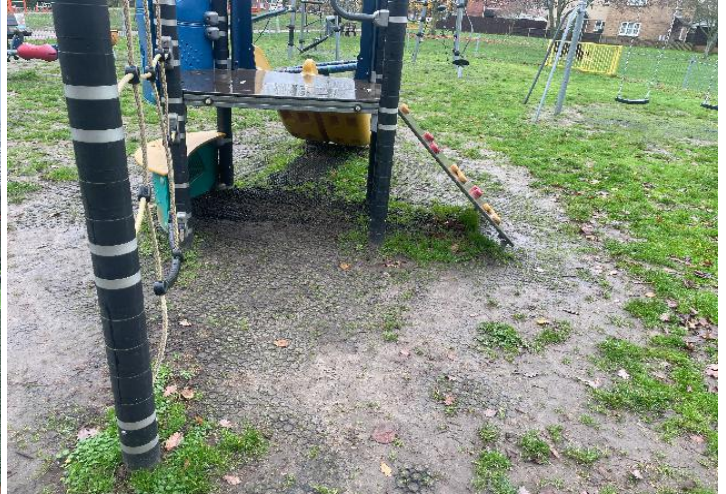
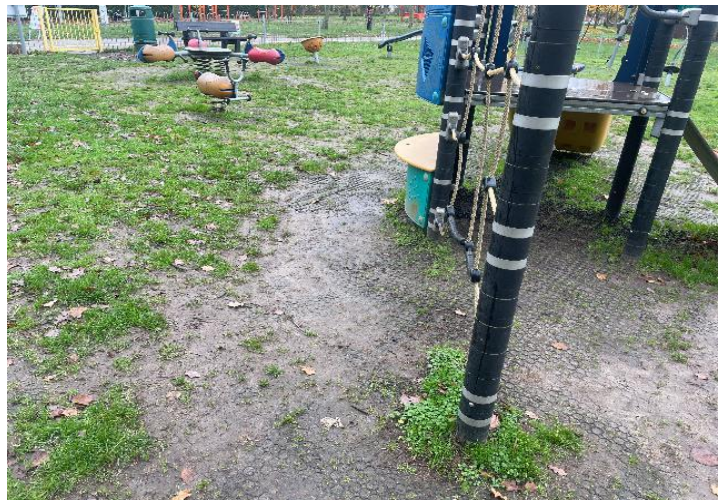
Finding: The grass mats are silted up, the soil is compacted and the area will become very slippery when the soil is wet. **Action:** Reinstate as required

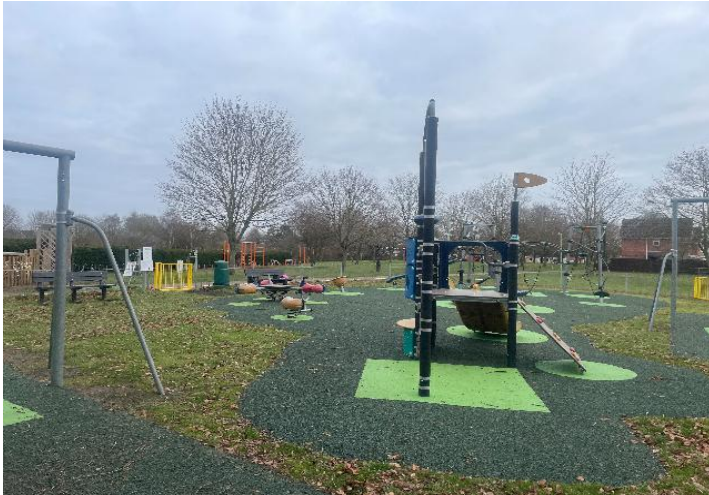
Finding: The grass mats are silted up and the soil is compacted; this may have an effect on the impact absorbing properties of the surface

Action: Consider HIC testing impact absorbing properties to ensure the correct surface qualities are maintained for the equipment and replace as required

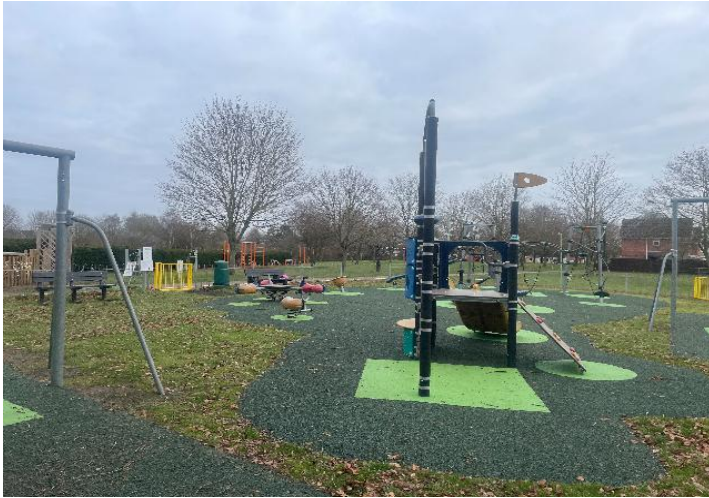
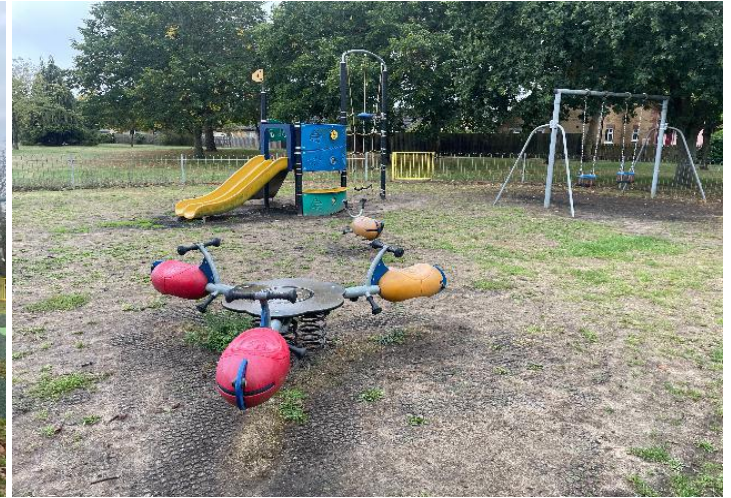
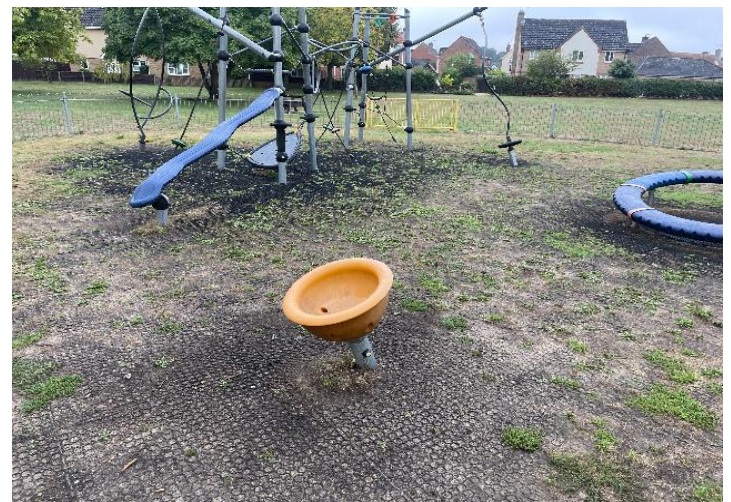
Finding: The grass mats are silted up, the soil is compacted and the area will become very slippery when the soil is wet. **Action:** Reinstate as required

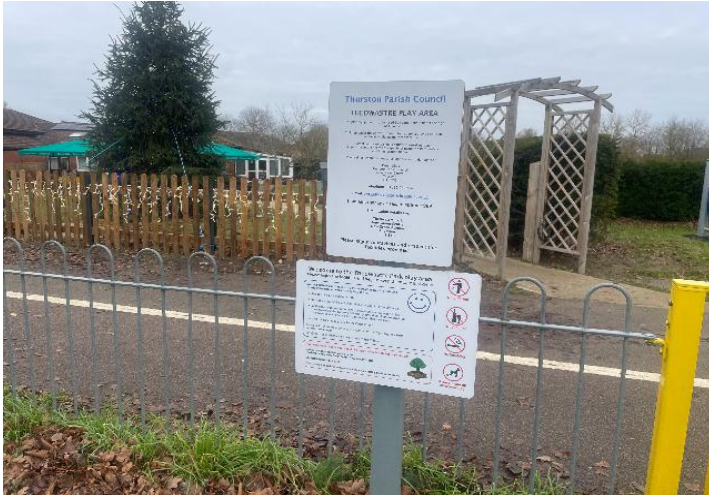
Finding: The paintwork on this item has been damaged or worn exposing the metal underneath which is rusting

Action: Treat any rusting components and repaint
