Operational Inspection

Thurston Parish Council

Thurst Coffee Shop Playground

Inspection Ref: 2245030

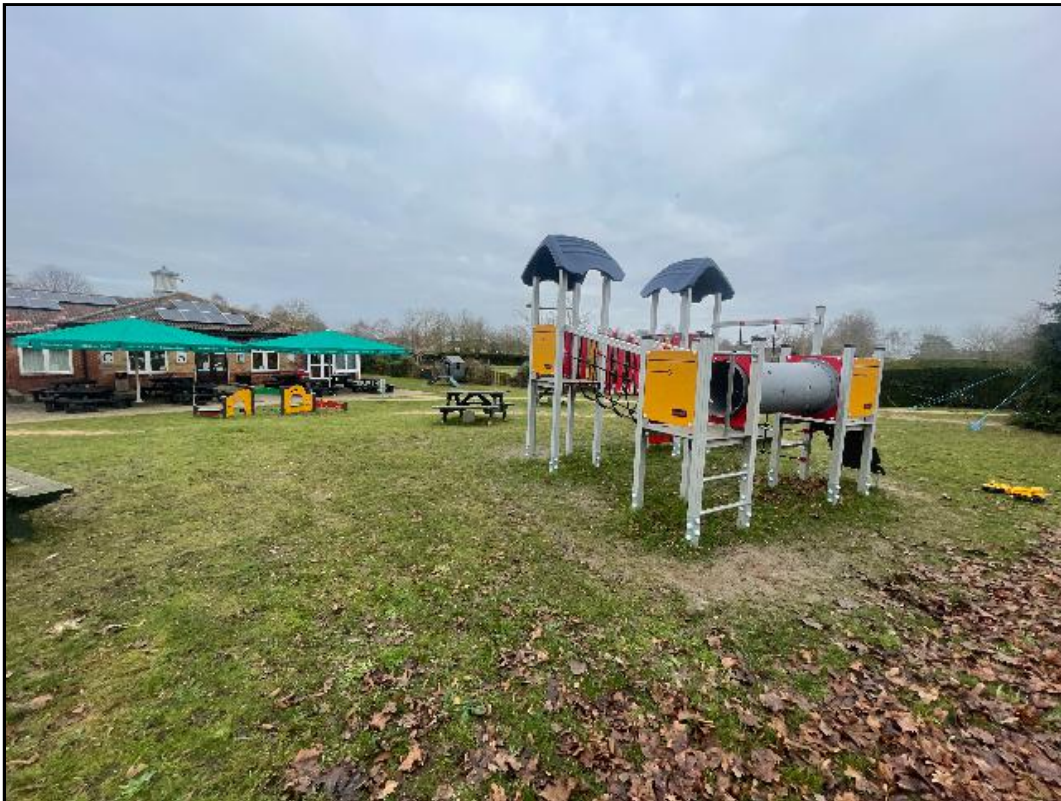
i 5 - Very Low Risk

Item: Multi Play (Junior)
Manufacturer: Kompan Ltd
Surface Type: Grass Matrix Tiles
Item Quantity: 1
Equipment Compliance: N/A
Surface Area Compliance: N/A

Total Findings: 1
