Annual Inspection

Mid Suffolk District Council

Thurston - Thedwastre Park

Inspection Ref: 2273556

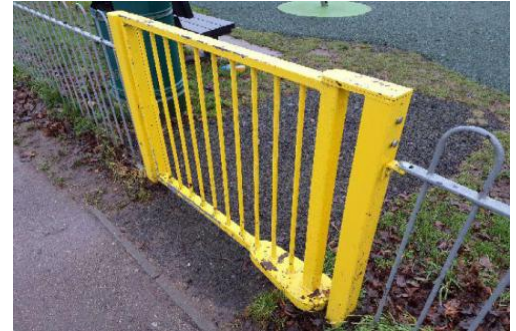
The surface has eroded in some areas and may be slippery in wet conditions - Reinstate the surface

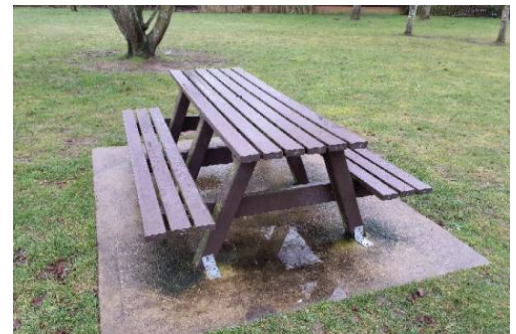
There are trip hazards at the edges of the surface - Reinstate surrounding surface levels to remove the trip points

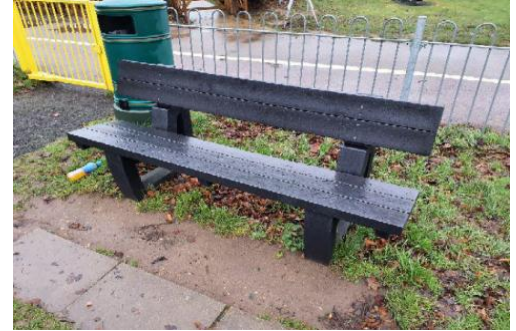
The surface has eroded in some areas and may be slippery in wet conditions - Reinstate the surface

There are trip hazards at the edges of the surface - Reinstate surrounding surface levels to remove the trip points

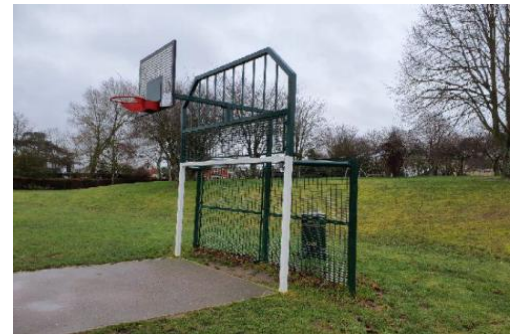
There are trip hazards at the edges of the surface - Reinstate surrounding surface levels to remove the trip points

The weld(s) on this item have failed - Repair item

The surface has eroded in some areas and may be slippery in wet conditions - Reinstate the surface

There is/are inserts missing - Replace missing inserts

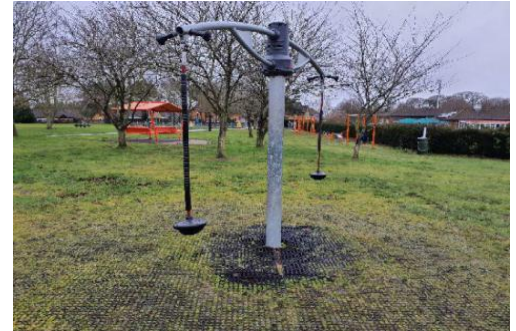
There are gaps opening between the grass mat tiles - Provide additional ties or secure / reinstate surface

The seat connection cannot be inspected without dismantling the seat - Dismantle the seat to inspect the seat connection for wear

There is moderate damage to the surface - Repair the damaged areas of surfacing

There are post / end caps missing from the item - Replace missing post caps

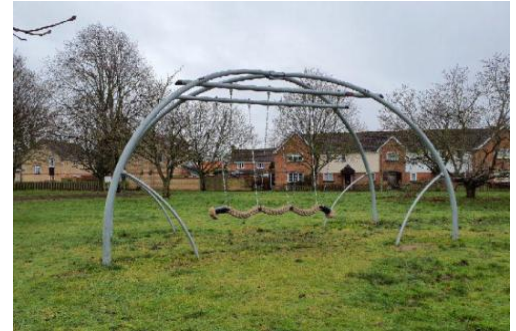
The fixings or components for this item were in excess of 2.5m above the standing surface and could not be fully accessed by the inspector. We have completed a visual inspection of the fixings from ground level but a maintenance inspection should be undertaken to assess the condition, security and wear of the components at intervals in accordance with the manufacturers recommendations. - Inspect in accordance with the manufacturers recommendations

The surface has eroded in some areas and may be slippery in wet conditions - Reinstate the surface

The seat has minor damage or wear - Monitor for any further deterioration and replace as required

There is some notable evidence of chain wear - Monitor for any further deterioration and replace when 40% worn

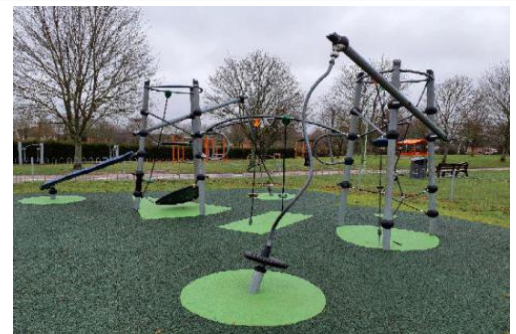
There is/are bolt cap covers missing or damaged on the item - Replace missing or damaged bolt cap covers

There is some notable evidence of chain wear - Monitor for any further deterioration and replace when 40% worn

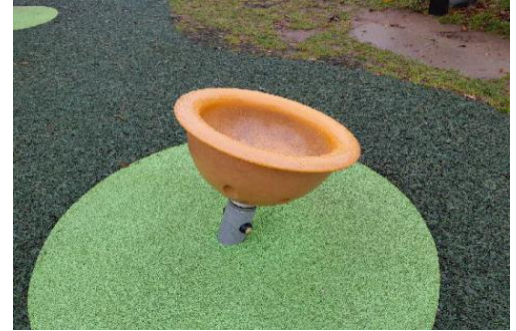
There is some damage to the item - Monitor for any further deterioration and repair as required

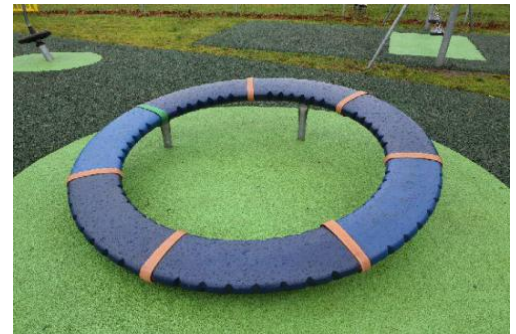
There is some damage to the item - Monitor for any further deterioration and repair as required

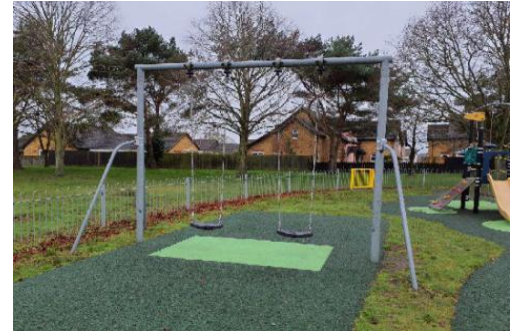
The fixings or components for this item were in excess of 2.5m above the standing surface and could not be fully accessed by the inspector. We have completed a visual inspection of the fixings from ground level but a maintenance inspection should be undertaken to assess the condition, security and wear of the components at intervals in accordance with the manufacturers recommendations. - Inspect in accordance with the manufacturers recommendations

The seat clearance from finished surface level to the underside of the seat is too low and does not meet the requirements of BS EN 1176 Part 2 (350mm minimum clearance required) - Adjust seat height/s (400mm-500mm is recommended)

The chain openings are in excess of 8.6mm and do not meet the recommendations of BS EN 1176 Part 1 - Monitor - No remedial work recommended

The connecting links are in excess of 8.6mm and less than 12mm and fail the requirements of BS EN 1176 Part 1; clause 4.2.13, Chains - Monitor use and replace with compliant links at the next maintenance cycle

The seat has minor damage or wear - Monitor for any further deterioration and replace as required

There is some notable evidence of chain wear - Monitor for any further deterioration and replace when 40% worn

There are post / end caps missing from the item - Replace missing post caps

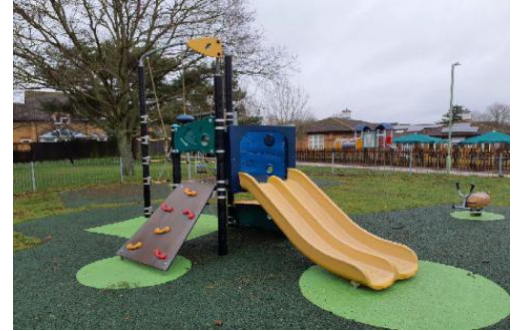
The chain openings are in excess of 8.6mm and do not meet the recommendations of BS EN 1176 Part 1 - Monitor - No remedial work recommended

There is/are finger entrapment/s in the barrier and the item fails to meet the requirements of BS EN 1176 Part 1 4.2.7.6 Entrapment of fingers - Monitor - No remedial work recommended

There is some damage to the item - Monitor for any further deterioration and repair as required

A number of fixing(s) have worked loose - Secure all loose fixings

There is/are inserts missing - Replace missing inserts

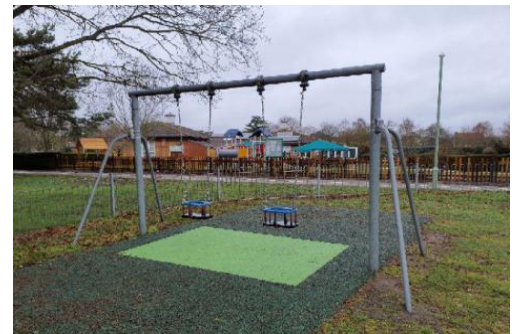
The chain openings are in excess of 8.6mm and do not meet the recommendations of BS EN 1176 Part 1 - Monitor - No remedial work recommended

There is some notable evidence of chain wear - Monitor for any further deterioration and replace when 40% worn

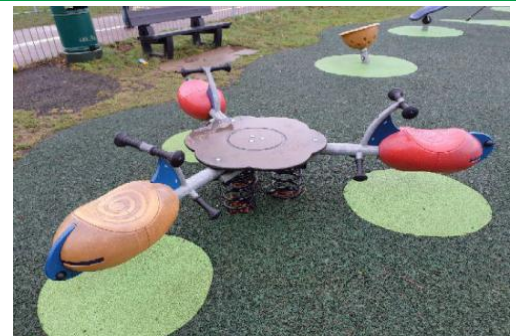
The spring clamps are loose - Tighten all loose fixings

A number of fixing(s) have worked loose - Secure all loose fixings

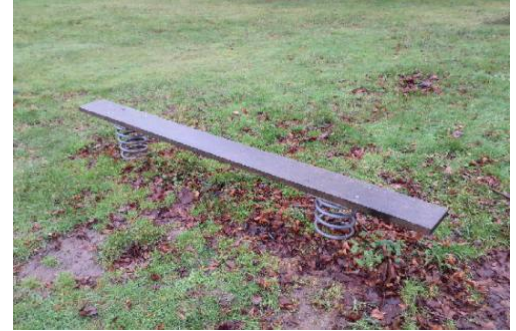
The fence forms a hard object within the falling space of the equipment and there is also insufficient surfacing provided in contravention of BS EN 1176 Part 1 - Consider re locating the item away from the fence (1.5m)

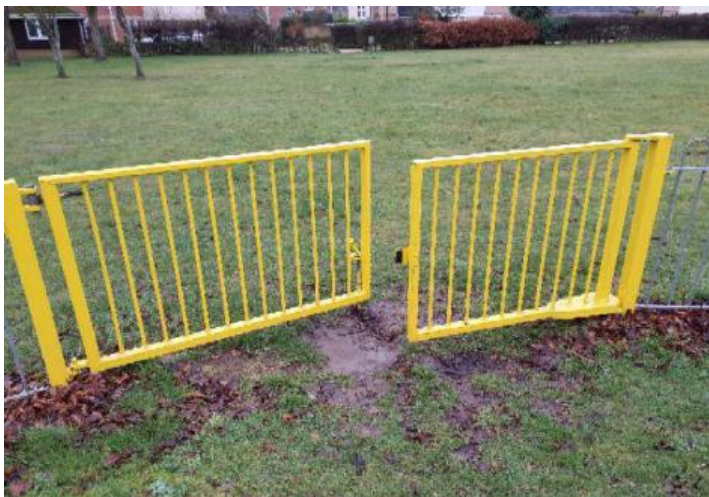
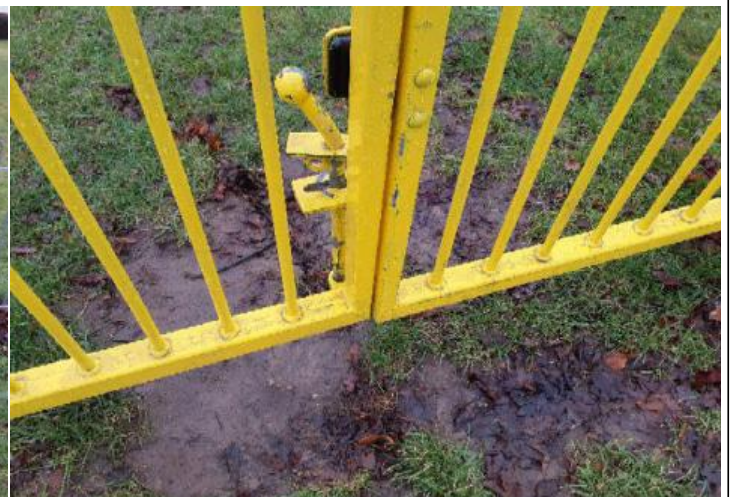
Finding: The gate has no drop bolt sleeves and/or drop bolts fitted
Action: Provide drop bolt sleeves and/or drop bolts

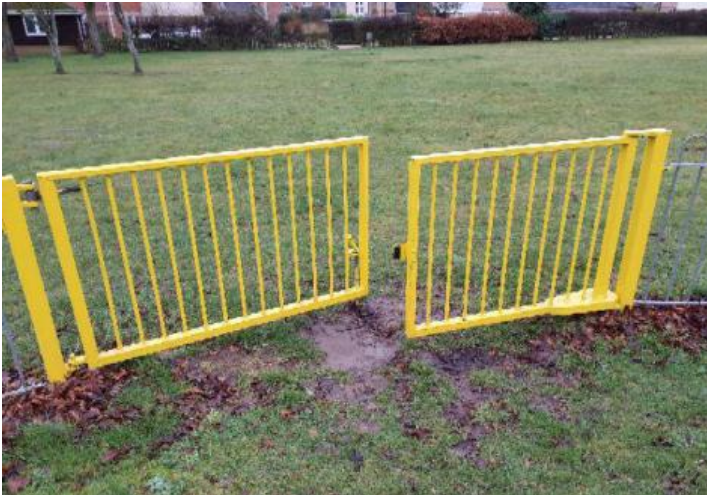
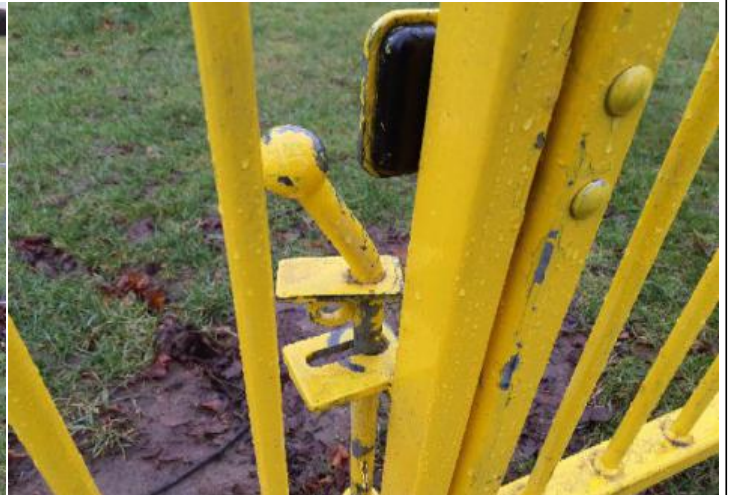
Finding: There is no padlock on the maintenance gate

Action: Provide a padlock to secure the gate

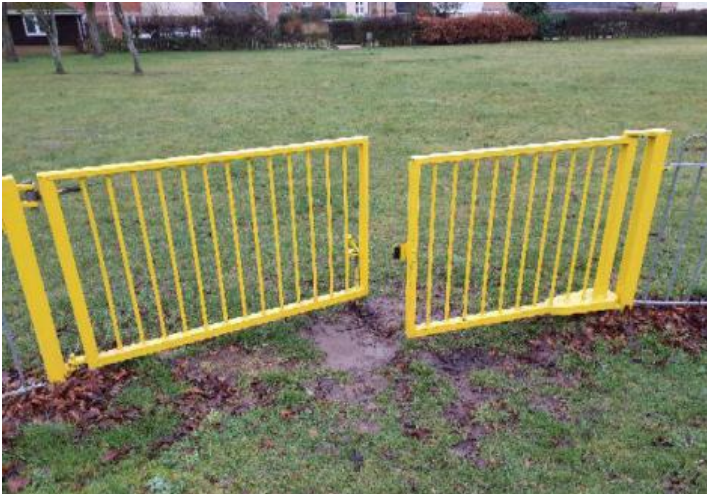
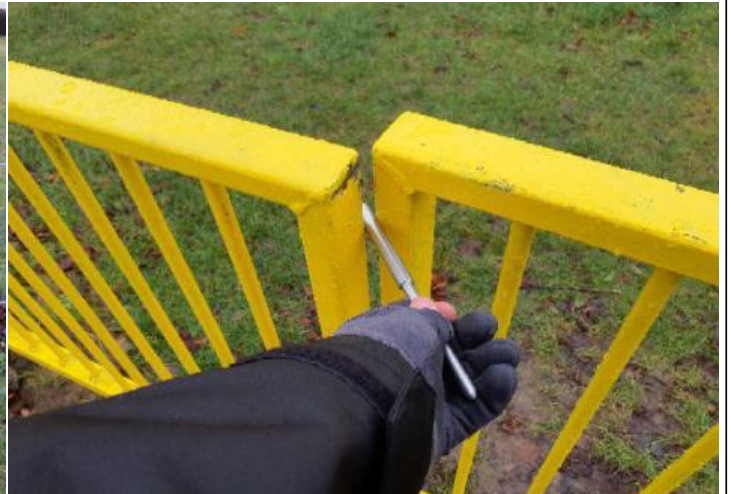
Finding: There are openings that are less than 12mm that could trap or crush fingers

Action: Provide a 12mm gap throughout full range of motion at both sides of gate

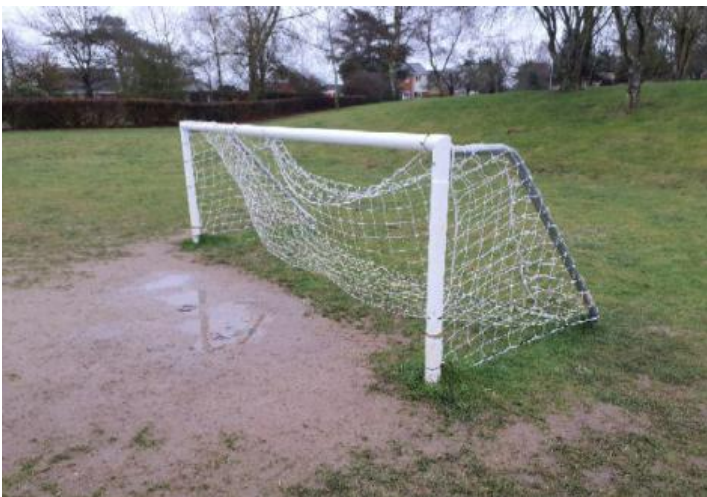
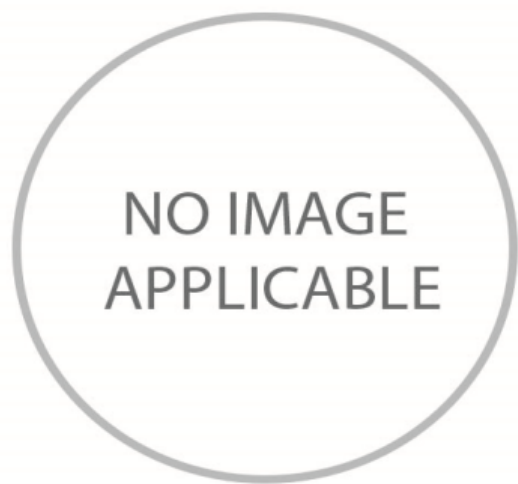
Finding: NB: We have undertaken a maintenance inspection only of the football goal(s); full load testing falls outside the scope of our inspection.
Action: Implement load testing as required

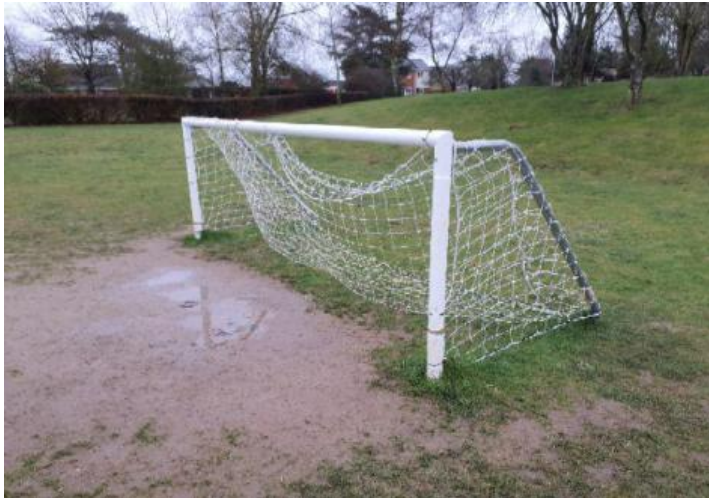
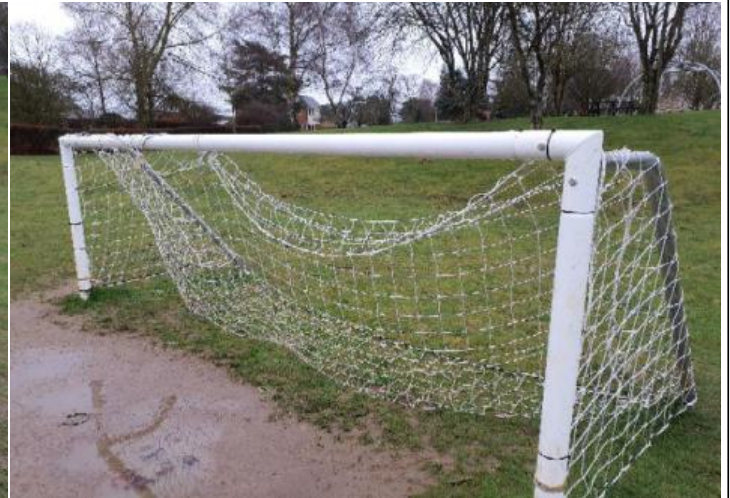
Finding: The net isn't fully secured

Action: Secure net

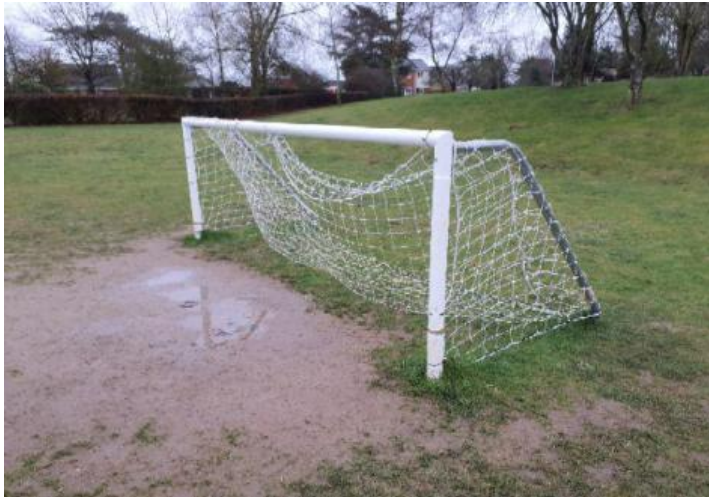
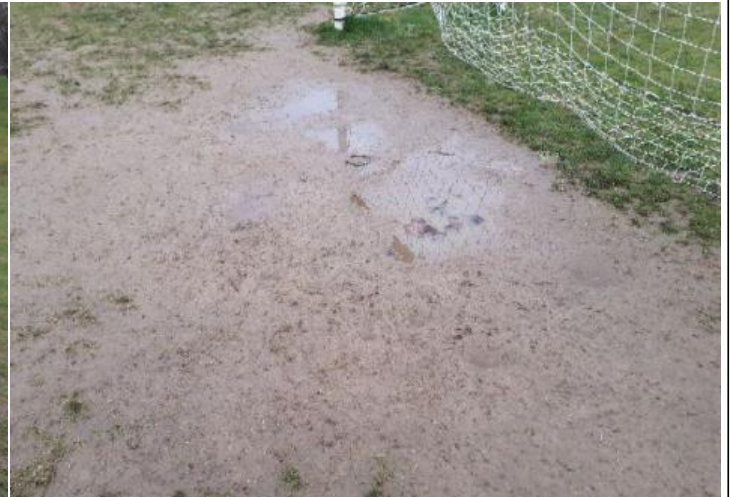
Finding: The grass mats are silted up, the soil is compacted and the area will become very slippery when the soil is wet.

Action: Reinstate as required

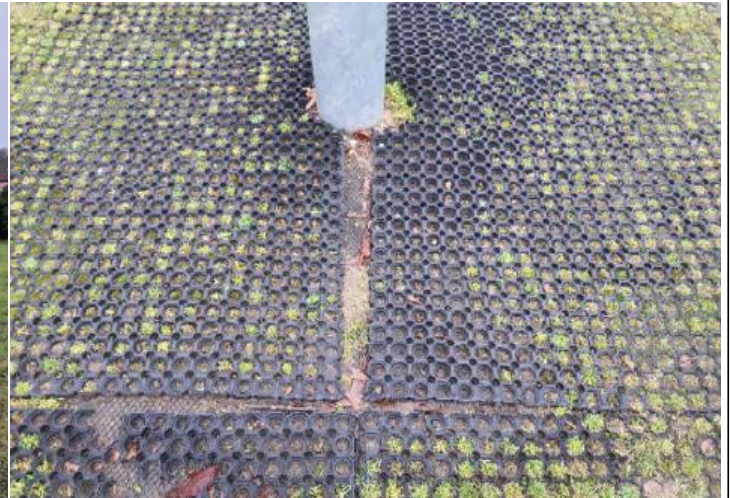
Finding: There are gaps opening between the grass mat tiles

Action: Provide additional ties or secure / reinstate surface tiles

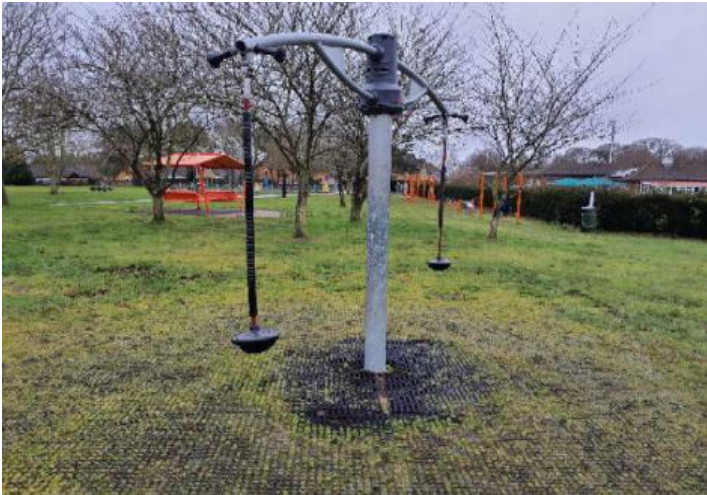
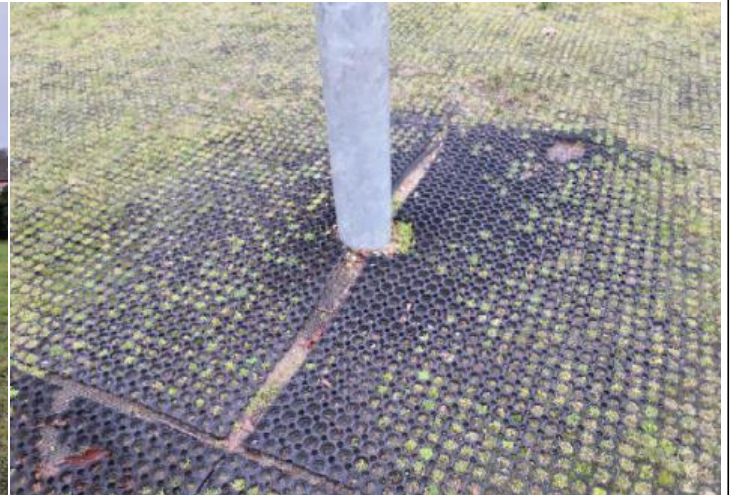
Finding: There is a lack of growth within the grass area

Action: Encourage growth with grass seeds

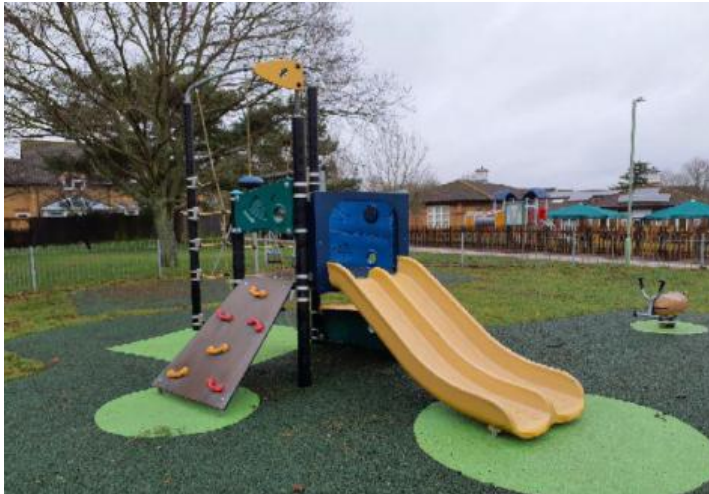
Finding: The chain openings are in excess of 8.6mm and do not meet the recommendations of BS EN 1176 Part 1

Action: Monitor - No remedial work recommended

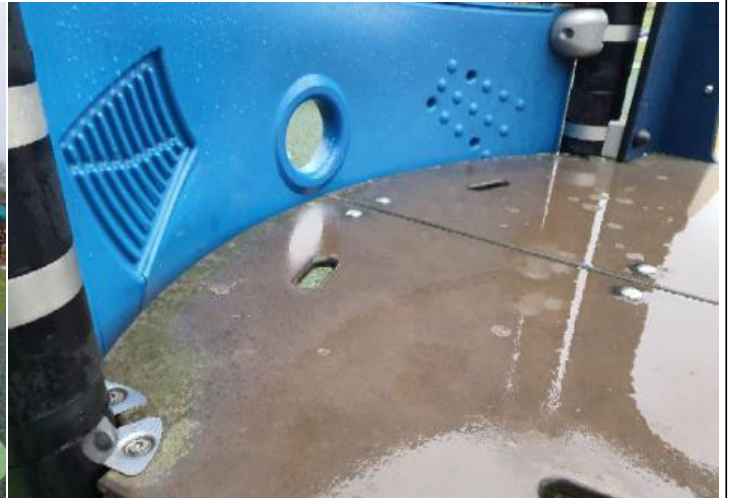
Finding: There is algae or moss on the surface of the equipment

Action: Clean and treat appropriately

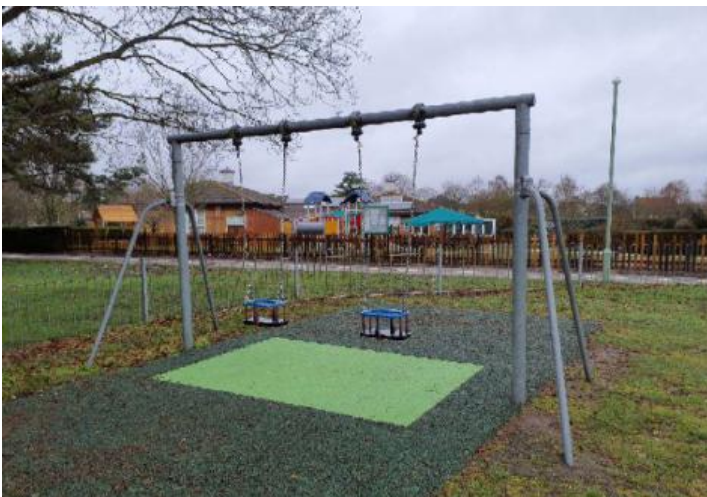
Item: Swings - 1 Bay 2 Seat (Cradle)
Manufacturer: Kompan Ltd

Risk Level: V - Very Low Risk
Surface: Bonded Rubber Mulch

Finding: The chain openings are in excess of 8.6mm and do not meet the recommendations of BS EN 1176 Part 1

Action: Monitor - No remedial work recommended

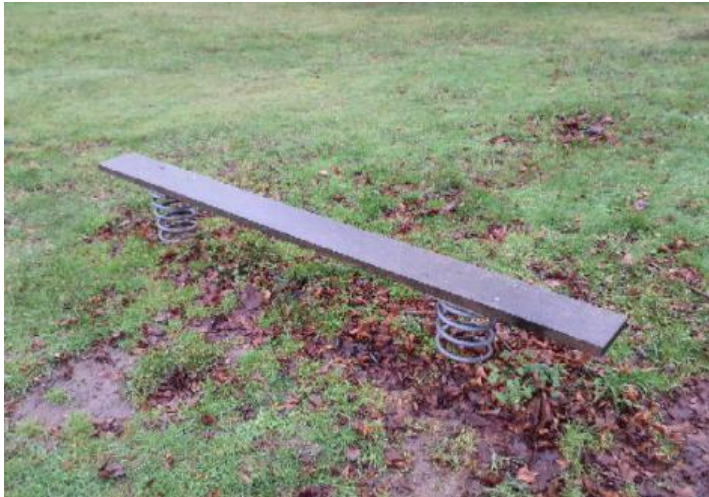
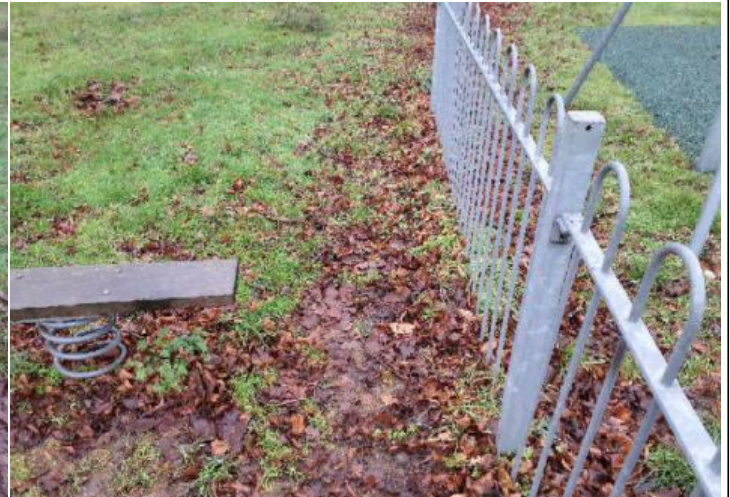
Item: Rocking Equipment - Wobble Board
Manufacturer: Not Identified

Risk Level: V - Very Low Risk
Surface: Grass

Finding: The fence forms a hard object within the falling space of the equipment and there is also insufficient surfacing provided in contravention of BS EN 1176 Part 1

Action: Consider re locating the item away from the fence (1.5m)
