Annual Inspection

Mid Suffolk District Council

Thurston Playing Field

Heath Road, Thurston, Suffolk, IP31 3PJ

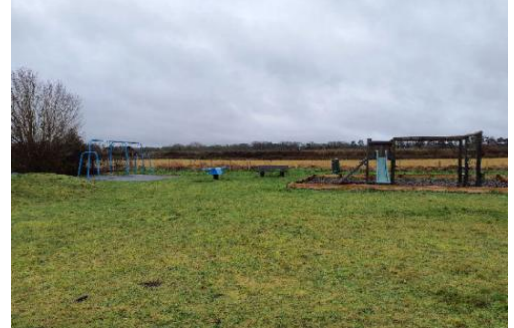
There are a number of molehills within the area and these may present unforeseen hazards for users - Remove moles by appropriate means, reinstate surfaces to level and maintain the area

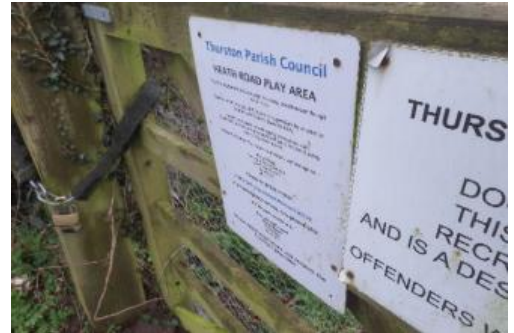
This item is satisfactory - no work required -

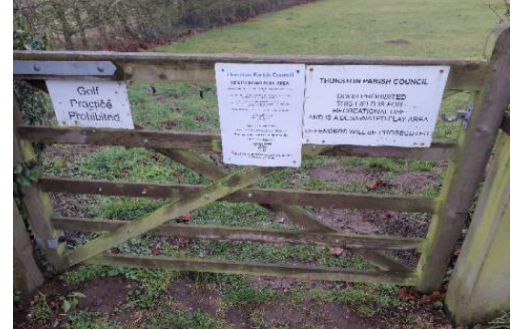
The surface has eroded in some areas and may be slippery in wet conditions - Reinstate the surface

i 4 - Very Low Risk

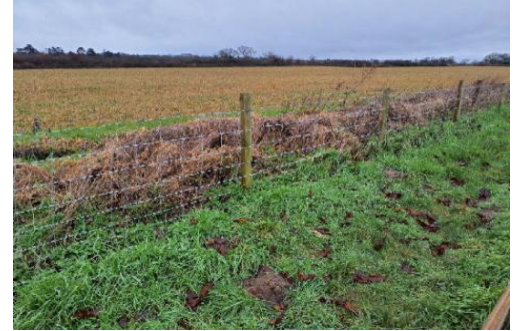
The fence is damaged in places - Repair or replace all affected sections

i 4 - Very Low Risk

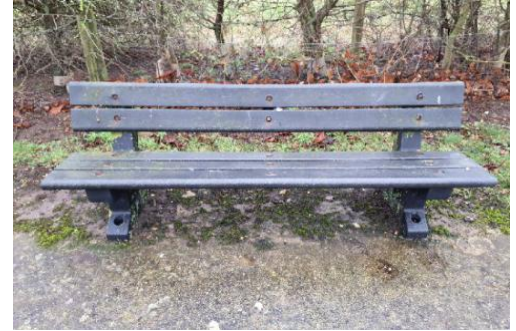
There is algae, silt or moss growth on the surface resulting in slippery conditions - Clean and treat appropriately

i 6 - Low Risk

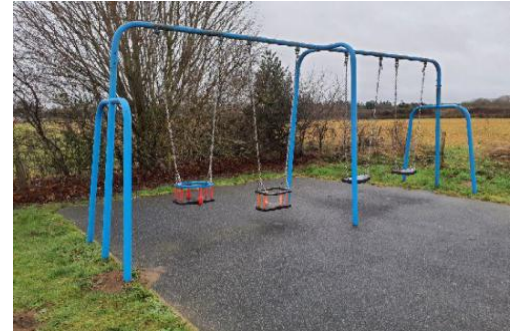
The surfacing dimensions are short and do not meet with the requirements of the current applicable standard - Monitor - no remedial action recommended

The seat clearance from finished surface level to the underside of the seat is too low and does not meet the requirements of BS EN 1176 Part 2 (350mm minimum clearance required / currently 220mm) - Adjust seat height/s (400mm-500mm is recommended)

There are gaps opening between the surfacing and the edging surround or between the joints in the surfacing - Monitor for any further deterioration and repair as required

The surface is lifting at the edges and creating trip points - Repair perimeter of surfacing to remove trip points

There is some notable evidence of chain wear - Monitor for any further deterioration and replace when 40% worn

The paintwork on this item has been damaged or worn exposing the metal underneath which is rusting / corroding - Treat affected areas and repaint

There is some wear to the shackles - Monitor for any further deterioration and replace when 40% worn

The bushes are worn or missing - Replace worn or missing bushes

The surfacing width under the seat/s is / are less than 875mm when measured from the centre of the seat outwards, and fails the requirements of BS EN 1176 Part 2 - Monitor - No remedial work recommended

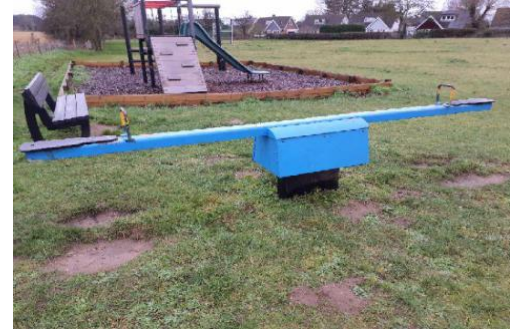
The grass has eroded within the impact area of the equipment and may not provide the necessary impact attenuating properties for the equipment fall height; the surface may also be slippery in wet weather - Reinstate the grass or provide an all weather surface

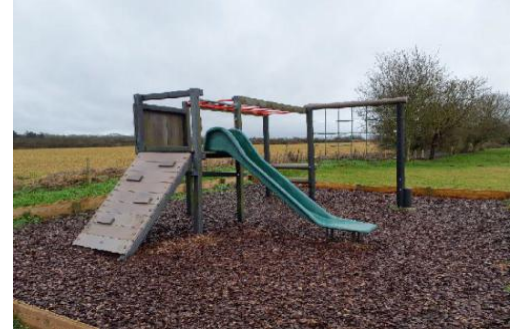
The exposed foundation forms a hard object within the impact area of the equipment in contravention of the requirements of BS EN 1176 Part 1 - Top up loosefill levels to cover foundations

The item has missing component(s) - Consider replacing missing components

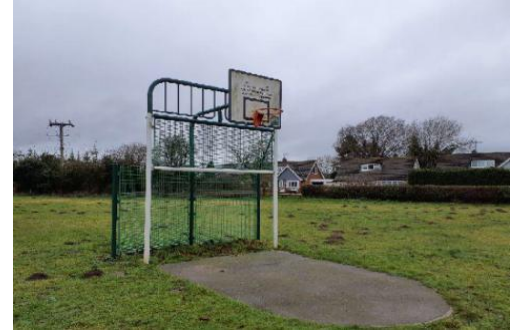
A clearly visible facility sign should be provided in a prominent position with the wording as detailed BS EN 15312- the equipment is not intended for children less than 3 years old- the warning - Do not climb on the framework or nets- the warning - Do not hang on the ring (if provided)- the warning - Do not wear rings or other jewellery- name and telephone number of the administrator- number to call in case of accident - Provide signage to BS EN 15312
